# Application of GPR on Forensic and Rehab Projects

**Dar-Hao Chen, John Bilyeu**  
**Tom Scullion, Andrew Wimsatt, Lee Gustavus**

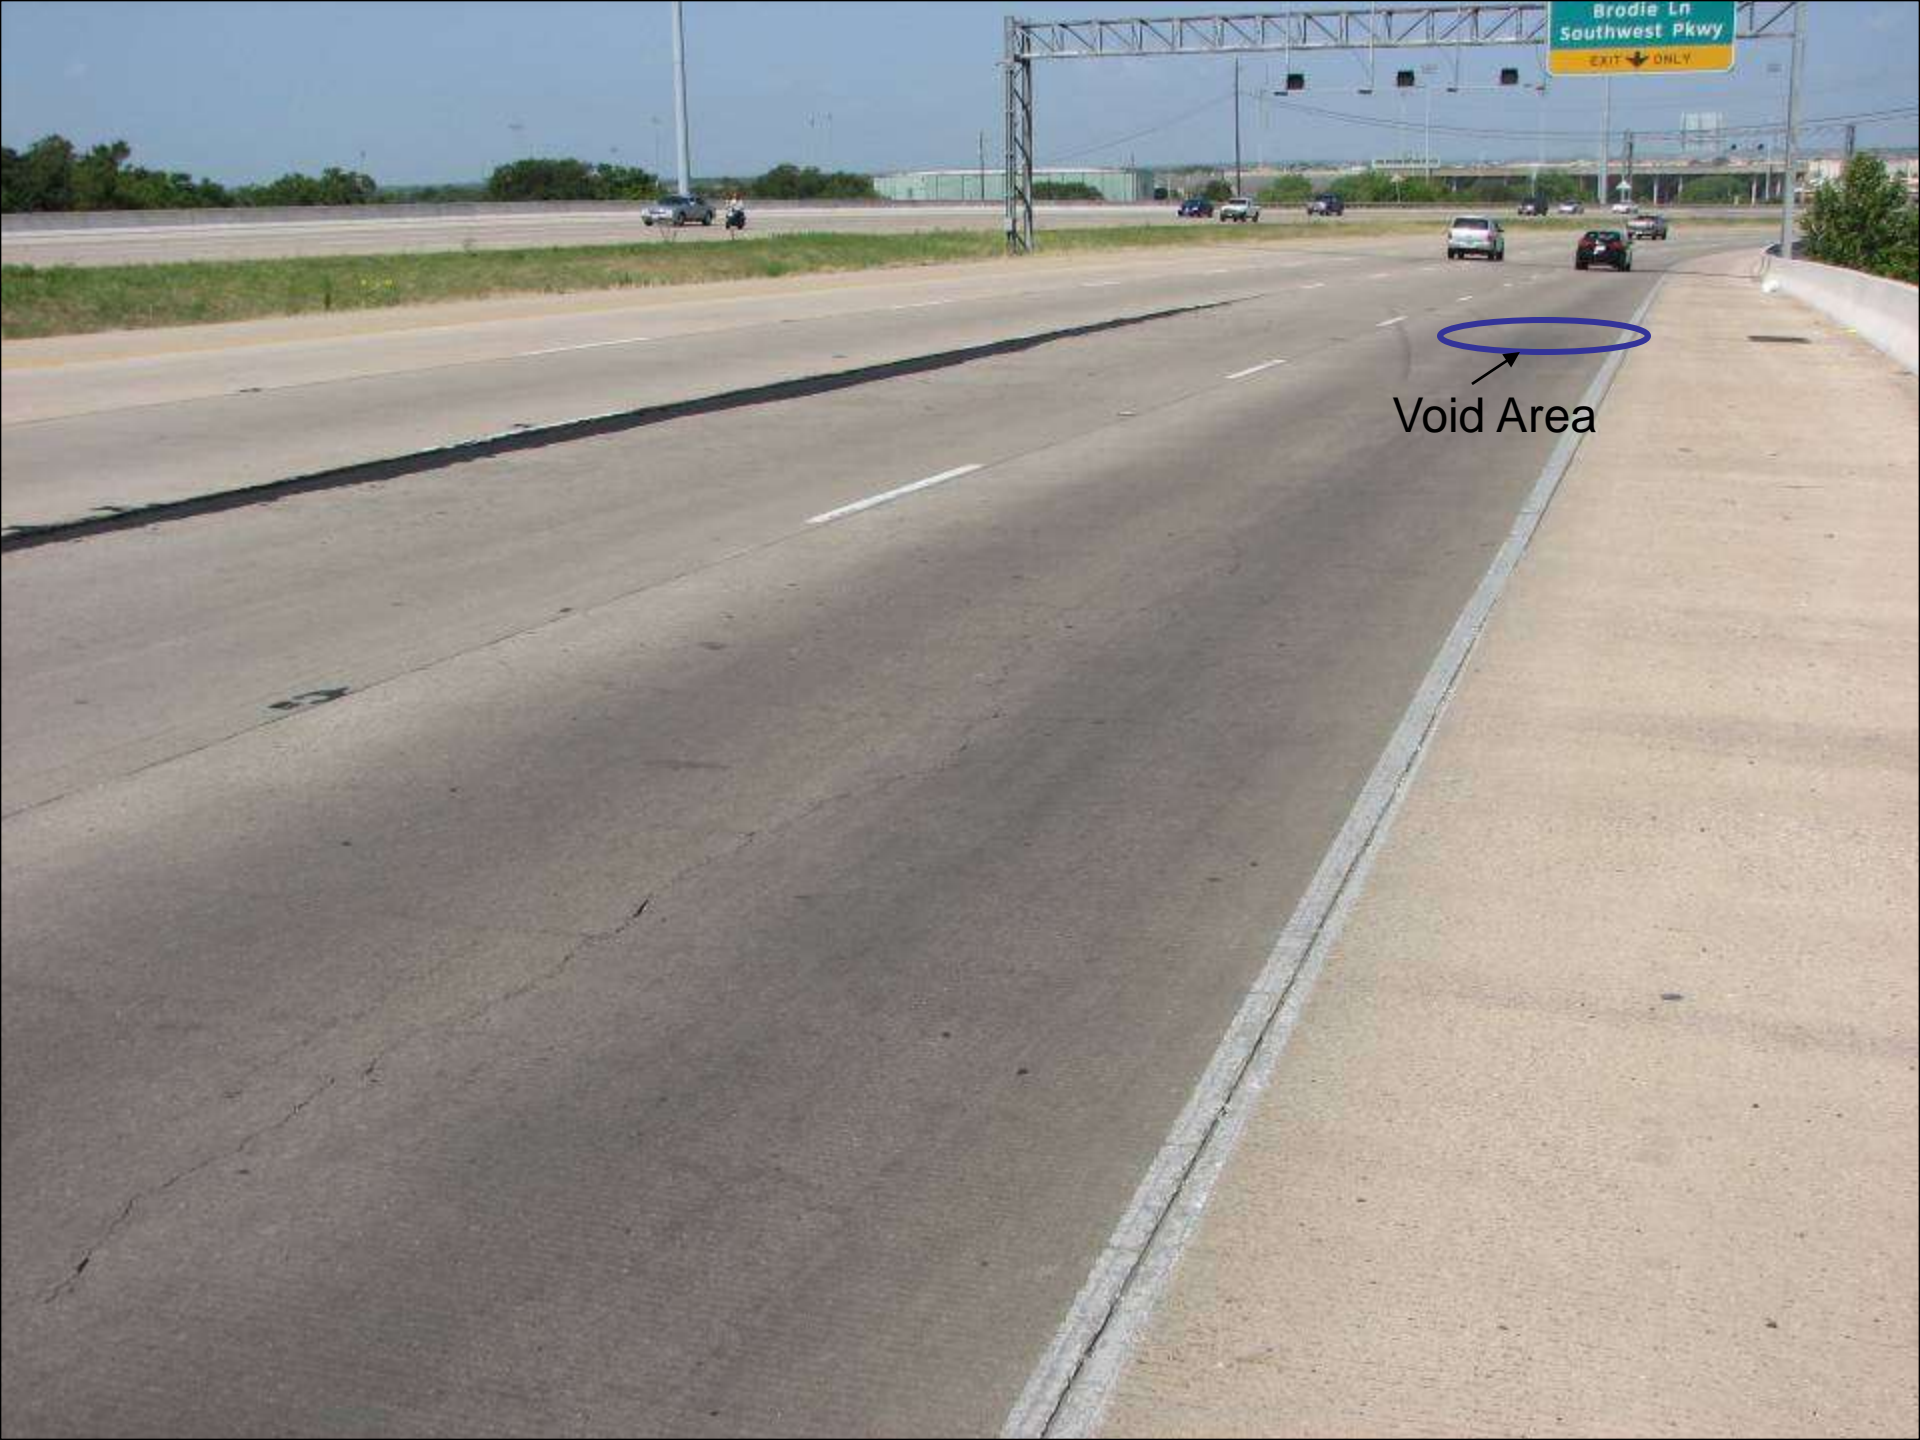
Void Area

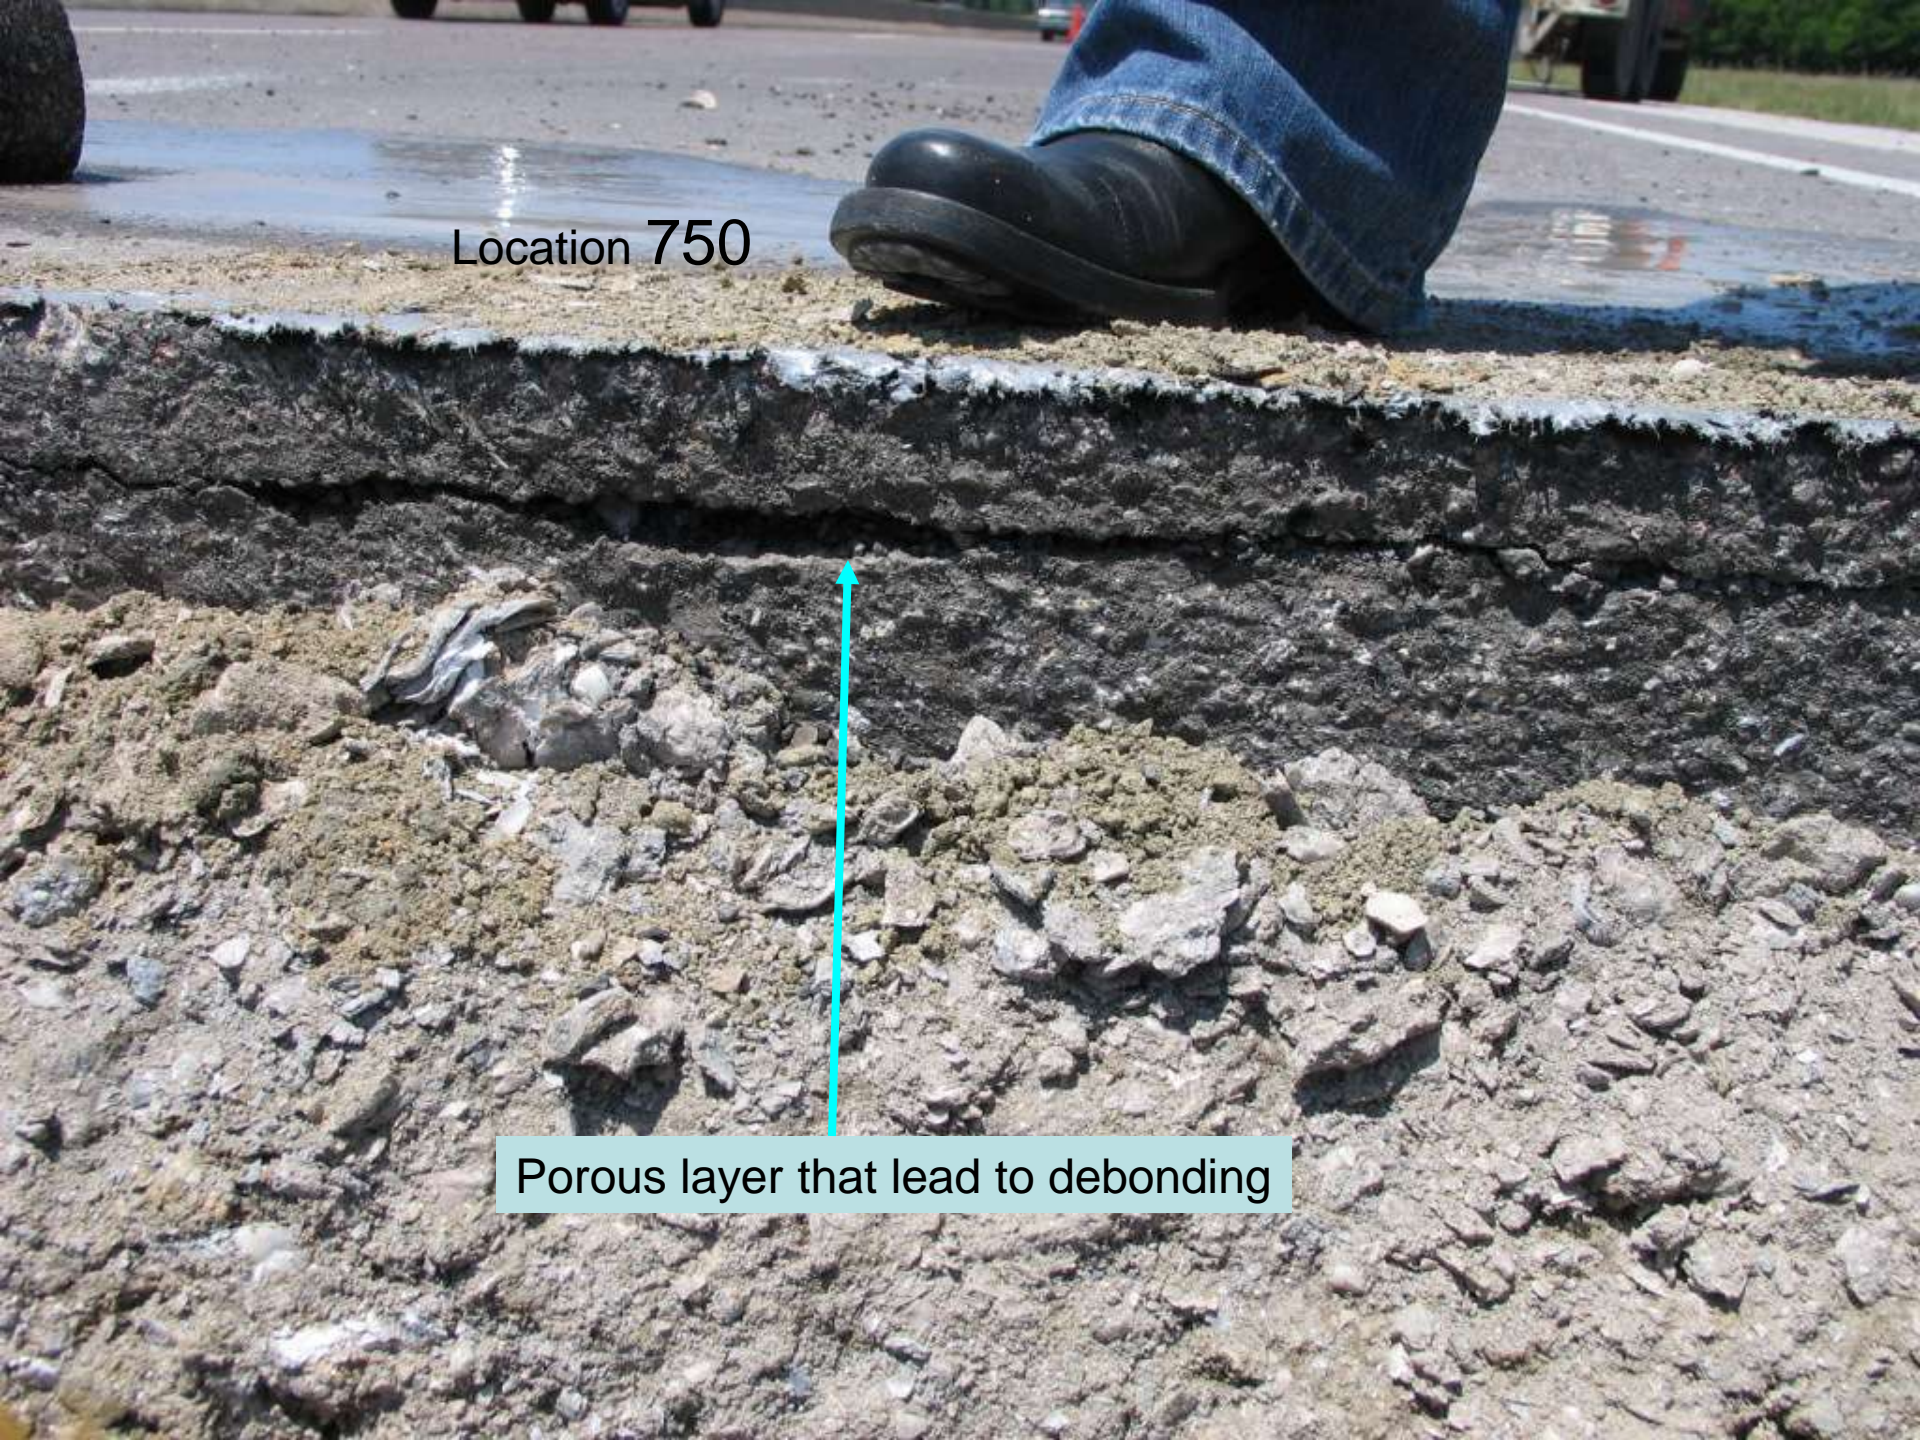
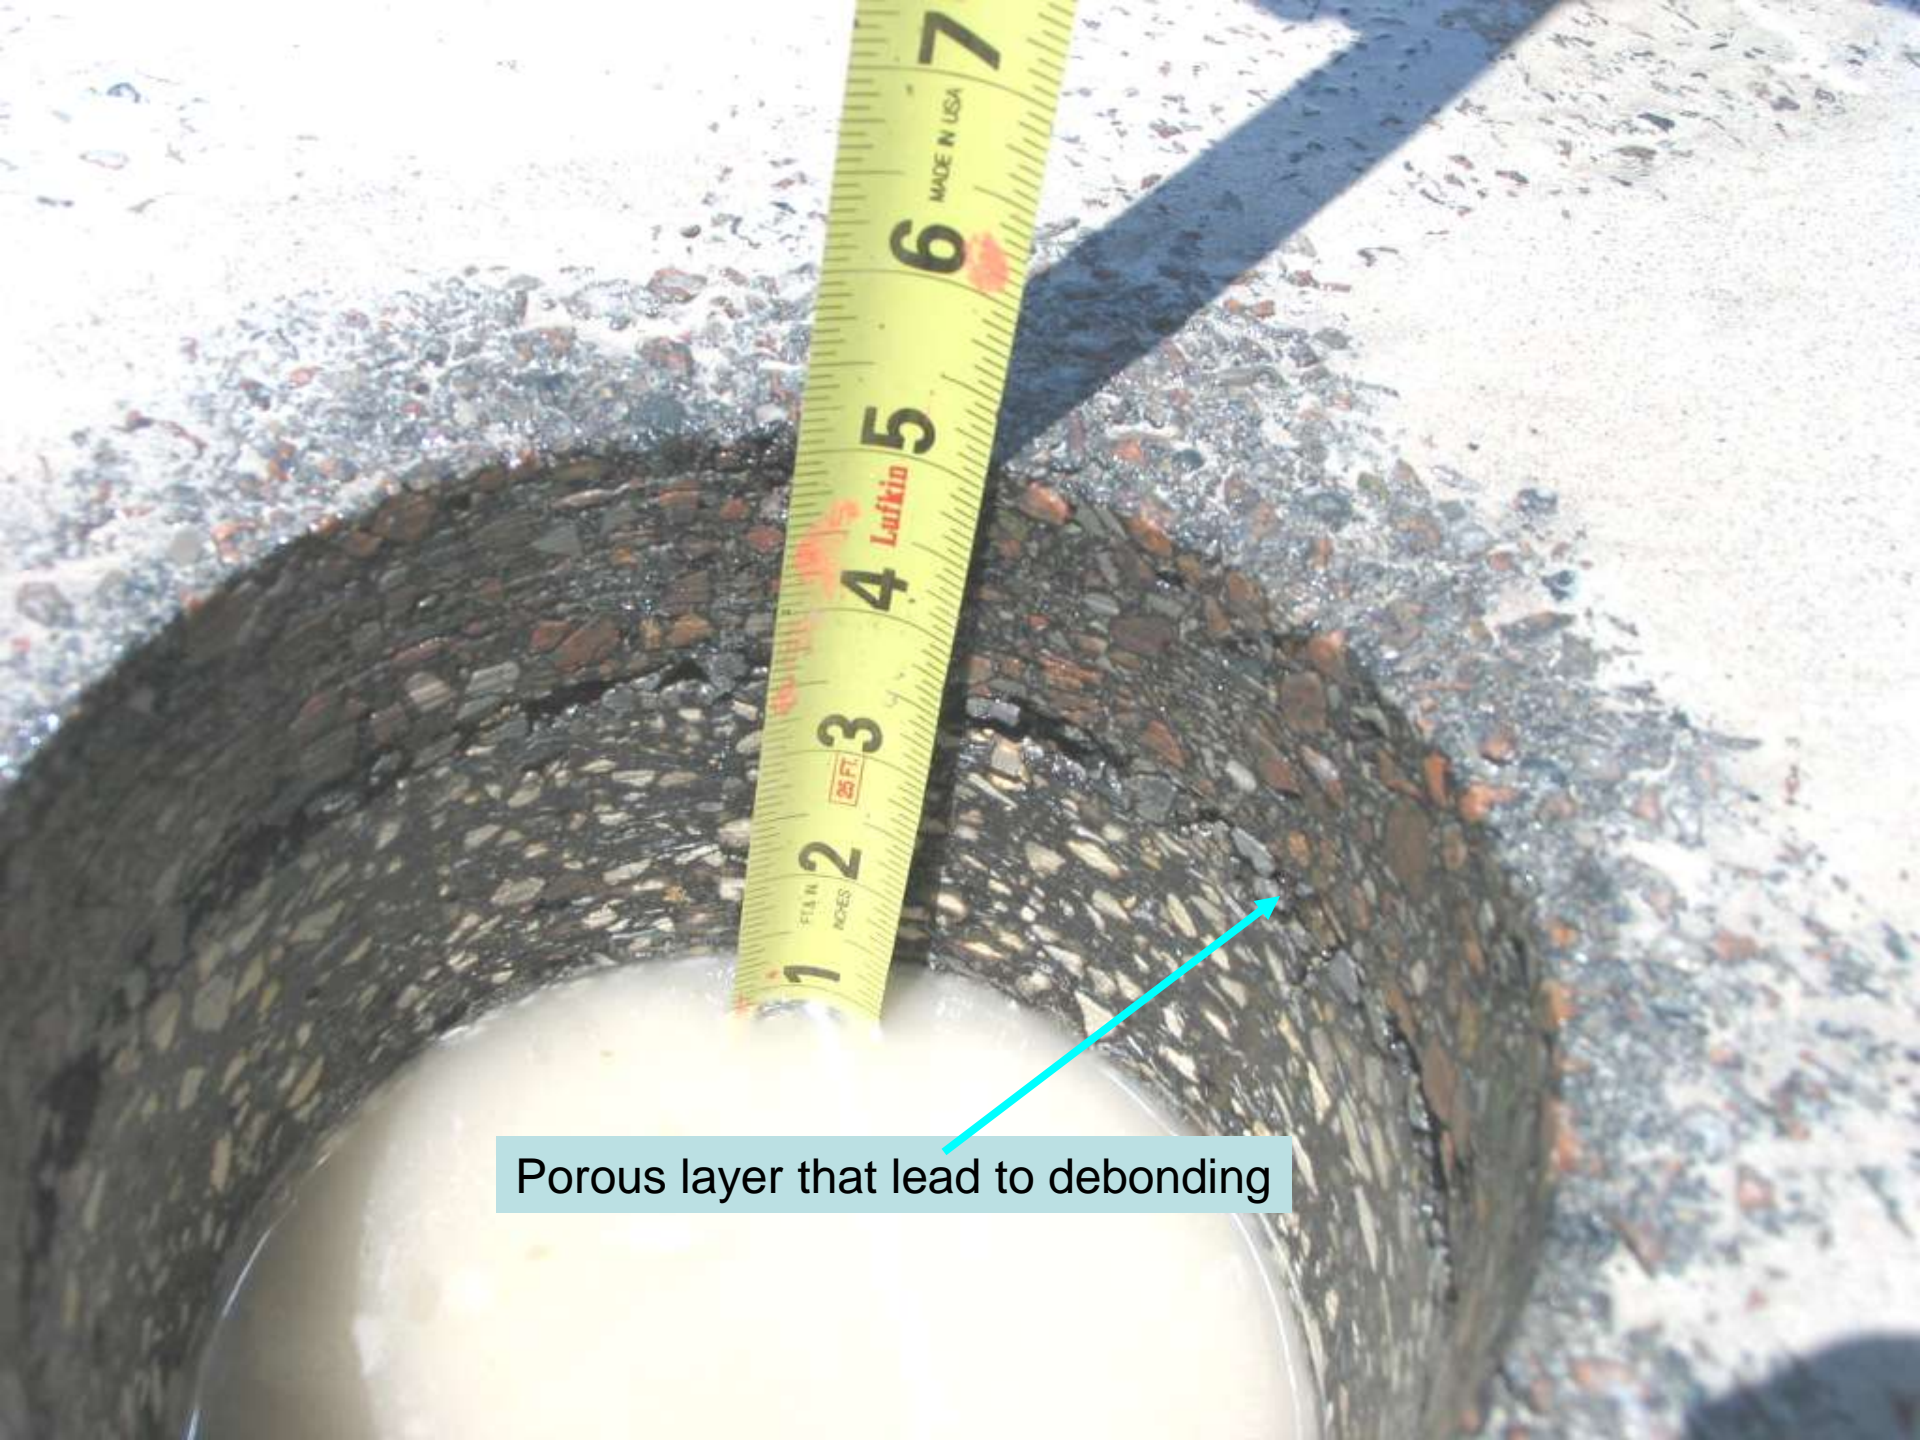
Porous layer that lead to debonding

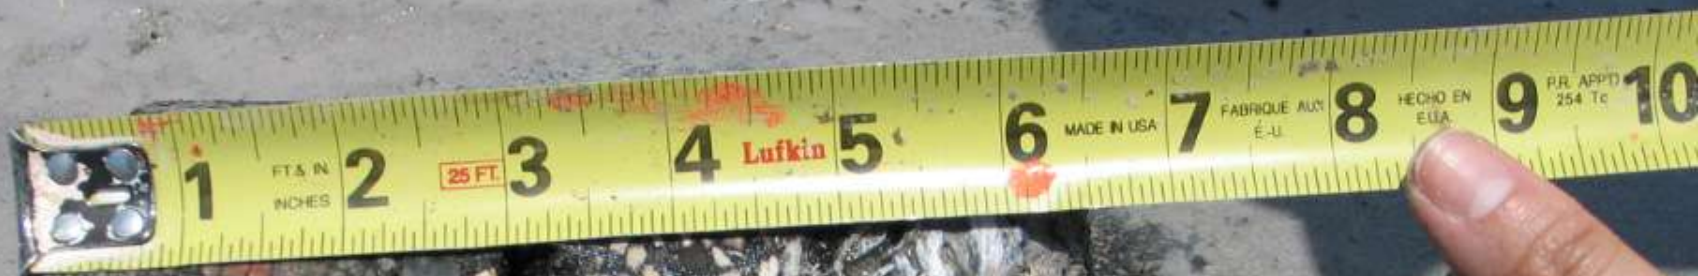
Debonded at 2.75 inch

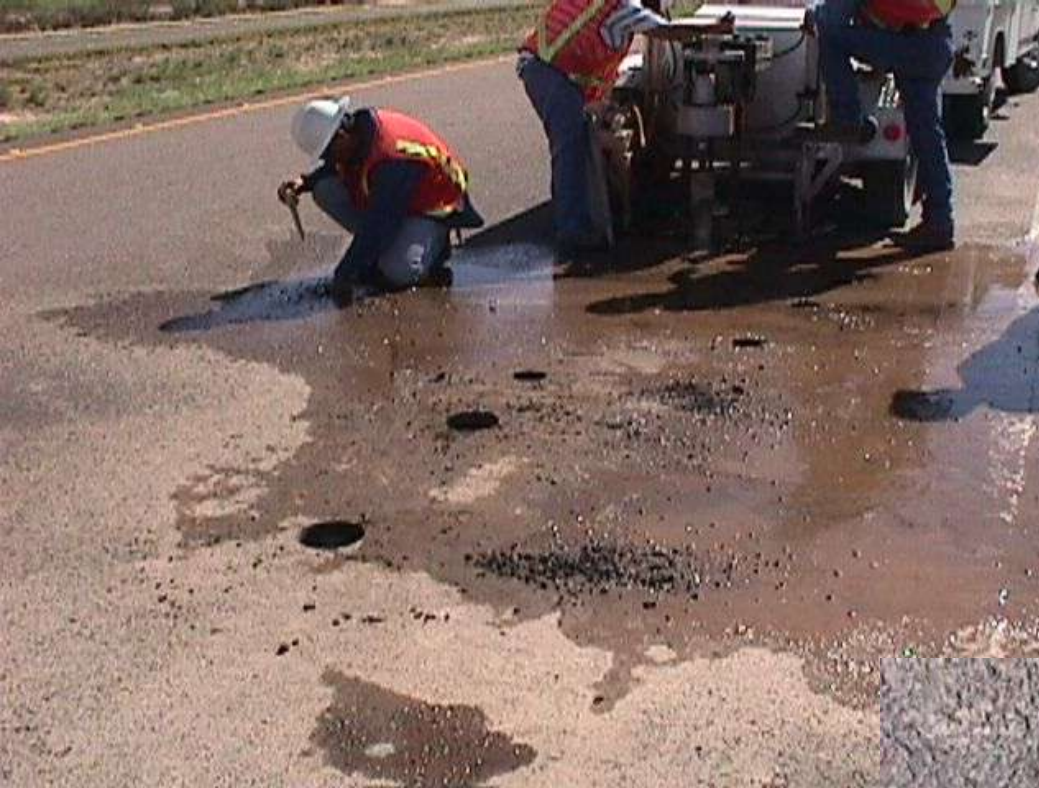
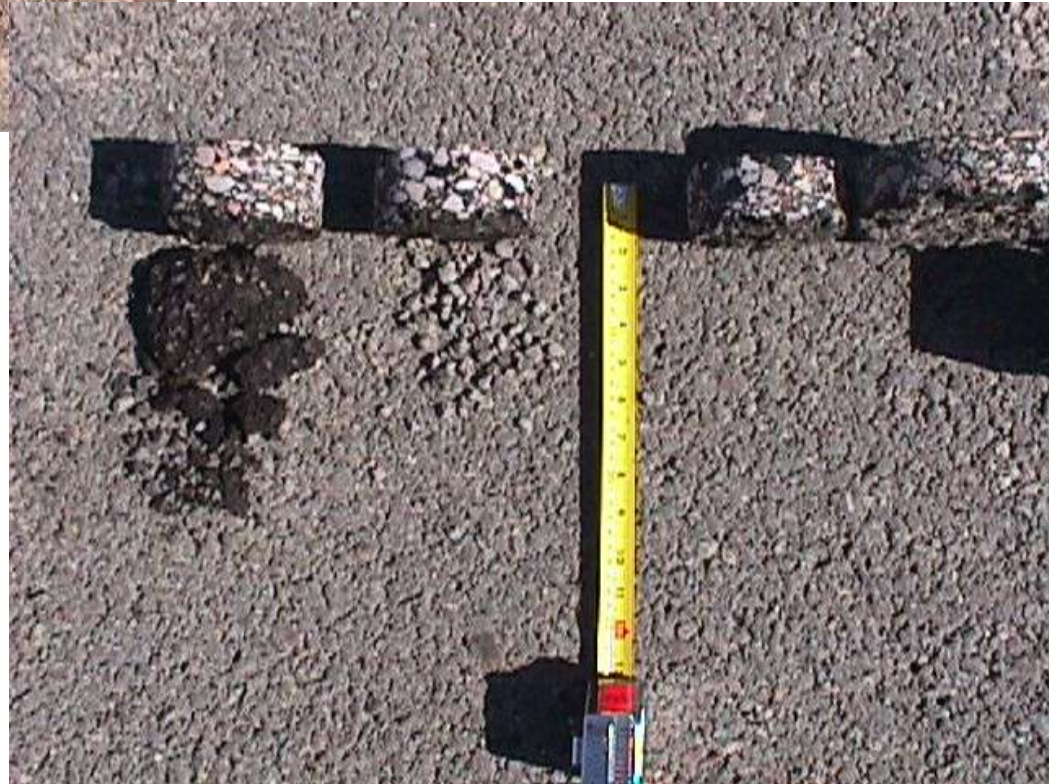
Stripping on US 175

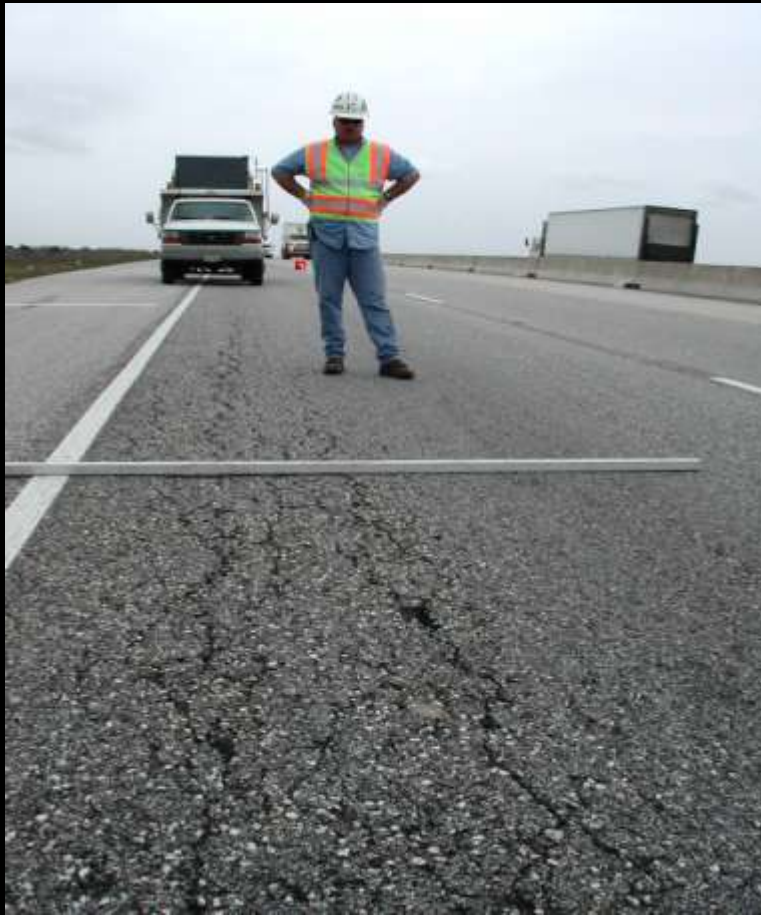
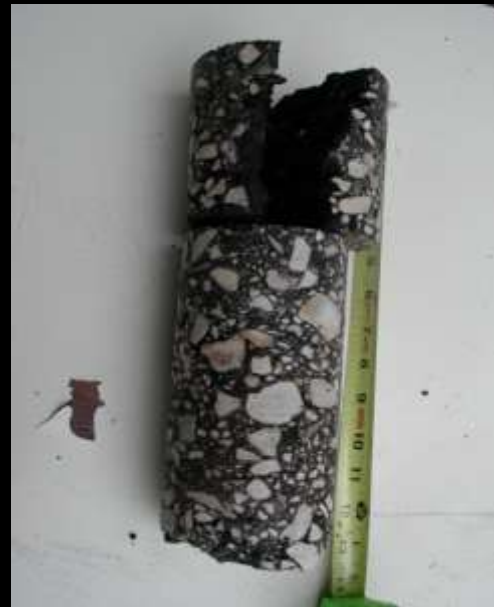
- Segregation all layers
- Burnt binder
- Poor tack

**Surface  
de-bonding**

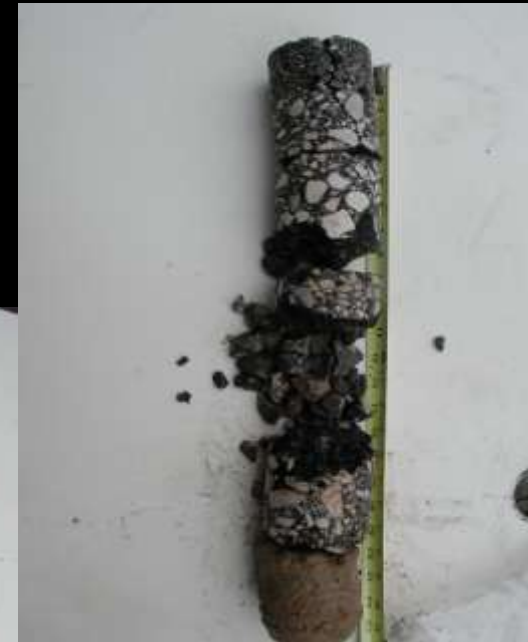
**Continued  
subsurface  
deterioration**
