“Creating affordable & reliable roads”

Health issues raised by poorly maintained road networks

Task leader: Johan Granlund
Swedish Road Administration, Consulting Services

Tests at the *Beaver Road 331*

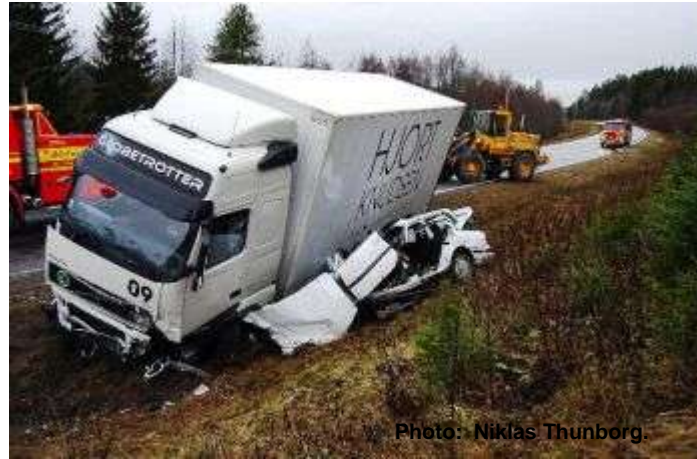
Yet a tragedy at the Beaver Road

Car driver killed by HGV, skidding on slippery “Black ice” at the Beaver Road 331.

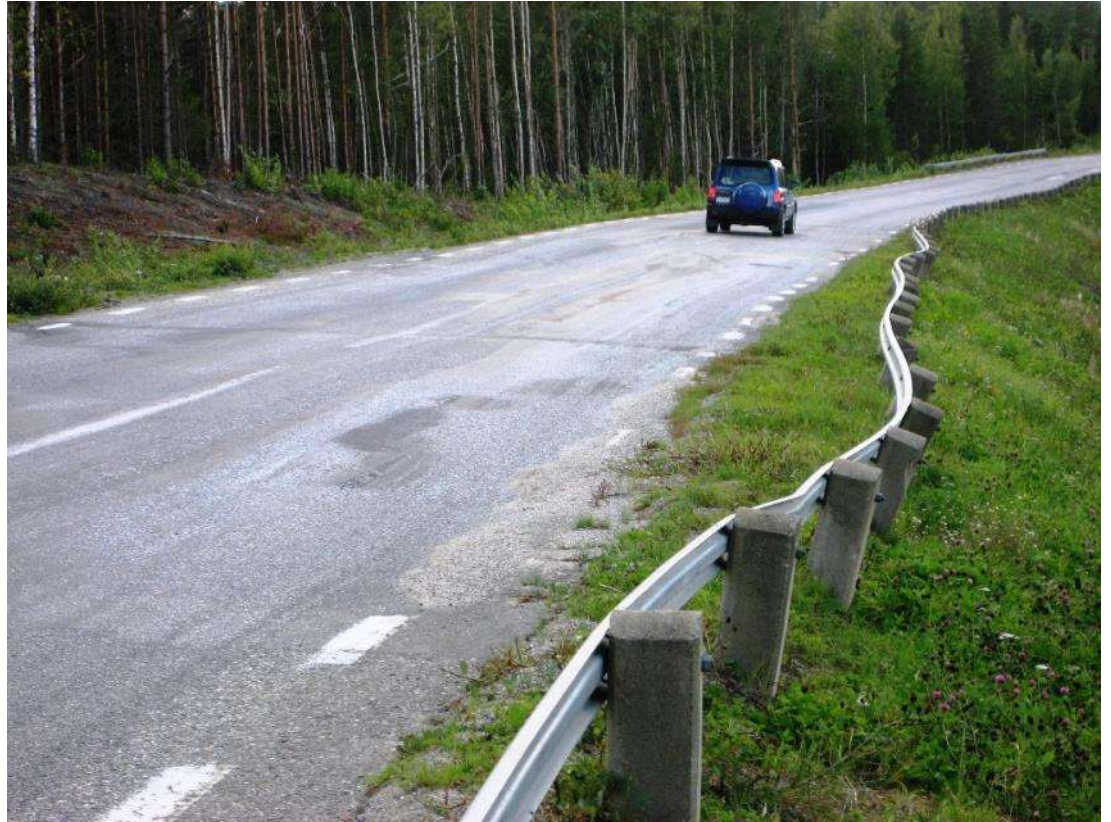
Road user behaviour at Rd 331

**Car driver avoiding
edge deformations.**

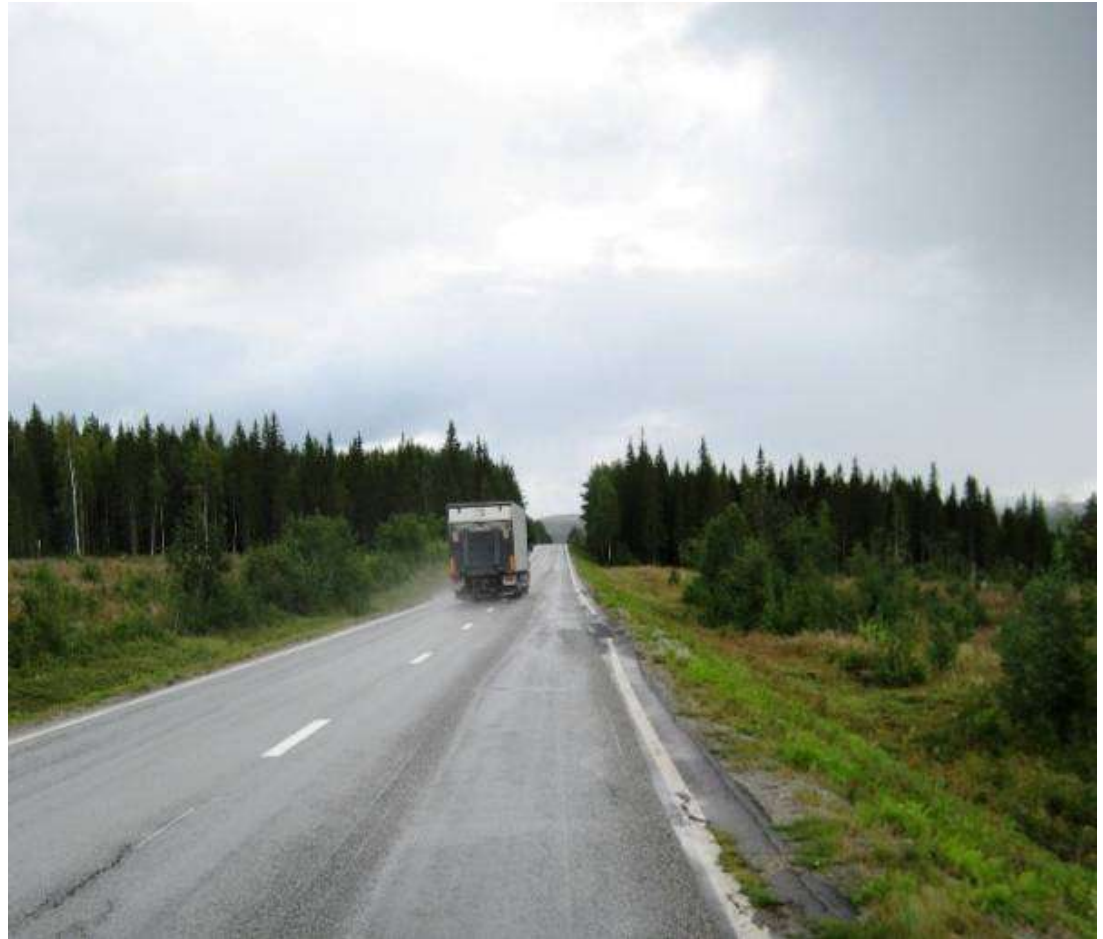
Behaviour at Rd 331, cont'd

**Truck driver avoiding
edge deformation.**

On heavy truck routes such as the Beaver Road 331, the pavement shoulders needs to be widened and strengthened.

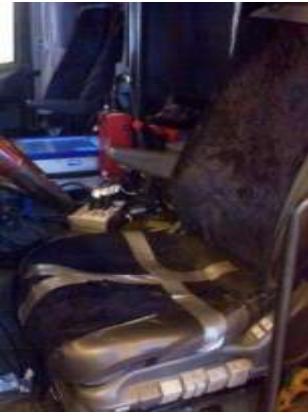
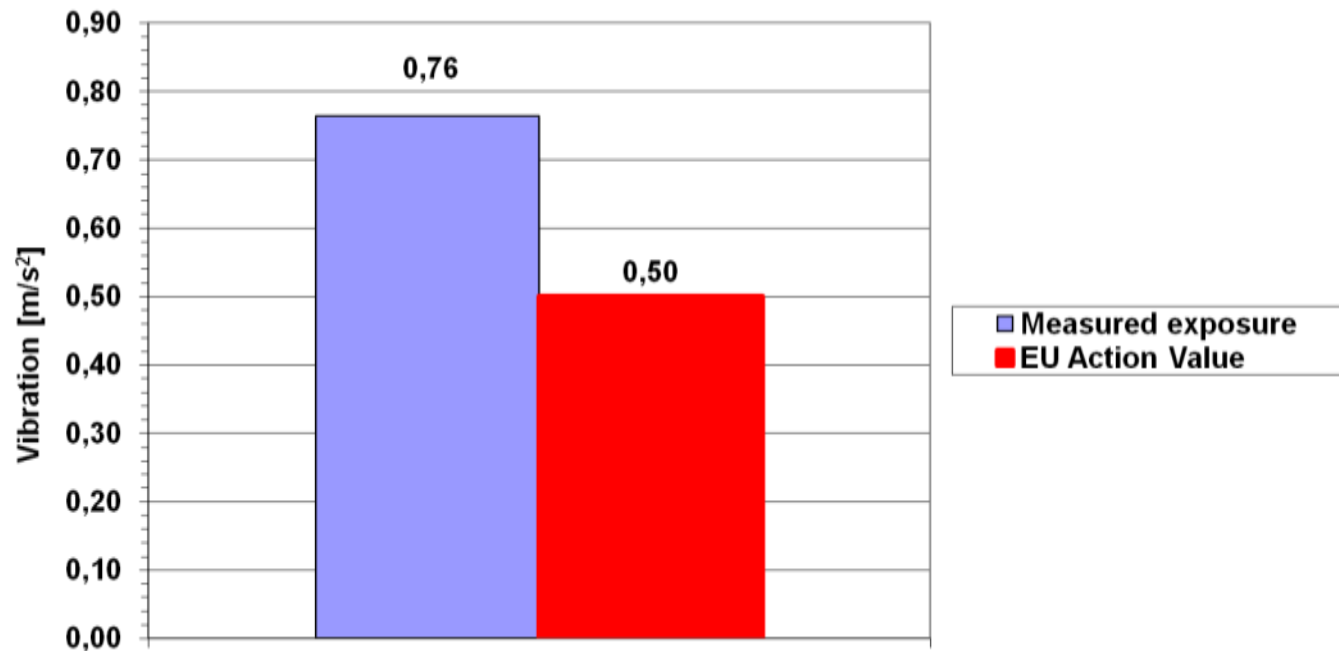
Results: 1. Daily vibration exposure $A(8)$

$$A(8) = 0.76 \text{ m/s}^2.$$

Exceeding the EU Action Value 0.5 m/s^2 .

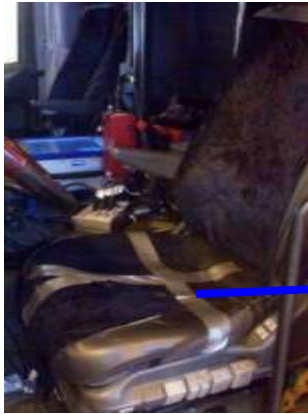
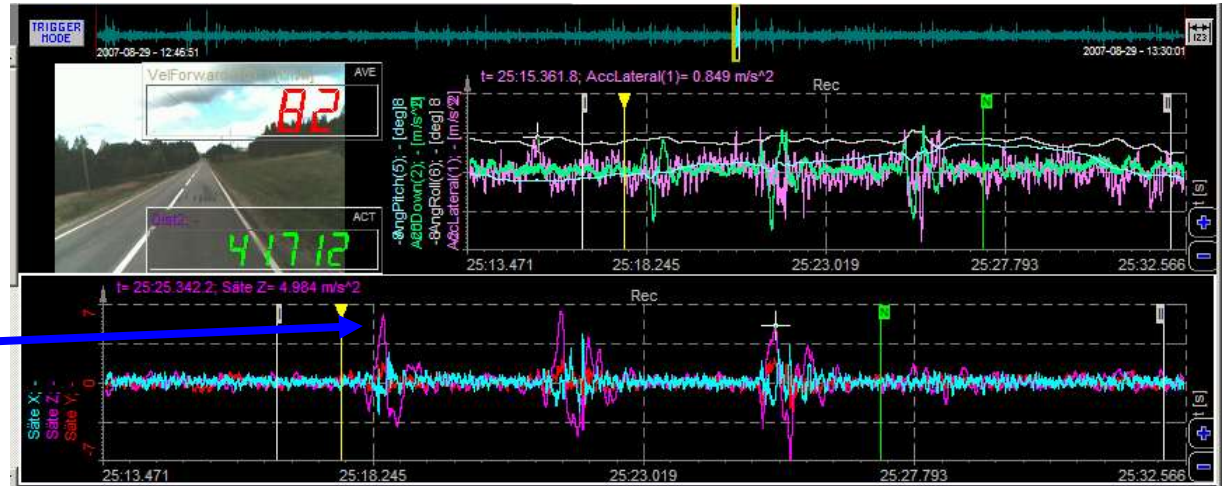
2. Bumps gave high compression stress

Transient vibration may cause high compression stress in the spine; a special health risk.

The worst bumps gave $S_{ed} > 0.5$ MPa.

Exceeding this stress level corresponds to health risk, as per ISO 2631-5 (2004).

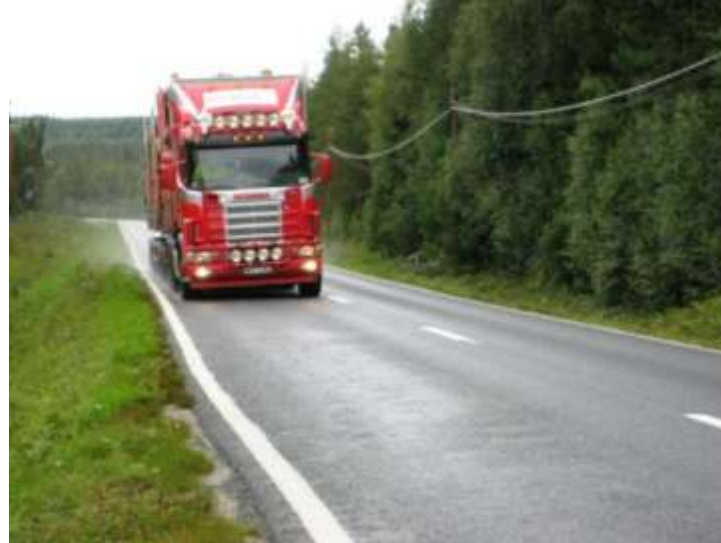
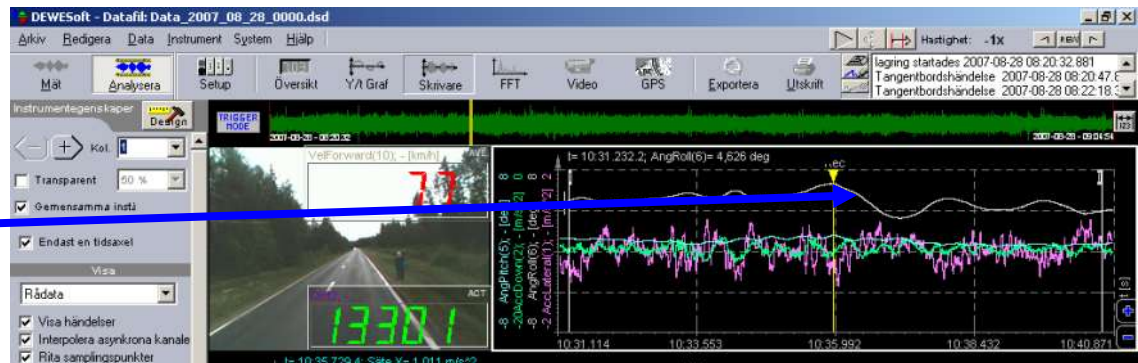
Rock n' Roll at Hazardous Site Backe

**Note the snake
rattling warping
between truck and
trailer.**

**In-truck data:
3,5°/s change in cab
roll angle**

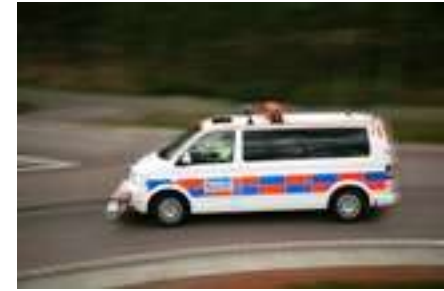
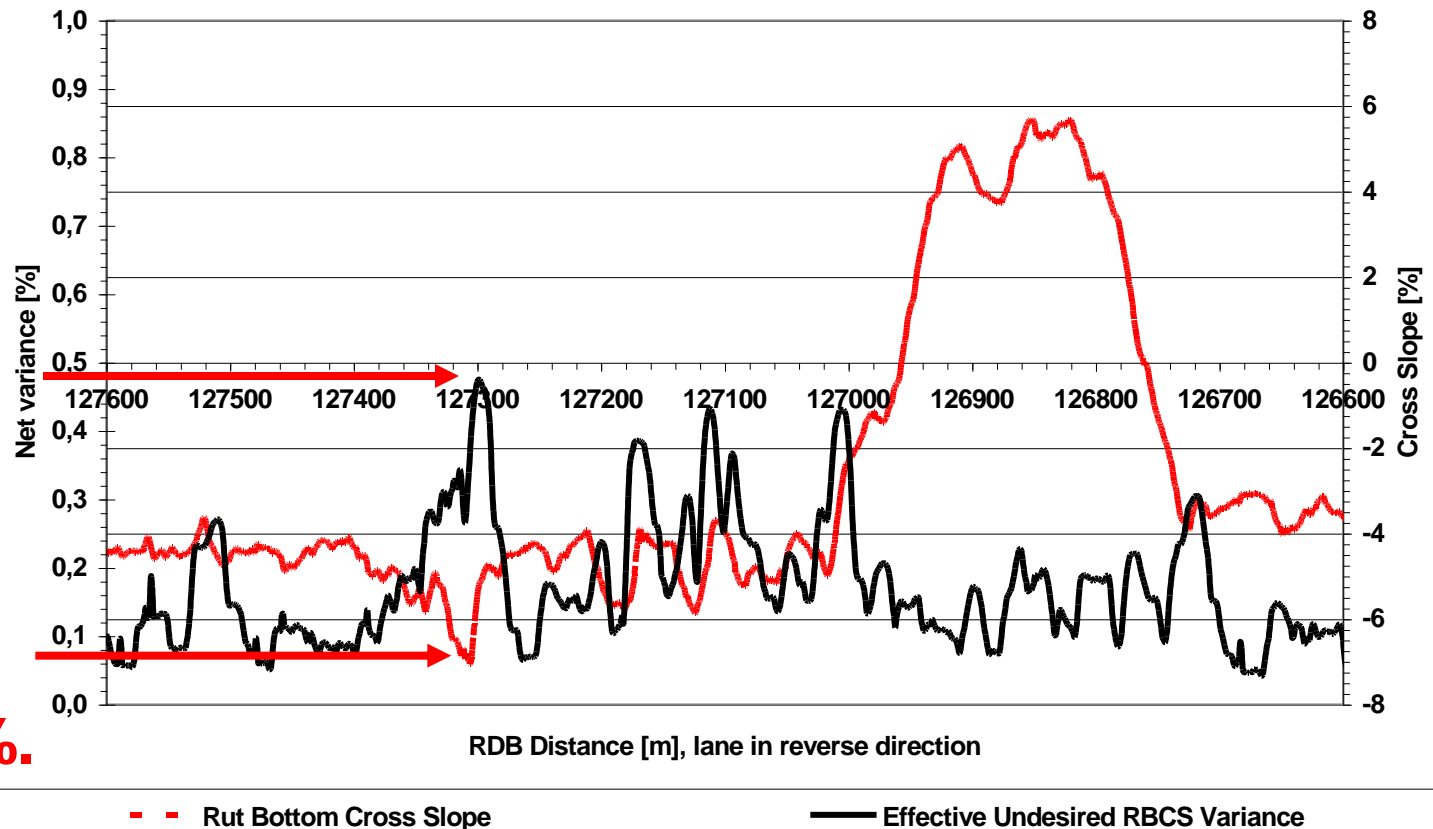
High RBCS variance at HS Backe

Alarm!
0.47 % RBCS
variance.
Cross Slope
warps
between
-5 and -7 %.

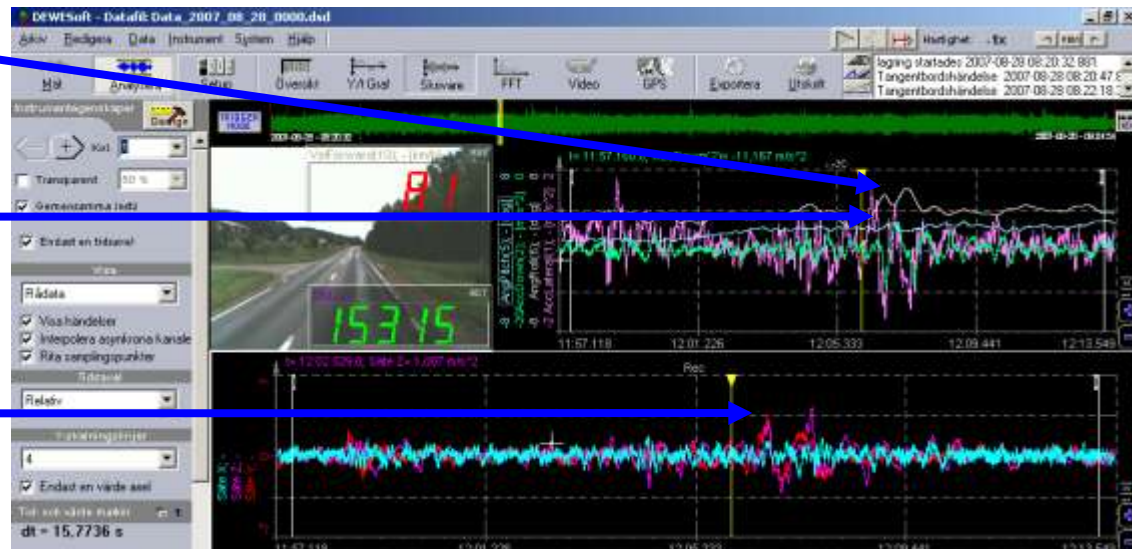
Rock n' Roll at HS Åkerö

**- Very high rate;
5°/s (at high freq).**

**High lateral acc in
cab: 2 m/s².**

**Very high lateral acc at
driver seat : 3.5
m/s². (+ 75 %)**

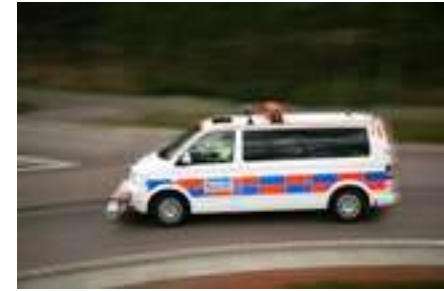
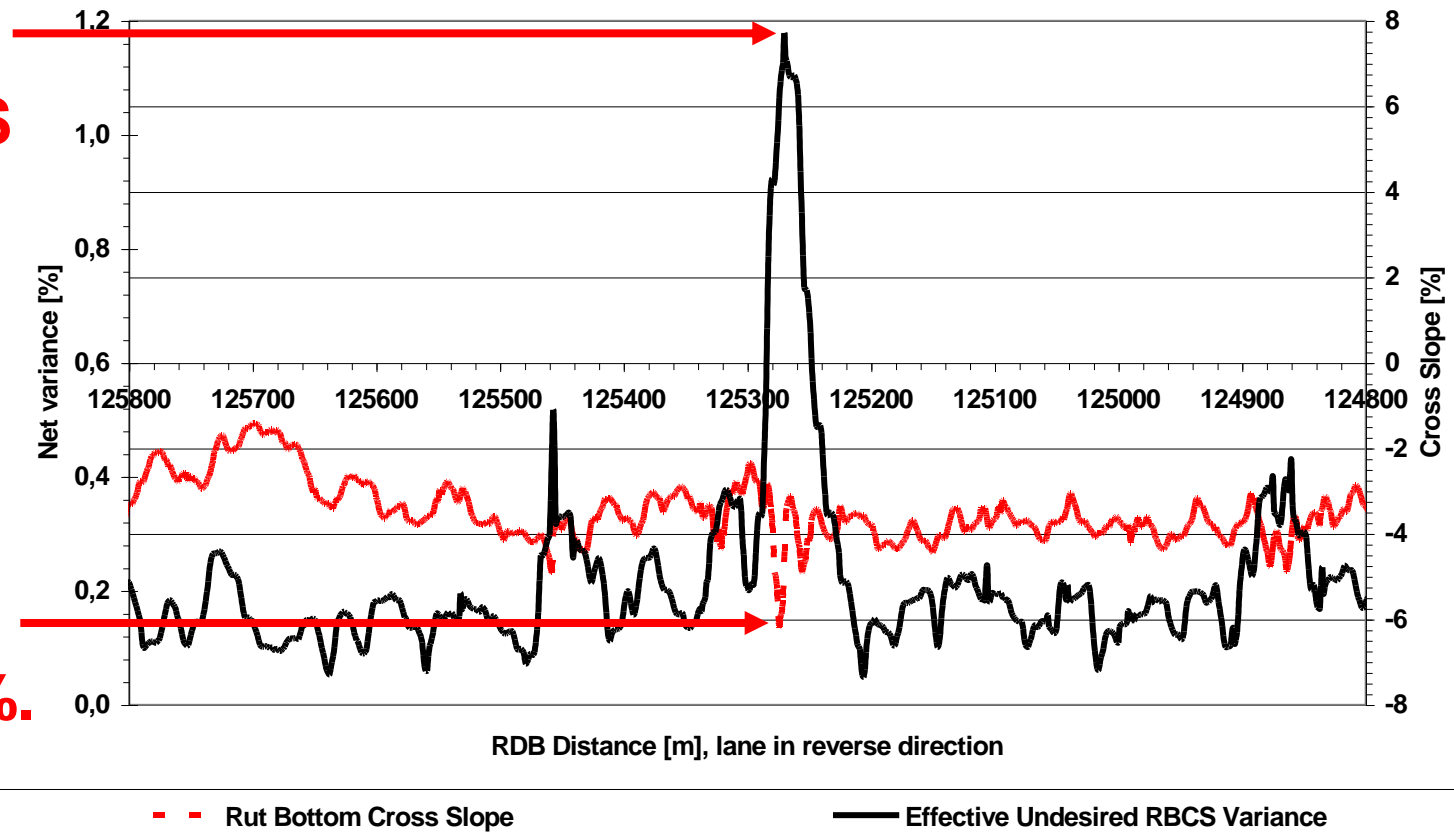
High RBCS variance at HS Åkerö

**1.18 % RBCS
variance.**

**RBCS warps
between
-3 and -6 %.**

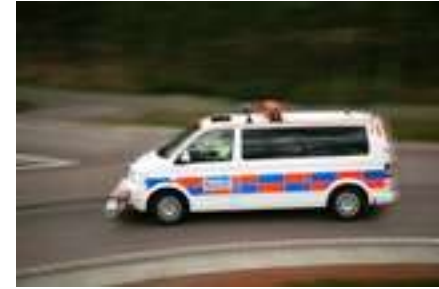
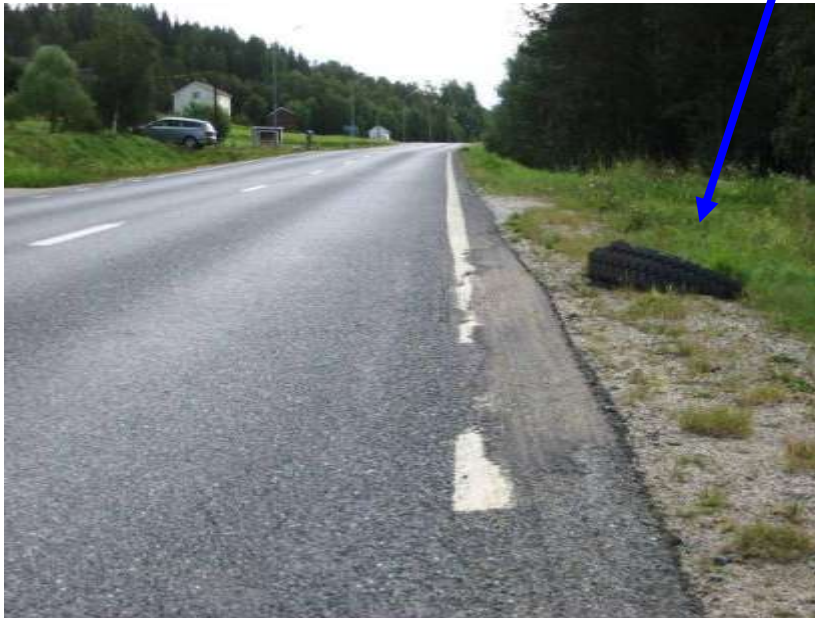
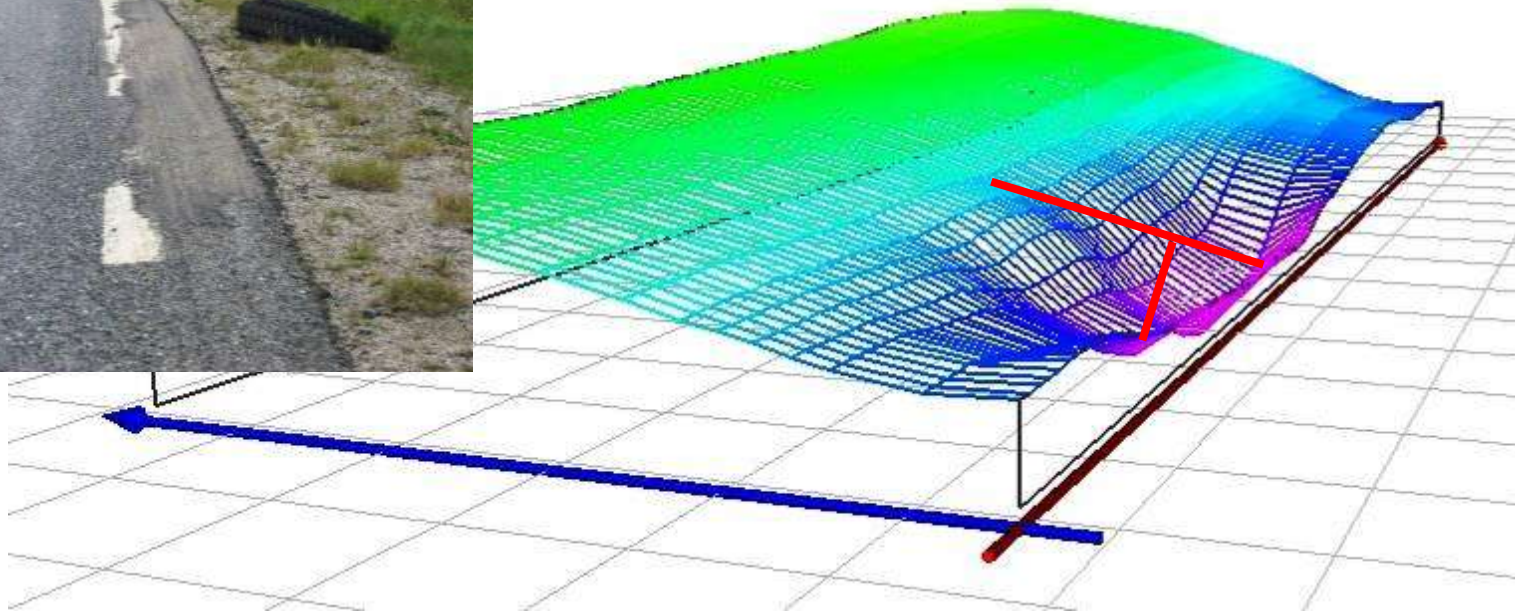
3D laserscan at HS Åkerö

Note: Exploded truck tire

**The 1.18 % RBCS variance
was caused by a 69 mm
deep deformation**

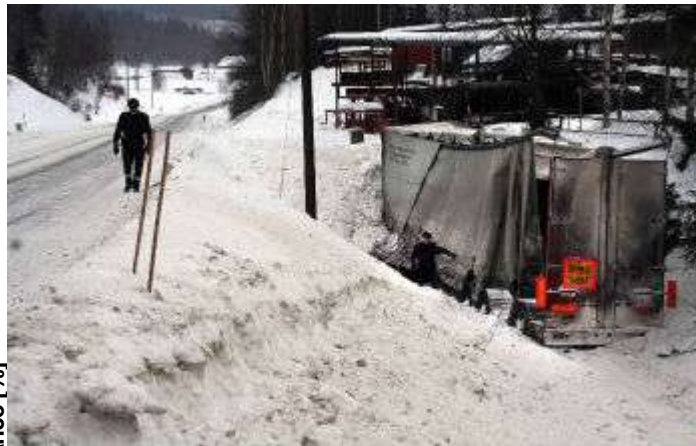
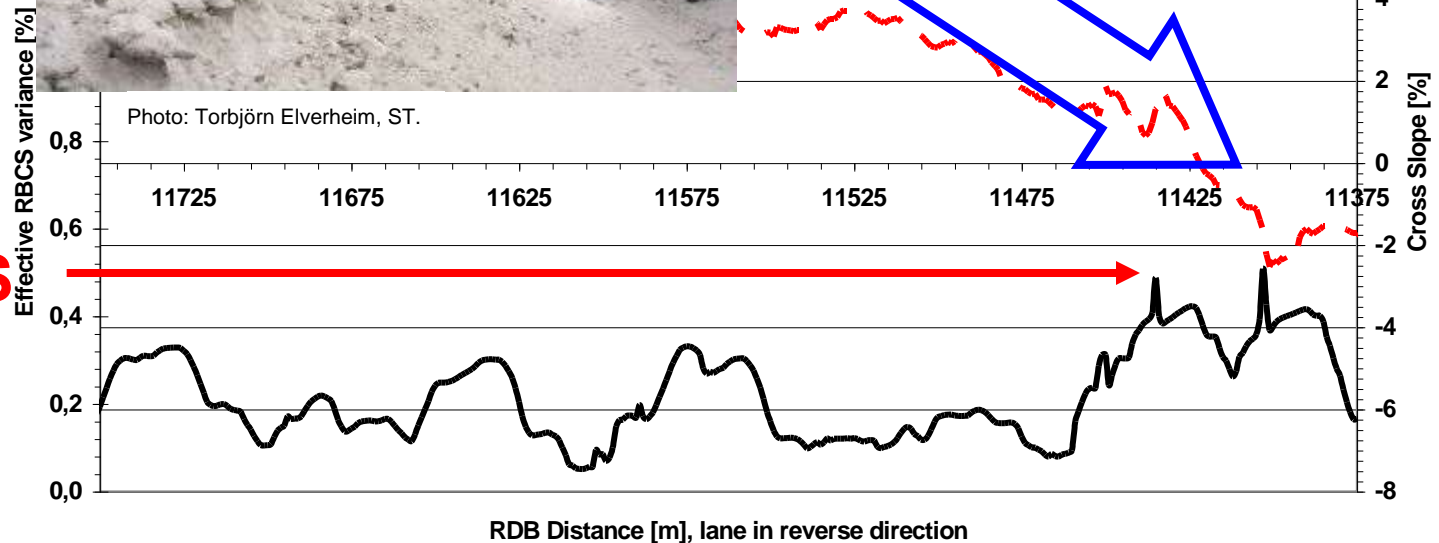
RBCS at HS Åsäng

Police: *The road surface was polished into zero friction.*

Alarm!
0.49 % RBCS
variance.

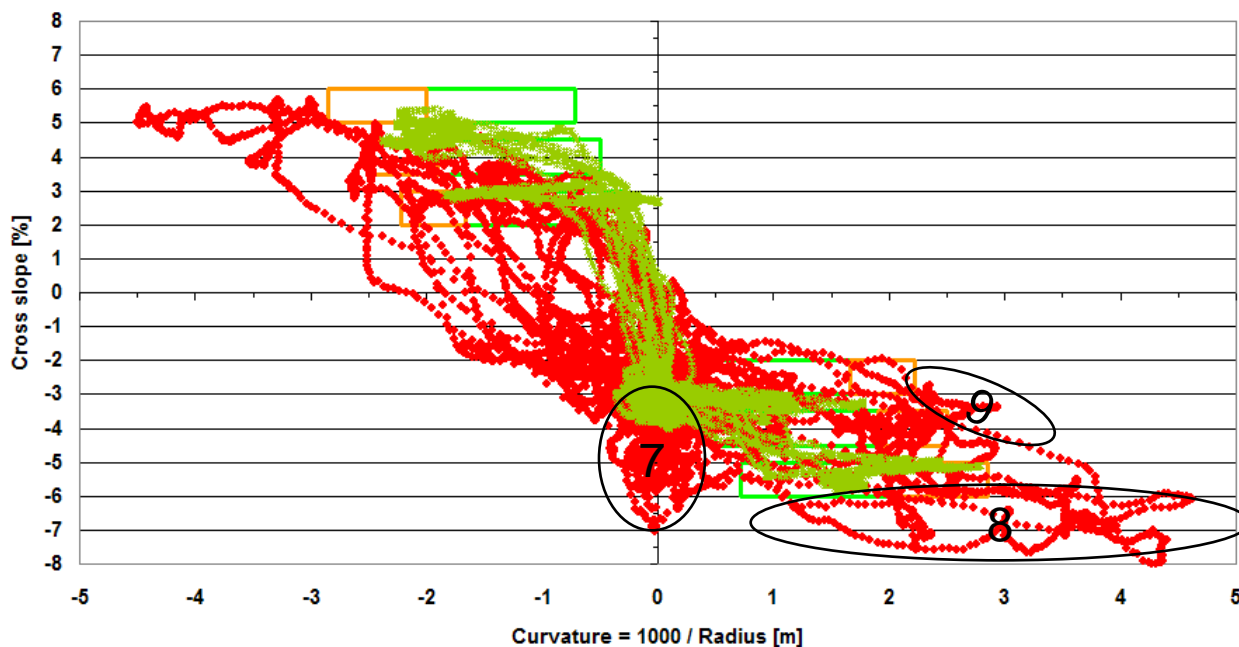
Rd 331: Improperly banked curves

7: Too much CS – uncomfortable.
Also hazardous when changing lane.

8: Too much CS – slip risk!

9: Too little CS – skid risk!

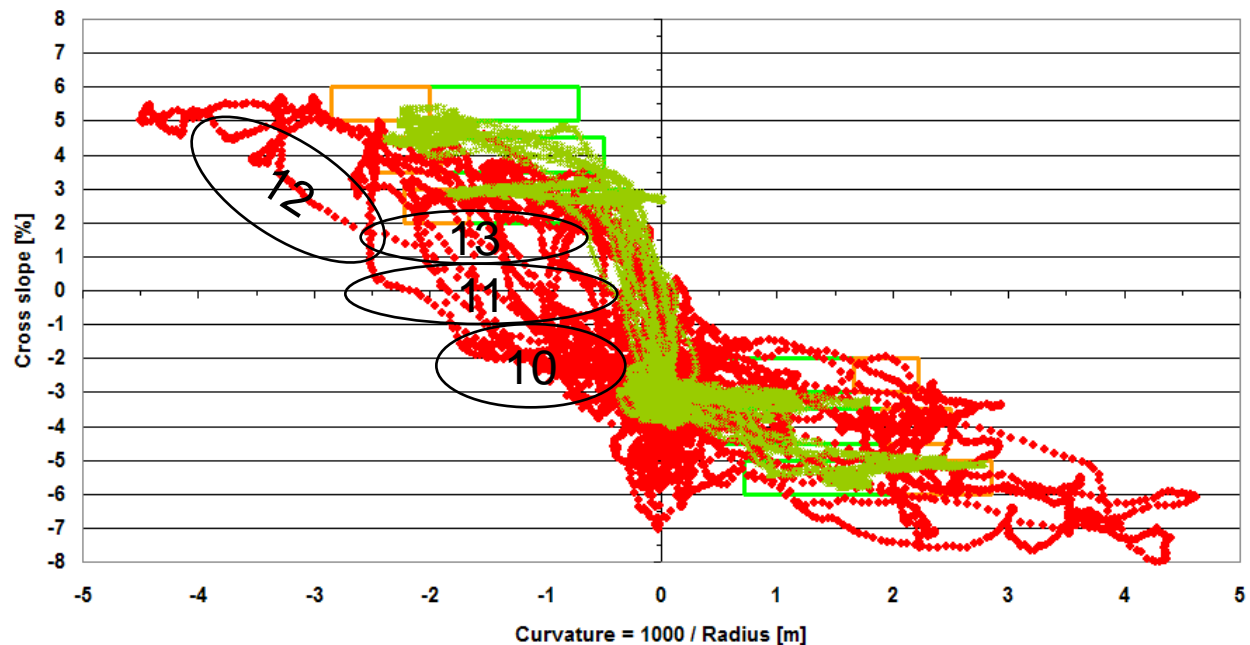
Improperly banked curves, cont'd

10: Negative CS – roll over risk!

12: Too little Cross Slope – skid risk!

11: No CS – skid risk!

10 - 13: Poorly synchronized transitions

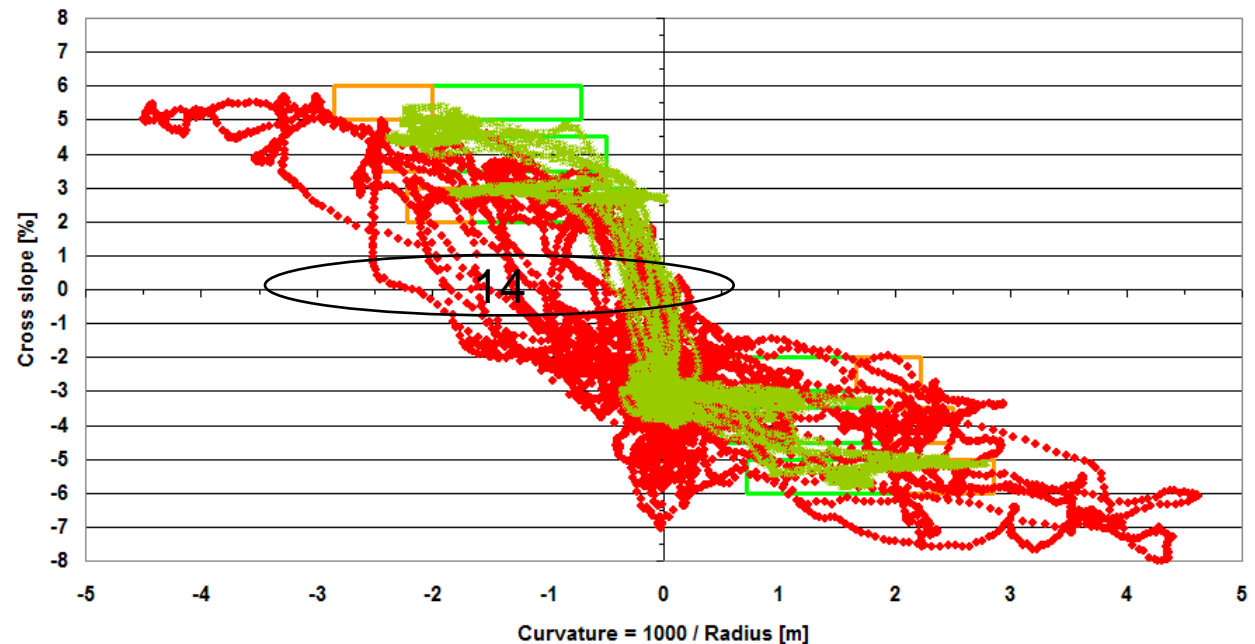
Improperly banked curves, cont'd

14: High skid risk - No Cross Slope!

Must have longitudinal Gradient for a Drainage Gradient > 0.5 %

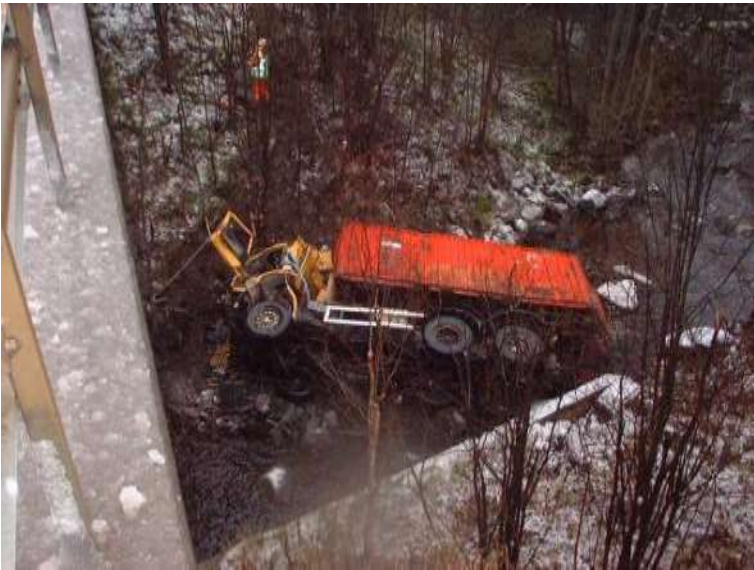
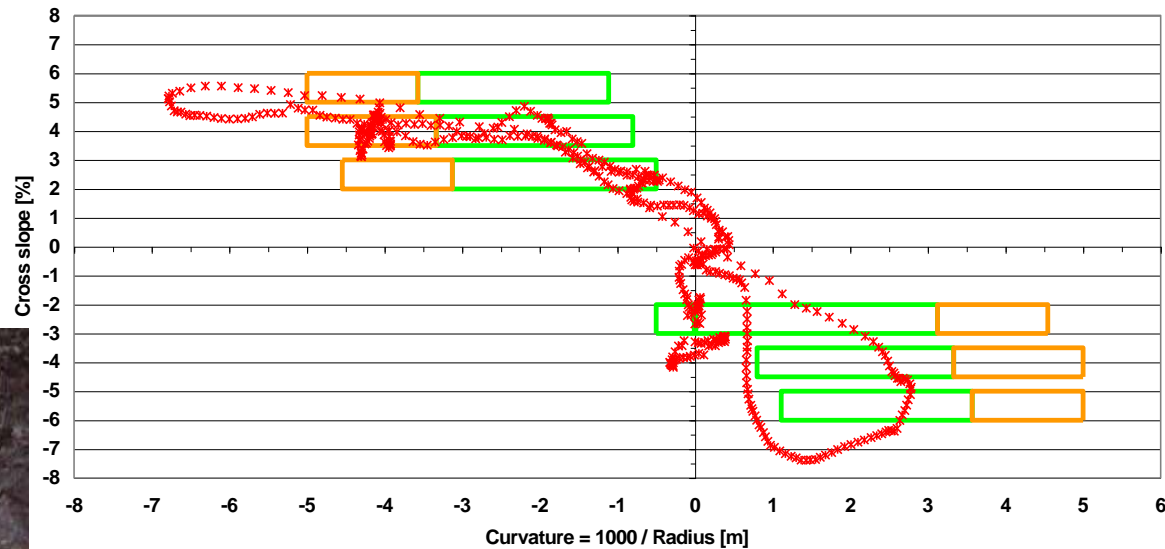
Hazardous Site Viksjö S

Lethal crash in Viksjö
*23 year driver died when
his heavy truck crashed
into rift*

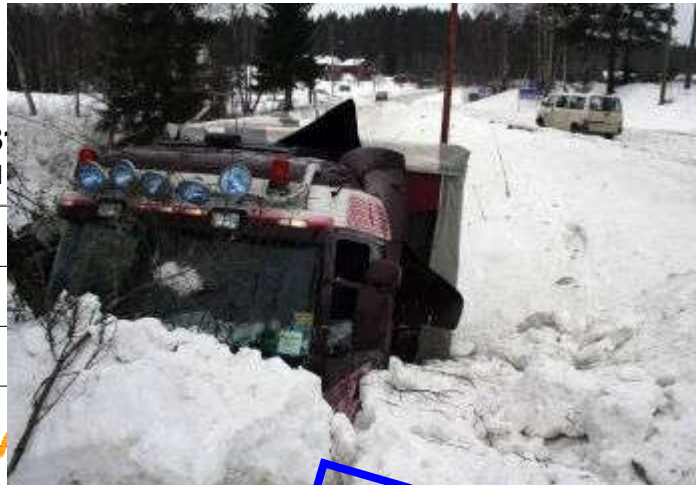
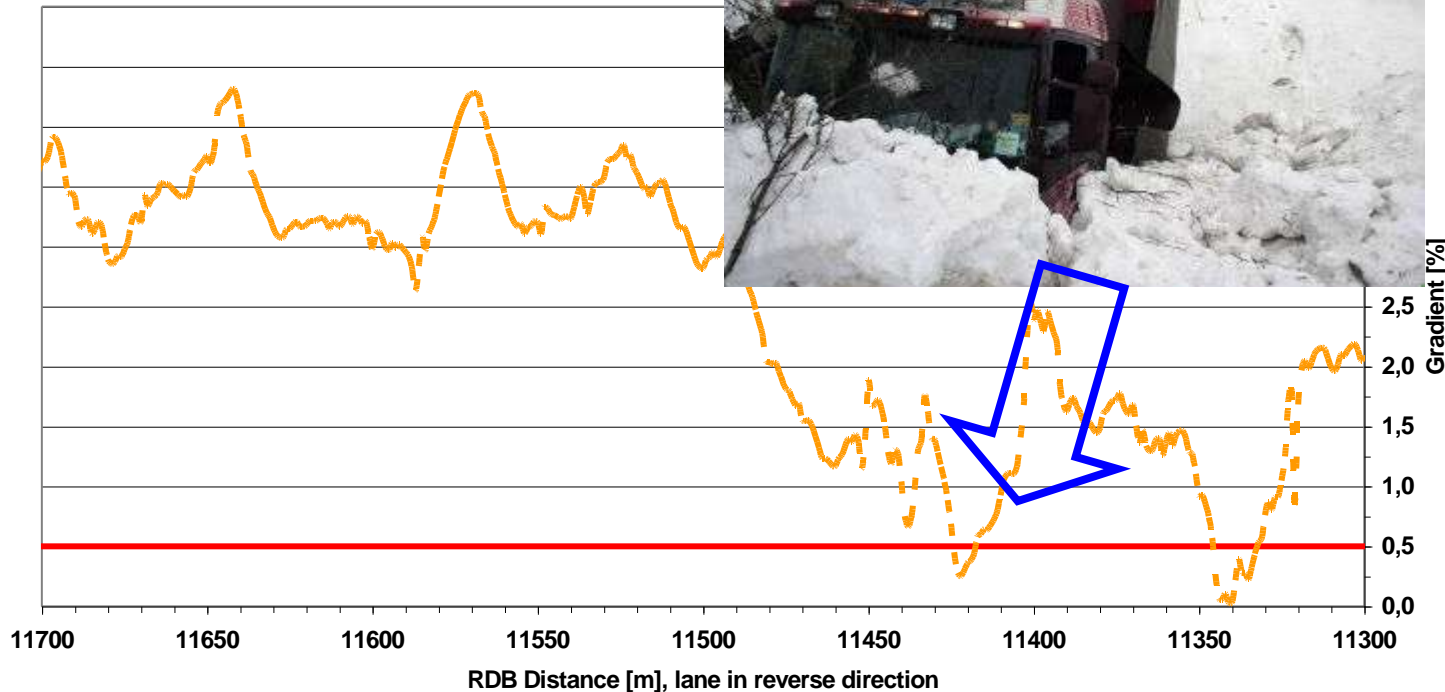
Hazardous Site Åsäng

Driver: *The truck didn't respond to either steering nor braking.*

Exit from left hand curve.

— Unacceptably low Drainage Gradient

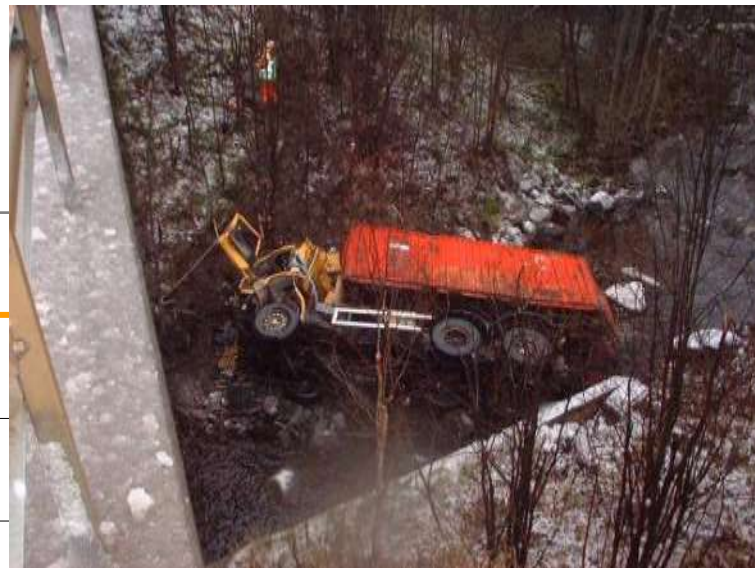
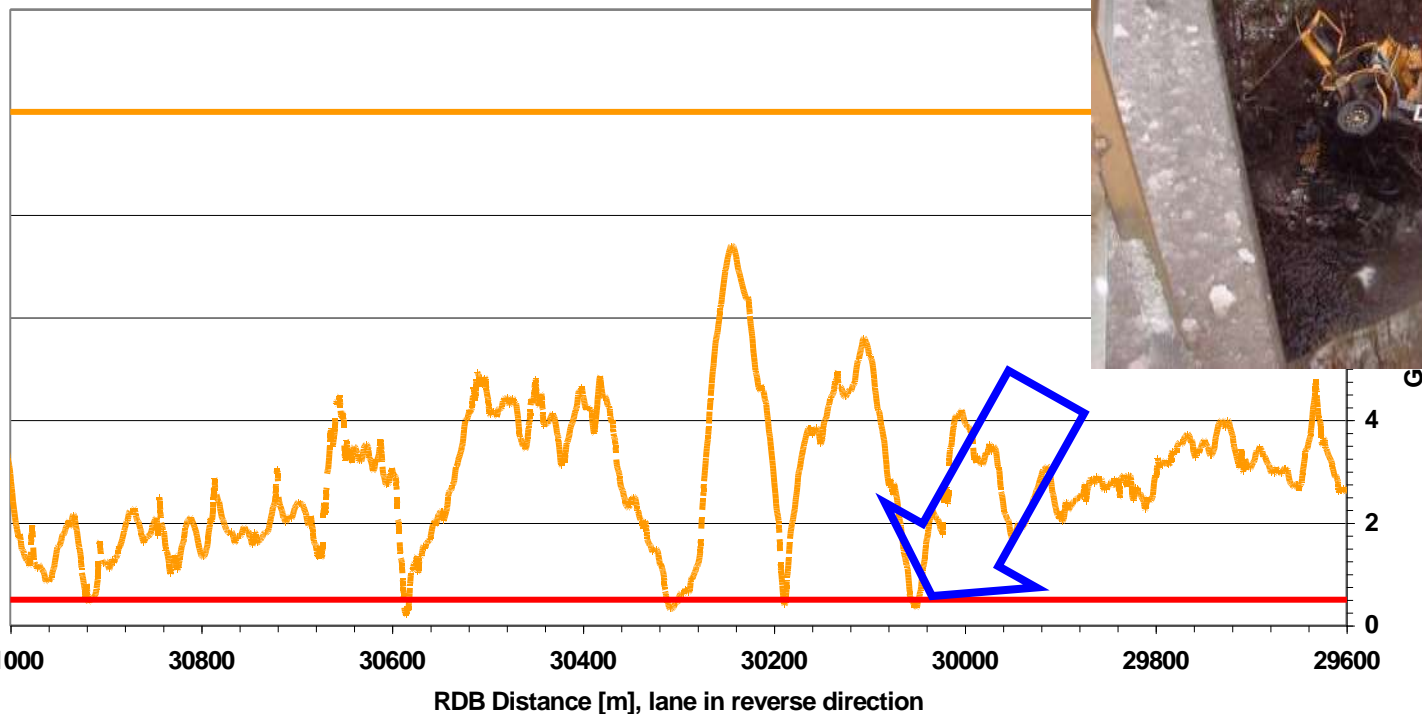
Hazardous Site Viksjö S

Exit from left hand curve.

— Unacceptably low Drainage Gradient

— Unacceptably high Gradient

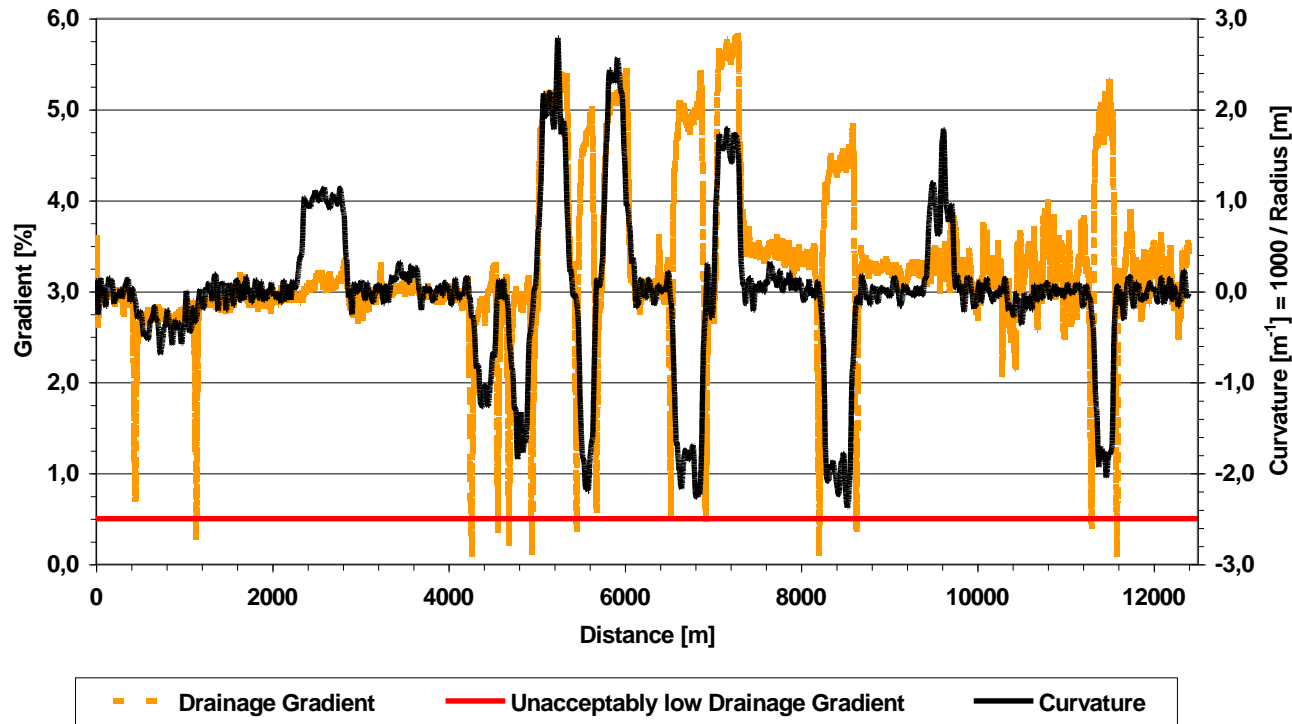
Also new highways can include hazards

New Hw 90: **12 Hazardous Sites** within 12.3 km.

All HS are at entrance or exits of **left hand curves**.
