#### EVALUATING PAVEMENT MACROTEXTURE USING 3D LASER TECHNOLOGY AND ITS CORRELATION WITH SKID RESISTANCE

#### INTRODUCTION

- A FORENSIC INVESTIGATION RELATED TO INCREASED WET WEATHER ACCIDENTS WAS CONDUCTED.
- THE ROAD OF INTEREST INCLUDED A 7-MILE SECTION OF INTERSTATE WITH 2/3 LANES PER DIRECTION. PAVEMENT STRUCTURE COMPRISED OF COMPOSITE PAVEMENT.
- ACCIDENTS OCCURRED MORE FREQUENTLY AFTER RESURFACING THE CONCRETE PAVEMENT WITH A SPECIALIZED ASPHALT CONCRETE MIXTURE: 1 IN. HIGH-PERFORMANCE THIN OVERLAY (HPTO).
- ANOTHER AREA WITH HPTO THAT WAS PREVIOUSLY CONSTRUCTED AND WITHOUT WET WEATHER INCIDENTS WAS EVALUATED FOR COMPARISON.
- AID WAS TASKED TO INVESTIGATE THE ROOT CAUSE OF THE PROBLEM AND RECOMMEND CORRECTIVE ACTIONS.

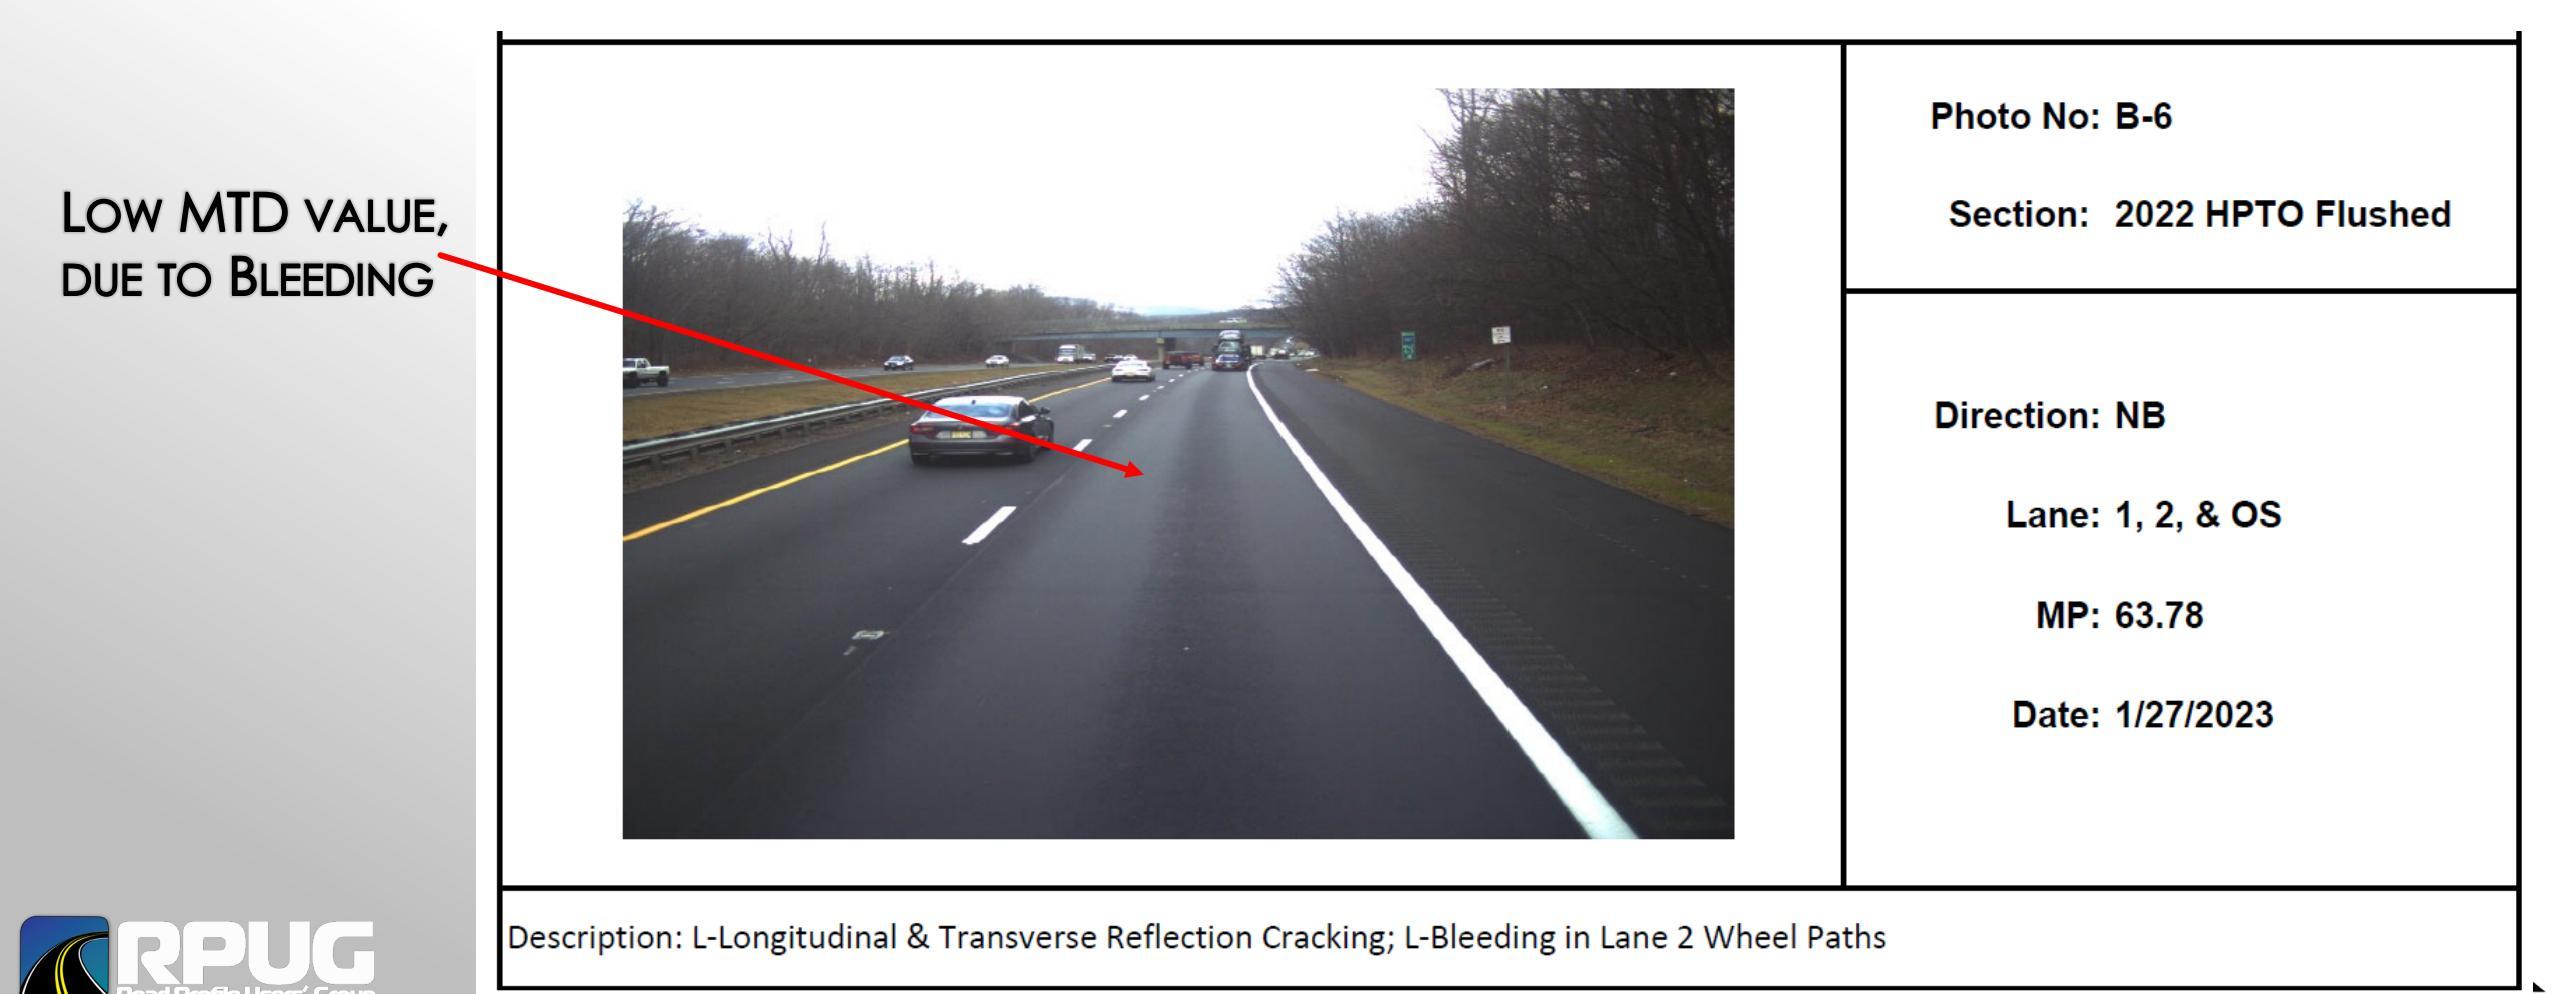
• SKID TESTING RESULTS

AREAS WITH LOW MTD VALUES SHOWED LOW SKID NUMBER AS WELL

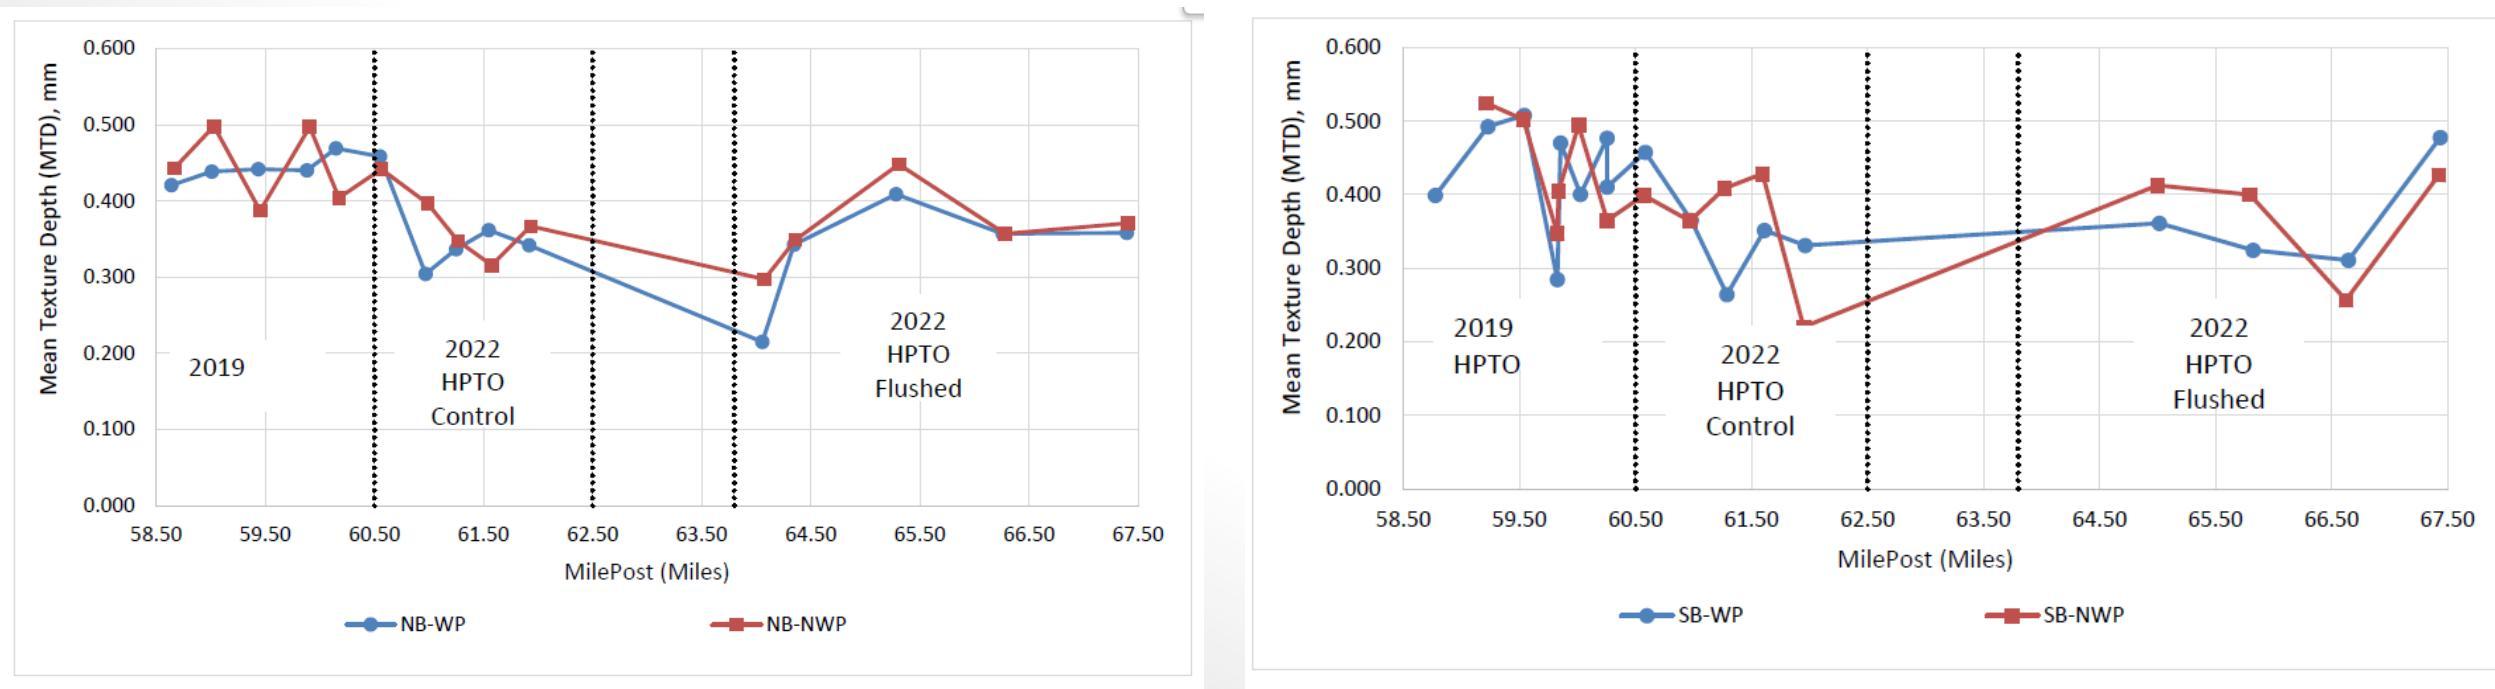
Figure 12. Sand Patch Test Results for the NB direction.

Figure 13. Sand Patch Test Results for the SB direction.

SIMILARLY, MTD HIGHER FOR THE 2019 SECTIONS. MORE VARIABILITY ON THE 2022 DATA.

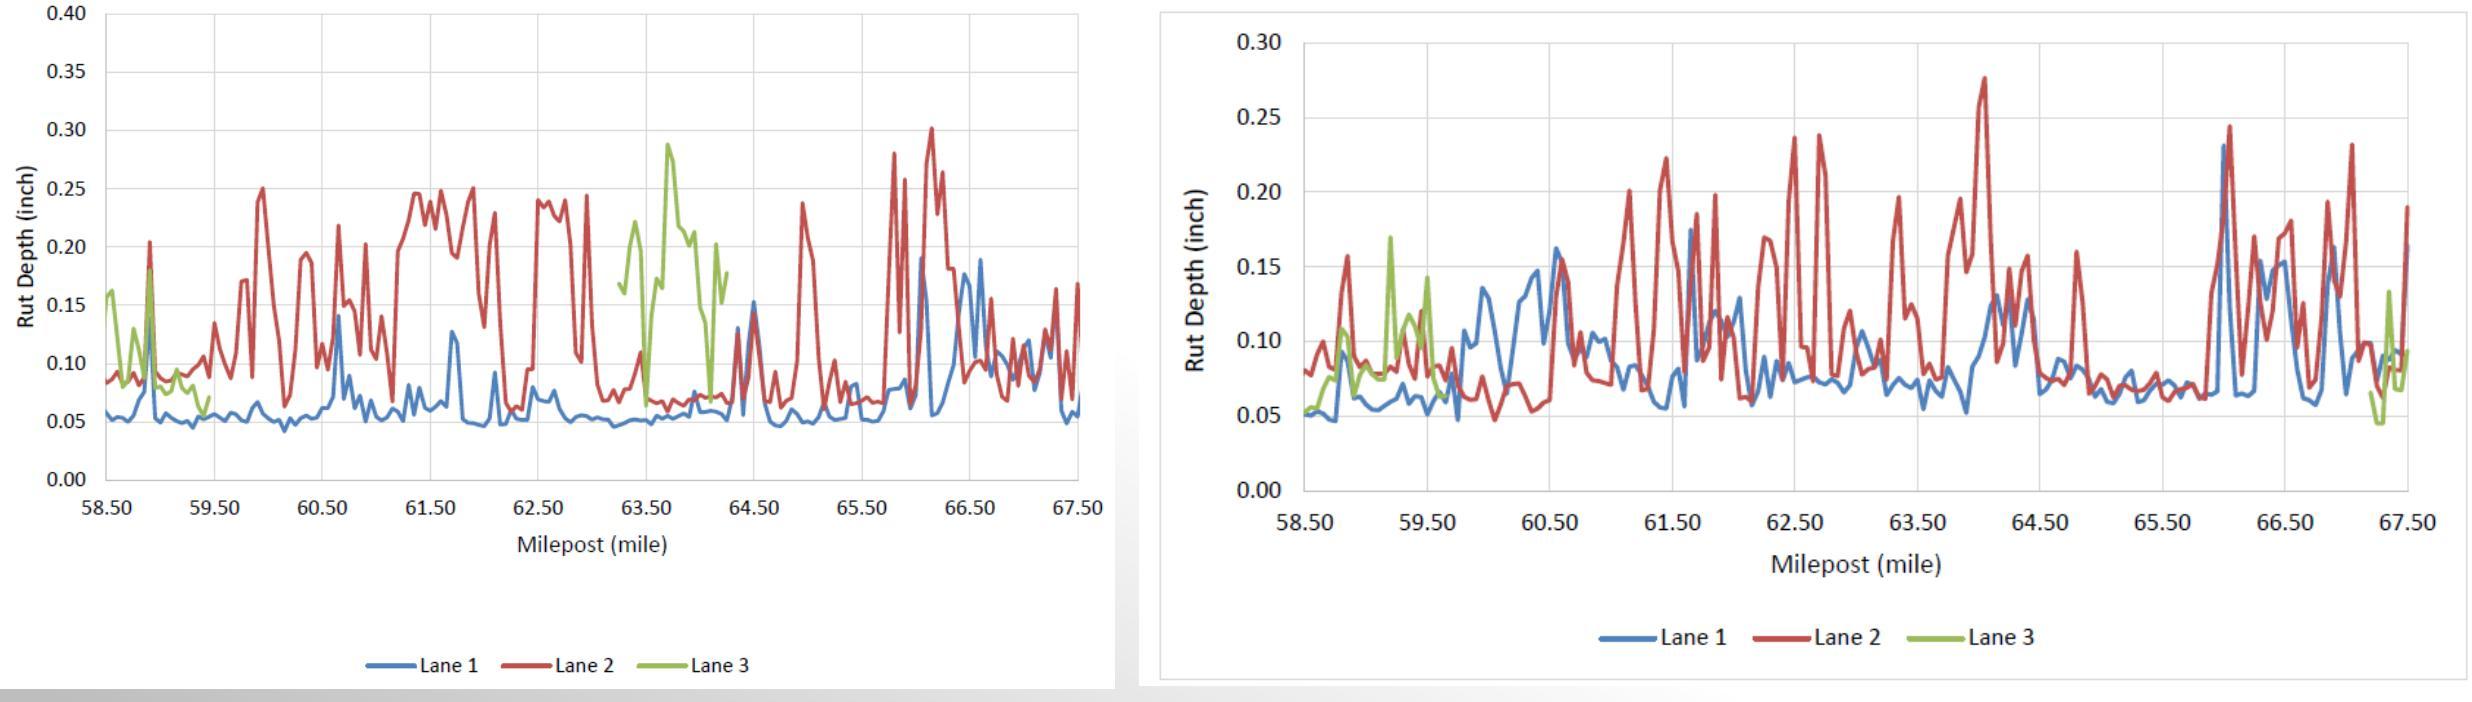
• RUTTING FORM LCMS-LTDM

LANES 2/3 SHOWED HIGHER RUTTING, PARTICULARLY IN THE SB DIRECTION

- RUTTING FORM LCMS-LTDM
- HIGHER RUTTING (0.10-0.25 IN.) WAS OBSERVED IN LANES 2 AND 3 THAN IN LANE 1 (< 0.10 IN.),
- IT SHOULD BE NOTED THAT EVEN THOUGH THE
  AVERAGE VALUES ARE LESS THAN 0.25 IN.,
  LARGER VALUES OF RUTTING WERE OBSERVED IN
  A FEW LOCATIONS IN THE "2022 HPTO FLUSHED
  SECTION" IN THE NB DIRECTION, ESPECIALLY IN
  THE VICINITY OF MP 64.0.
