# 3D Data Applications at 1mm and at 60mph

2013 Annual RPUG Meeting, San Antonio

# PaveVision3D Ultra Approach

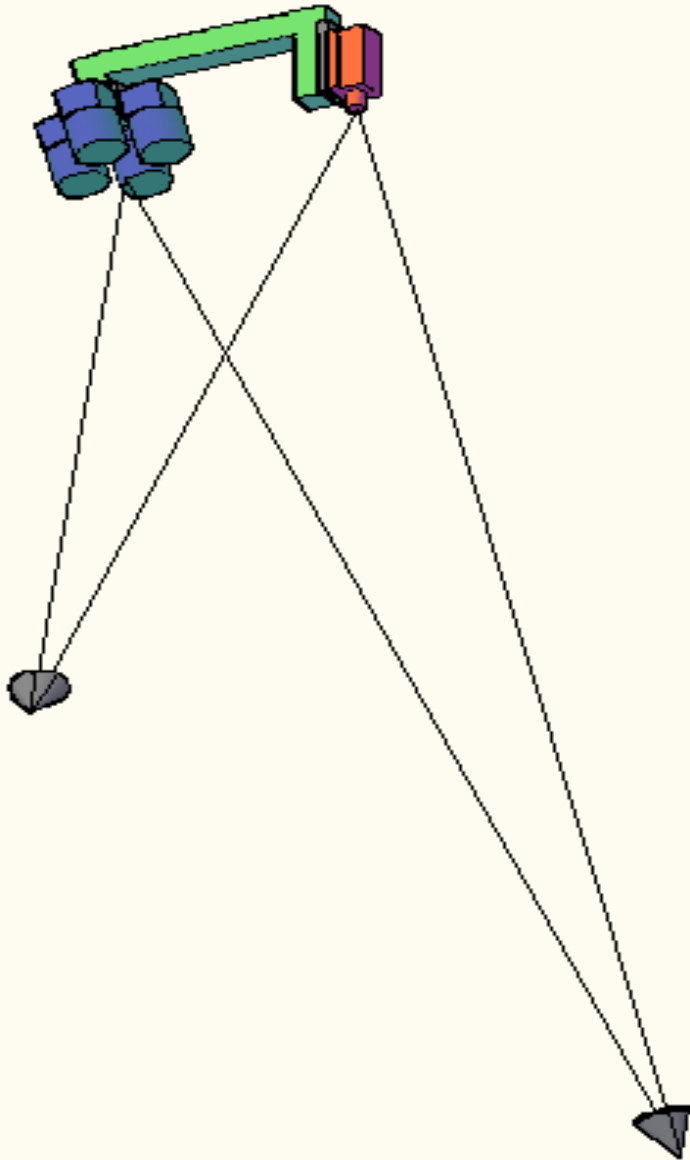
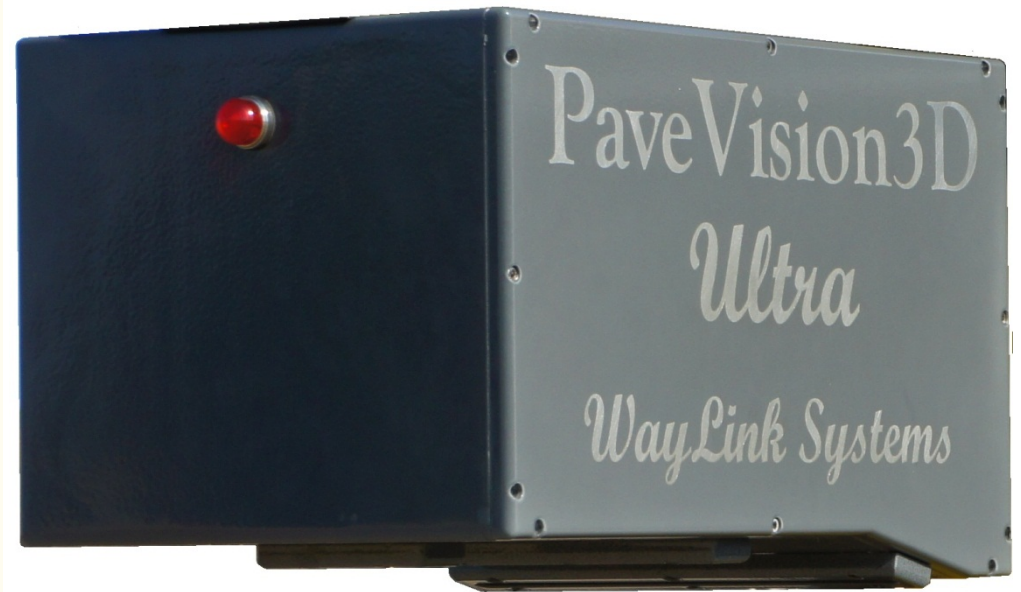
# PaveVision3D Ultra Design

- Multiple Sensors (8 3D Cameras)
- 3D Profile Line Rate to 30,000/s
- Complete Coverage of Pavement Lane
  - True 1mm at Any Data Collection Speed up to 60MPH (100KM/H)

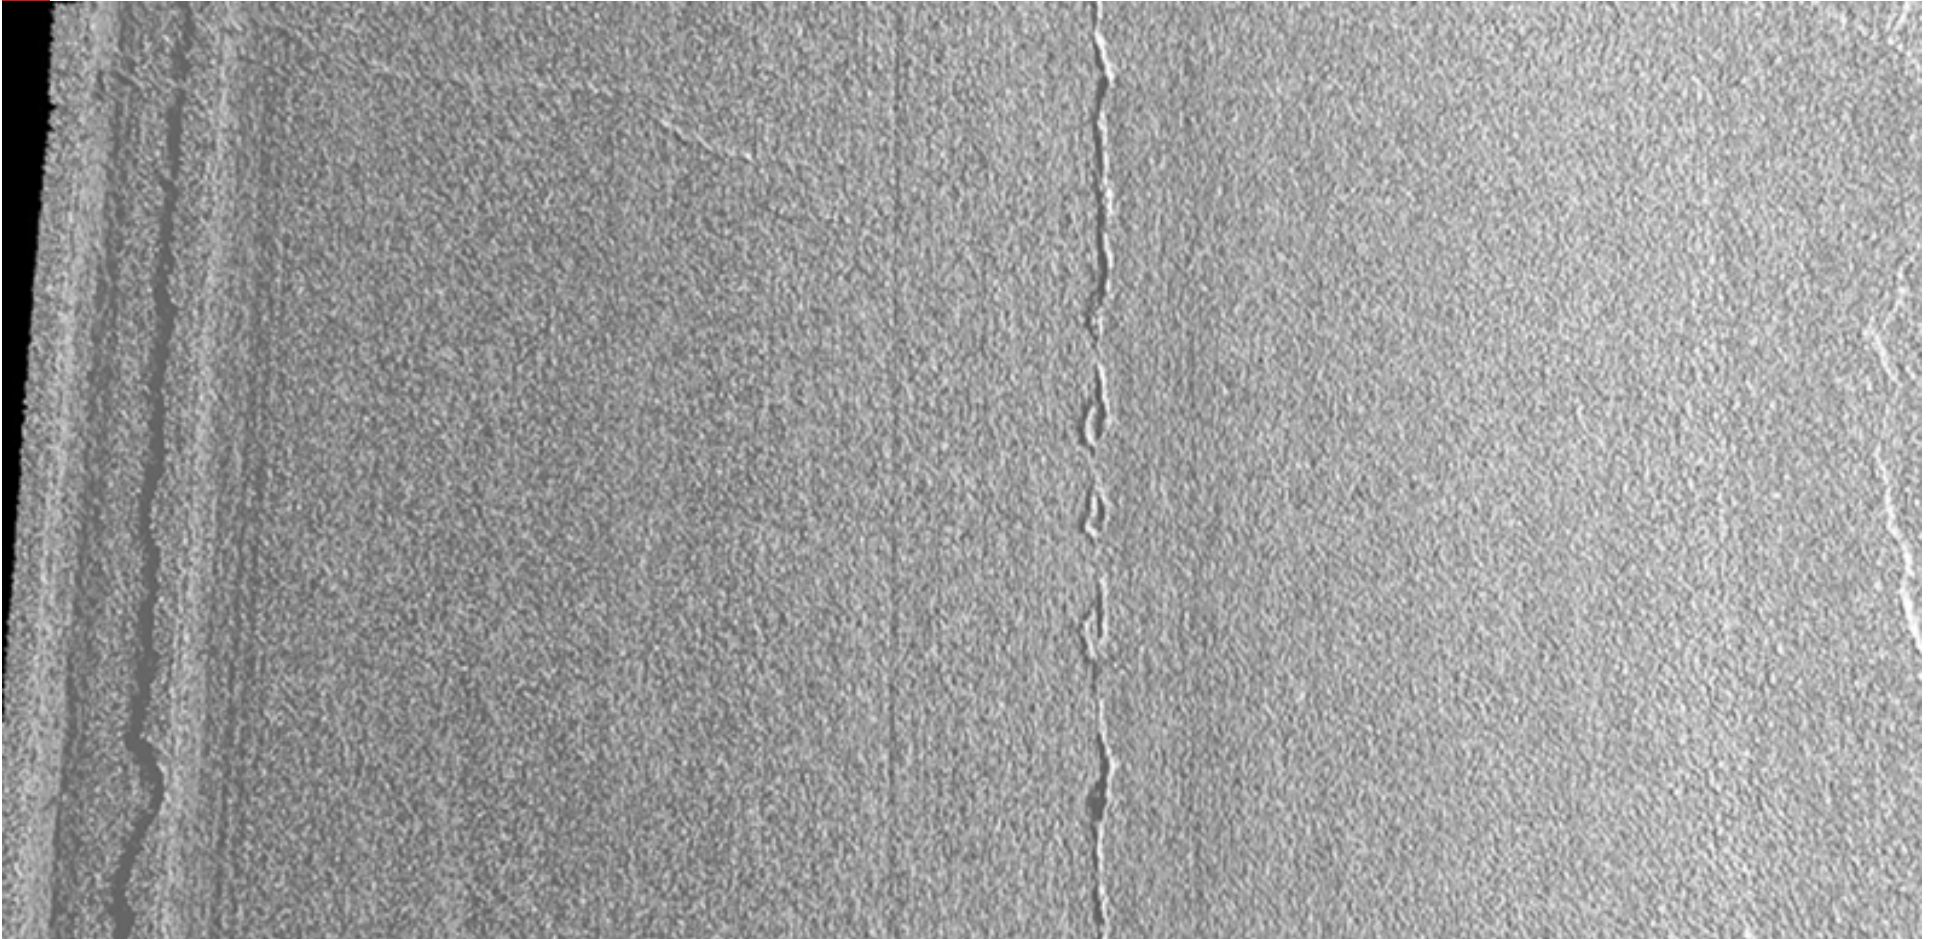
# Comparison on the Same Pavement

□ 7000 3D Profiles/Sec

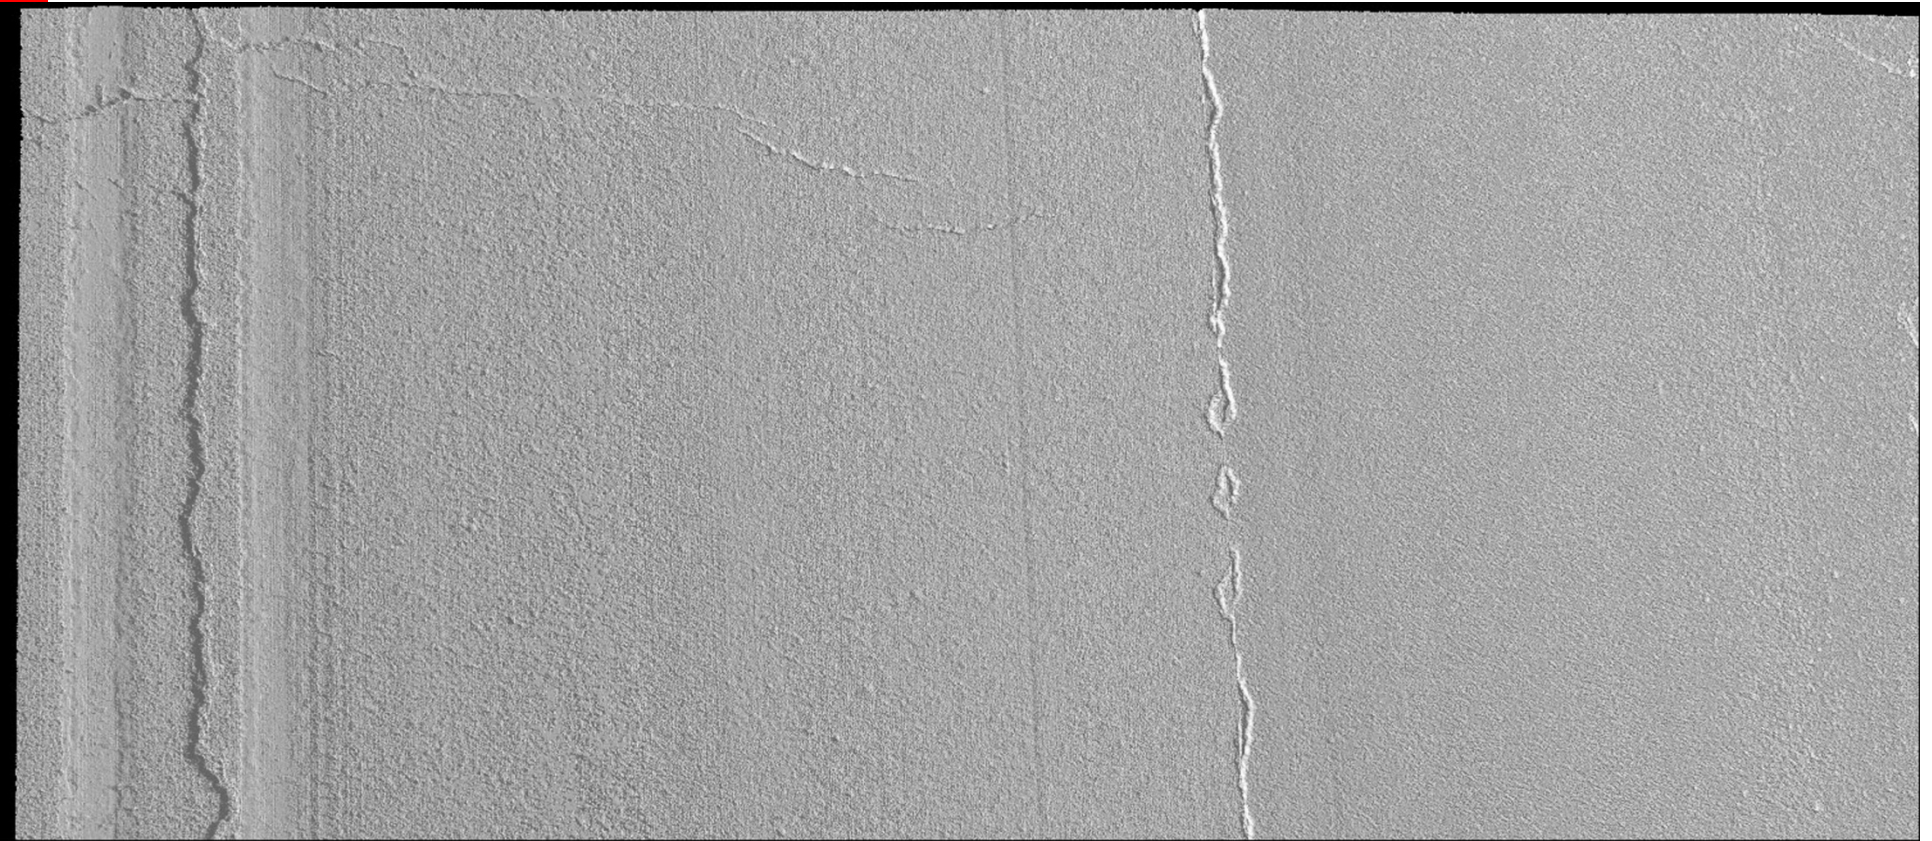
# Comparison on the Same Pavement

□ 28,000 3D Profiles/Sec

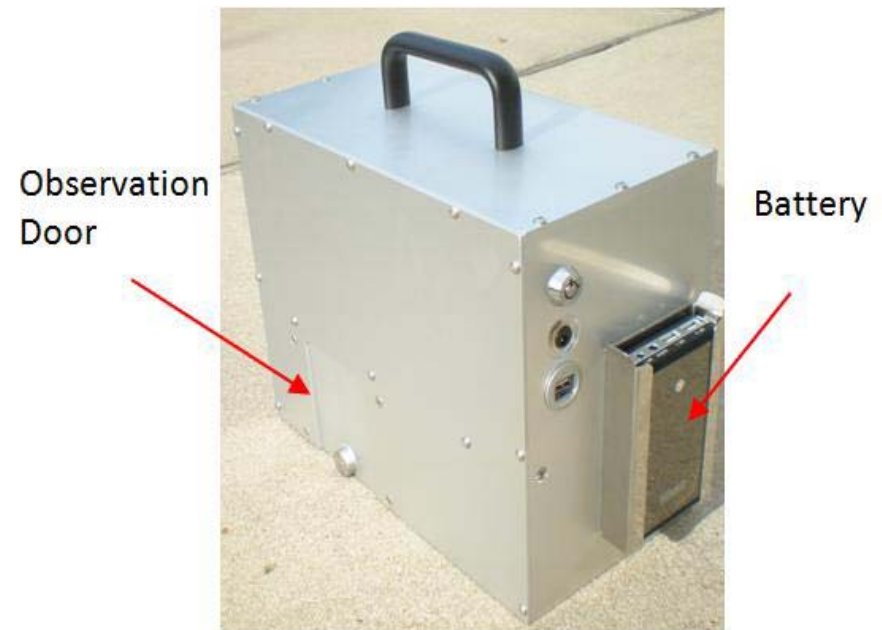
# LS-40 Pavement Surface Analyzer

- Scanned Area:
  - 4.5" long by 4" wide
- Data Pixel Quantity
  - 2048 x2448
- Horizontal Resolution
  - 0.056mm

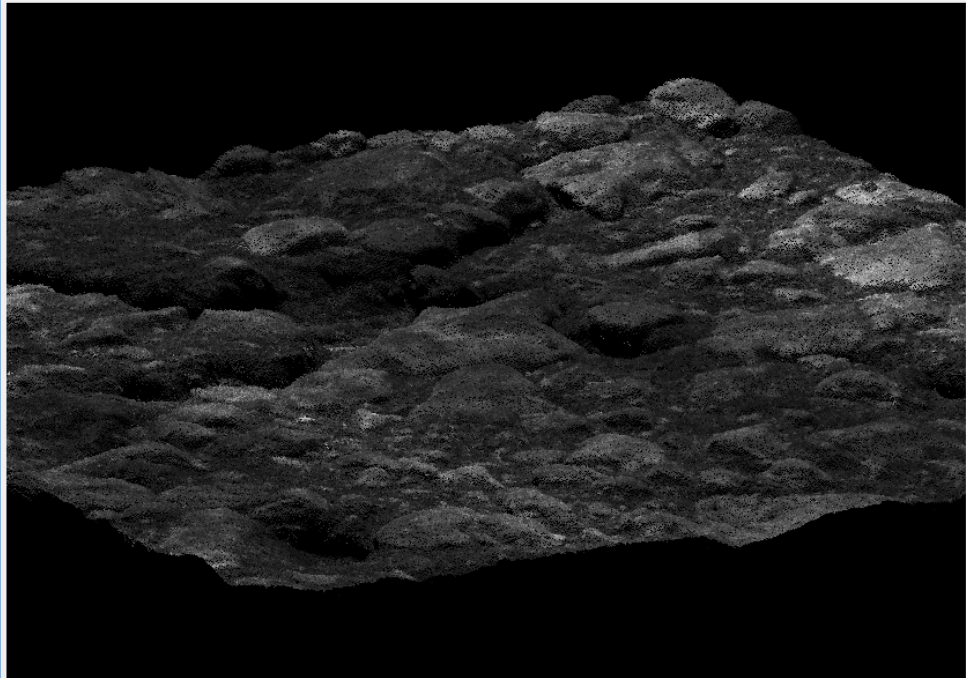
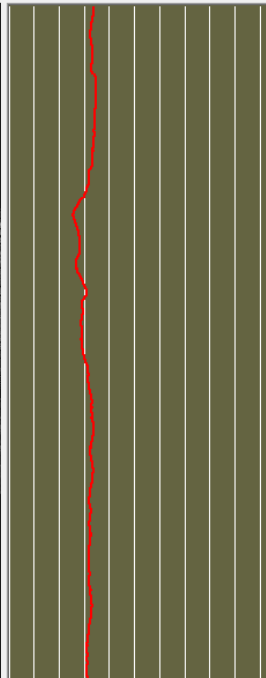
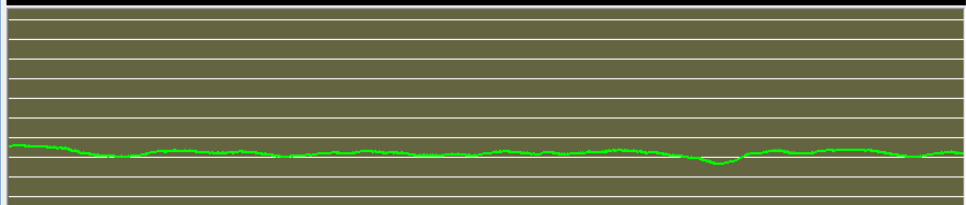
# LS-40 Software Interface

Measurement Parameters			Texture Data				Exit	
Stage: Not Found!	Calibration: Loaded		MPD: 2.90	APD: 7.77	PRO: 000.00	MAX: 4.48	X=0000, Y=0000	Exit
Camera: Not Found!	Index: 0	Rate: 10.0	ETD: 2.52	SPH: 4.13	STD: 0.597	MIN: 0.00	B=0000, R=0000

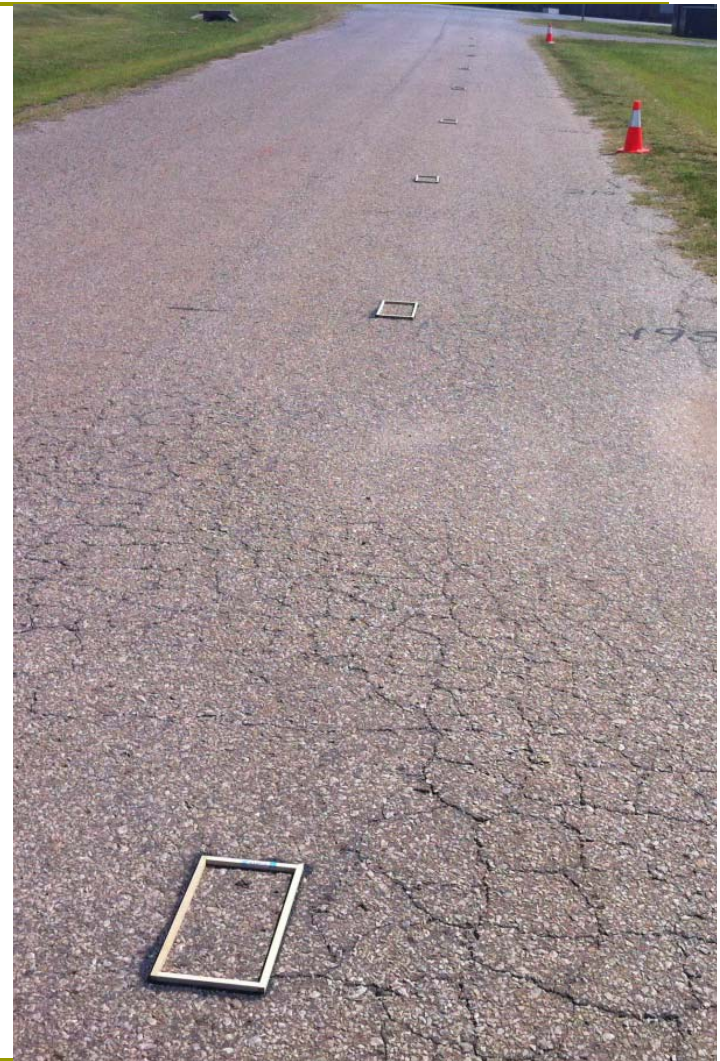
# Experimental Setup

- 21 areas marked on pavement
  - Evenly spaced (15ft)
  - 1ft long by 6 in wide
- Texture Measurements
  - Within marked area
  - LS40 MPD: static 5 runs
  - PaveVision3D MPD: two speeds, 10 runs each

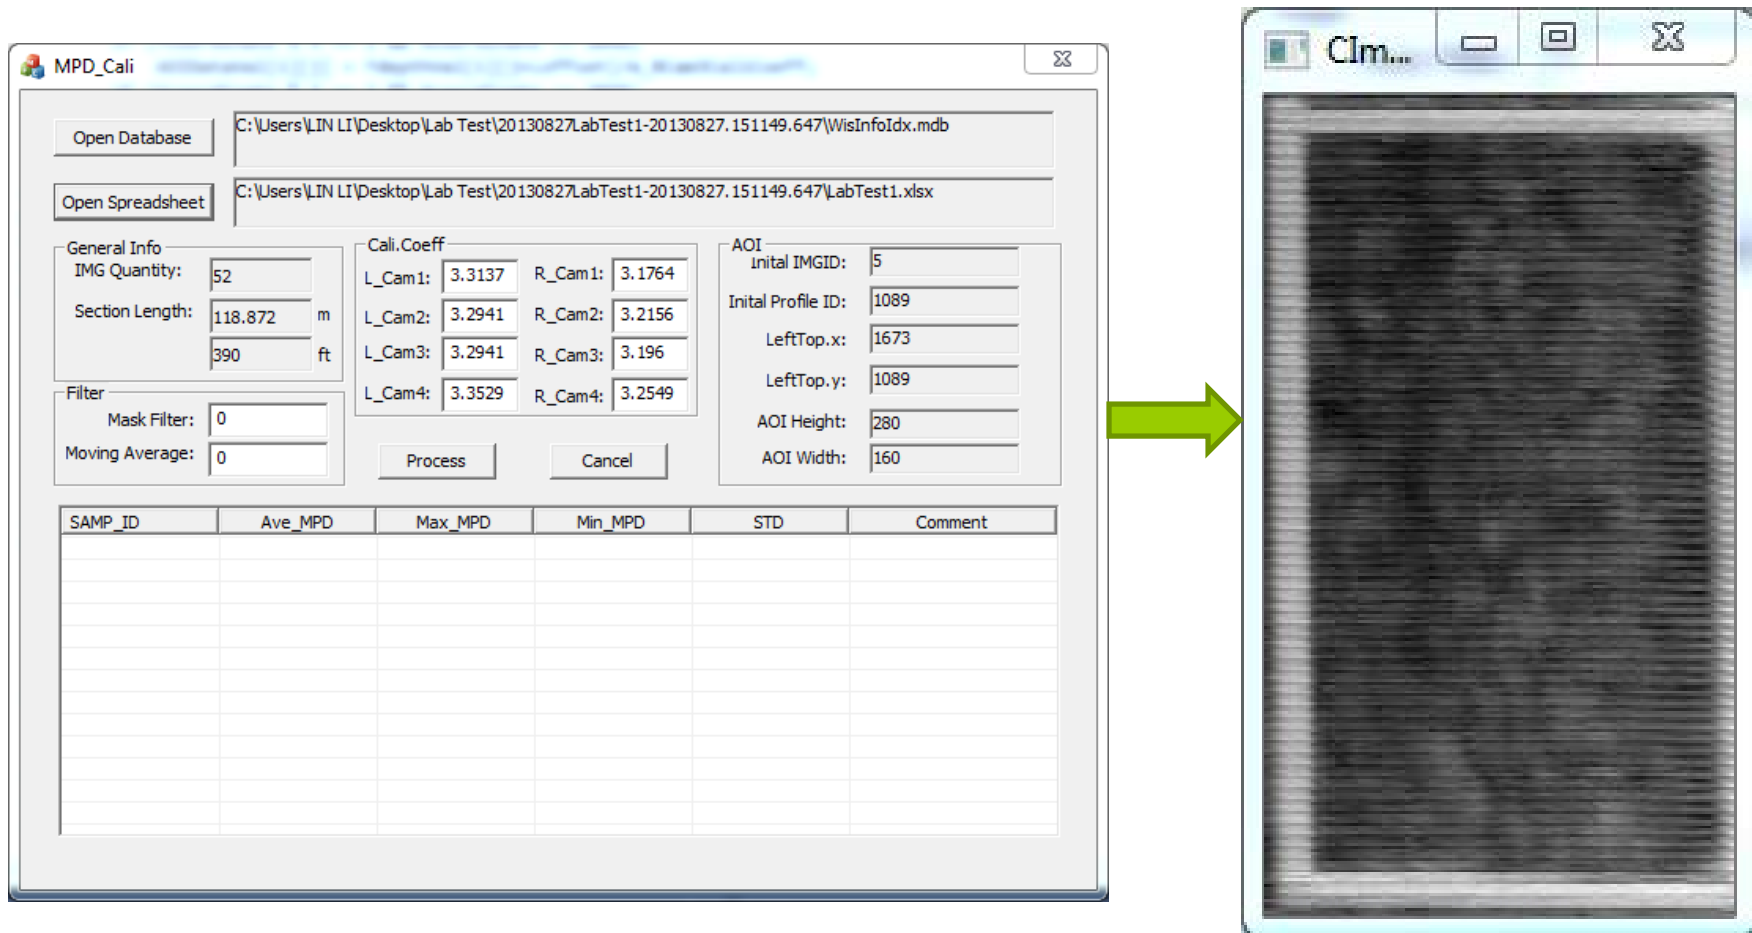
# PaveVision3D Texture Analysis

The screenshot displays the MPD\_Cali software interface. The window title is "MPD\_Cali". It features several input fields and buttons:

- Open Database:** C:\Users\LIN LI\Desktop\Lab Test\20130827\LabTest1-20130827.151149.647\WisInfoIdx.mdb
- Open Spreadsheet:** C:\Users\LIN LI\Desktop\Lab Test\20130827\LabTest1-20130827.151149.647\LabTest1.xlsx
- General Info:** IMG Quantity: 52; Section Length: 118.872 m / 390 ft
- Filter:** Mask Filter: 0; Moving Average: 0
- Cali.Coeff:** L\_Cam1: 3.3137, R\_Cam1: 3.1764, L\_Cam2: 3.2941, R\_Cam2: 3.2156, L\_Cam3: 3.2941, R\_Cam3: 3.196, L\_Cam4: 3.3529, R\_Cam4: 3.2549
- AOI:** Inital IMGID: 5, Inital Profile ID: 1089, LeftTop.x: 1673, LeftTop.y: 1089, AOI Height: 280, AOI Width: 160

Buttons for "Process" and "Cancel" are visible. Below the configuration fields is a table with the following columns: SAMP\_ID, Ave\_MPD, Max\_MPD, Min\_MPD, STD, and Comment. The table is currently empty.

A green arrow points from the "Process" button to a window titled "Cim..." which displays a grayscale texture analysis image.

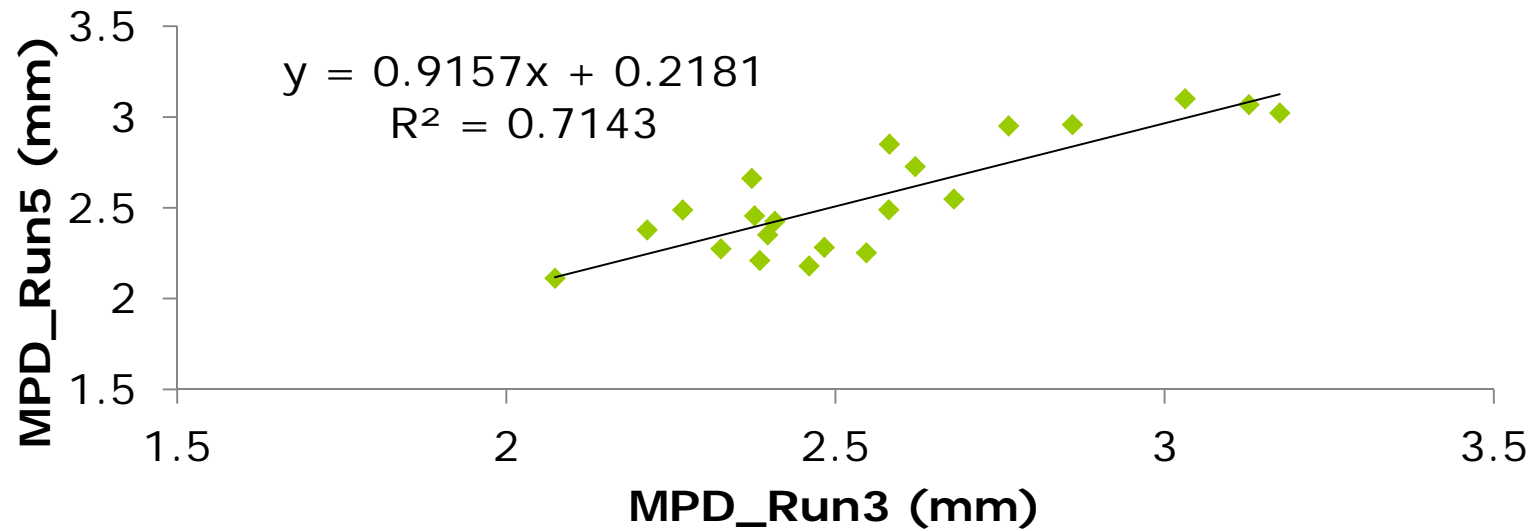
# Correlation Analysis (7mph)

run 1	run 2	run 3	run4	run5
run 1	1				
run 2	0.68	1			
run 3	0.66	0.63	1		
run 4	0.56	0.34	0.46	1	
run 5	0.63	0.55	0.71	0.61	1

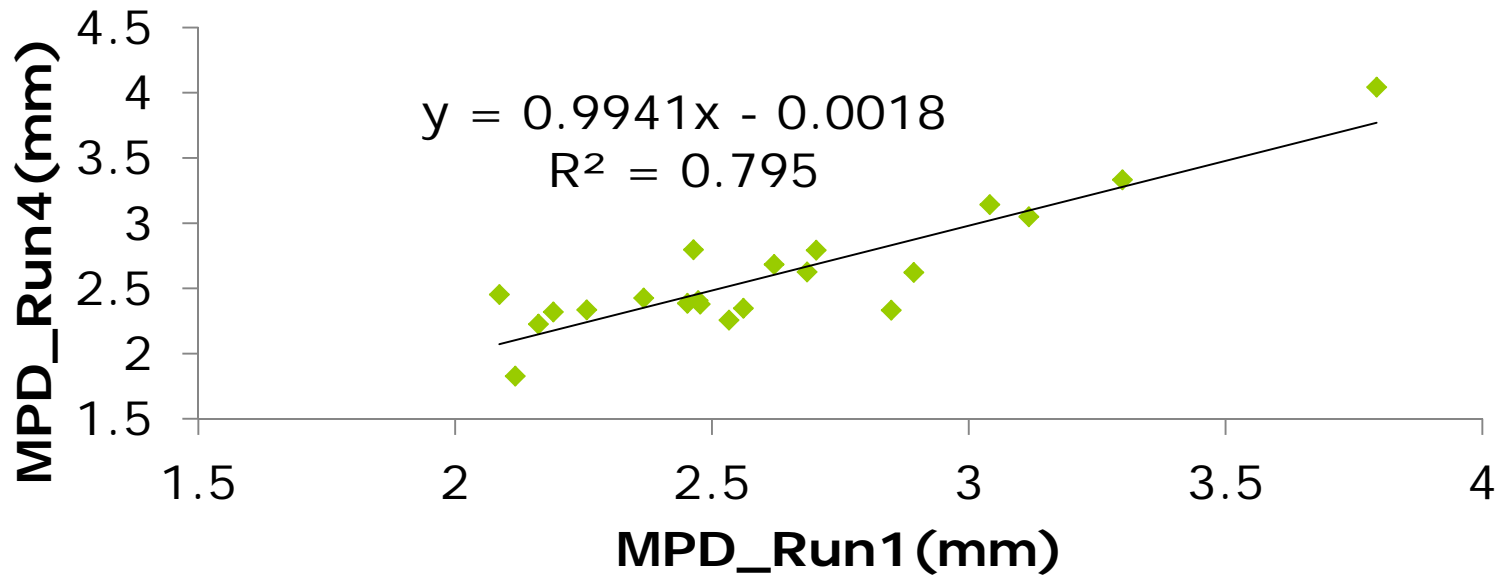
# Correlation Analysis (15mph)

run 1	run 2	run 3	run 4	run 5
run 1	1				
run 2	0.67	1			
run 3	0.72	0.35	1		
run 4	0.80	0.43	0.71	1	
run 5	0.64	0.38	0.76	0.69	1

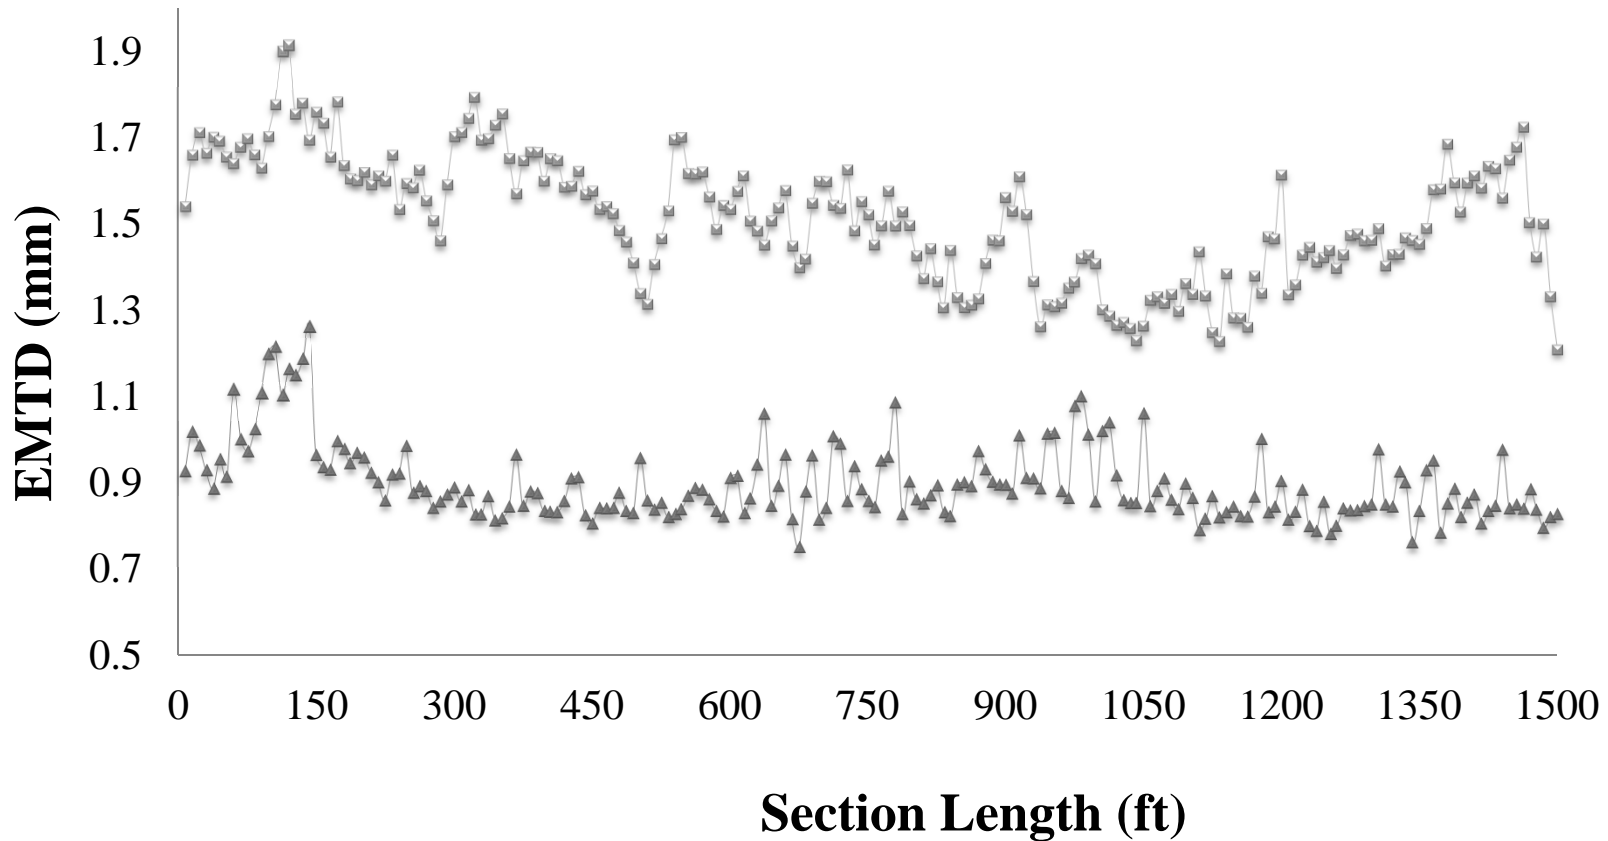
# Drainage Evaluation Test Results

—■— Test Site 1 —▲— Test Site 2

- Inertial Measurement Unit (IMU)
  - Consisting of accelerometers and fiber-optic gyroscopes
  - Collecting positioning, cross slope and vertical slope data
- PaveVision3D Texture Data
- Hydroplanning Speed Model
  - Water film depth: pavement type, cross slope, vertical grade, rain intensity

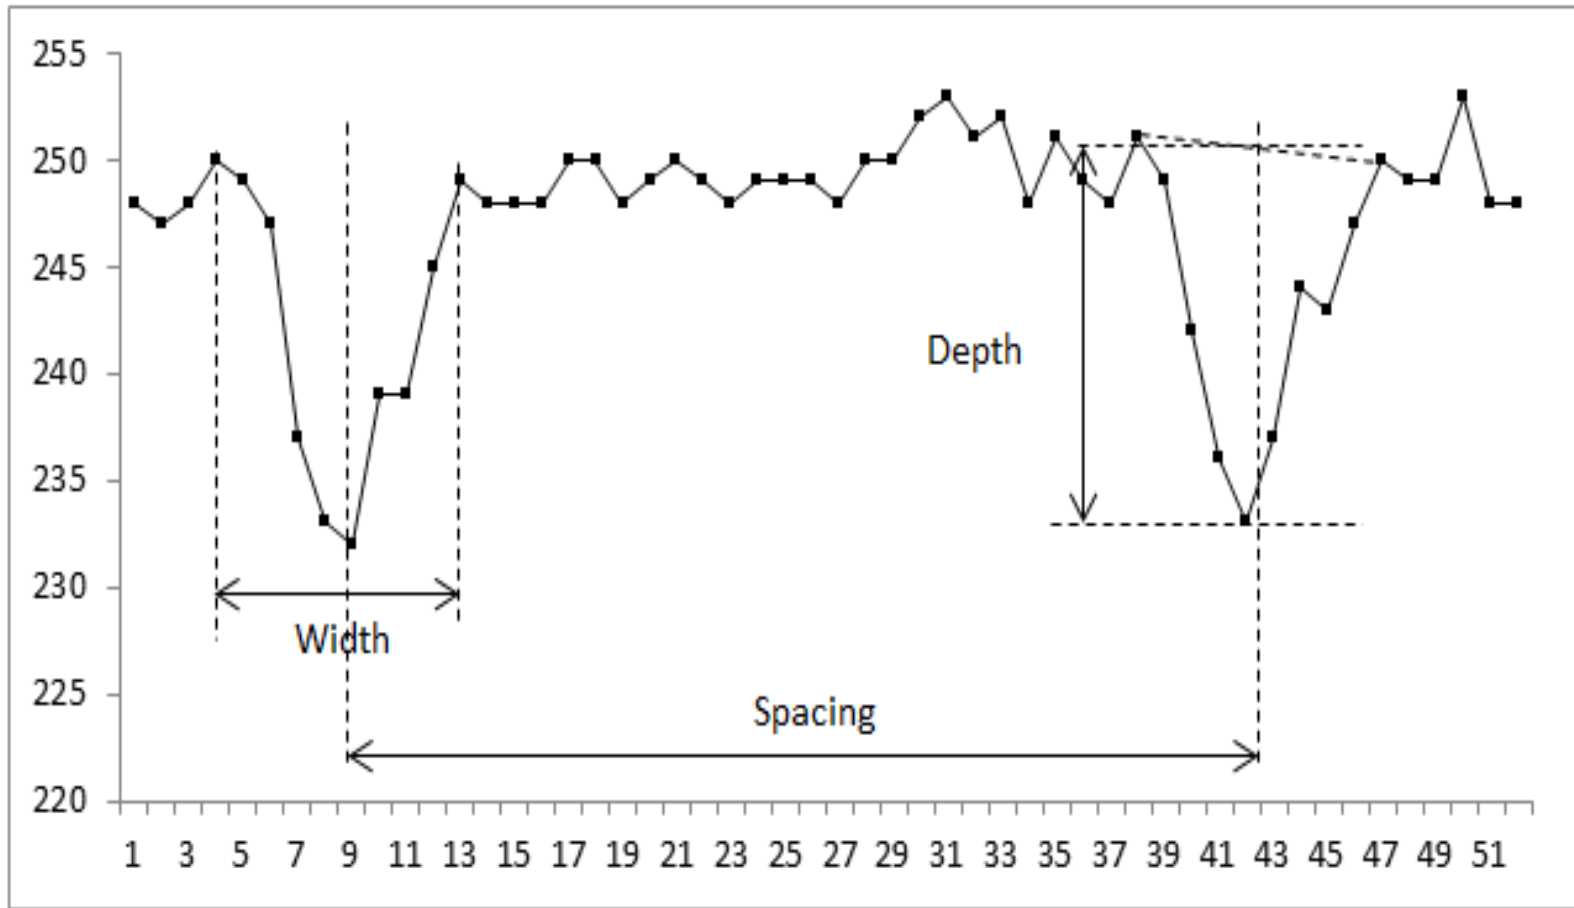
# Groove Dimensions

- To develop an algorithm to automatically estimate groove dimensions
  - Groove Depth, Width, and Spacing
- To evaluate groove performance
  - Calculated groove dimensions
  - Groove configuration, and
  - Standard groove evaluation guidelines
