Potential for Comprehensive Evaluation of Pavement Surface with 3D Laser Imaging

Kelvin C.P. Wang
Oklahoma State University and
WayLink Systems Co.

The 23rd Annual Road Profile Users' Group (RPUG) Meeting
The Harvey's Lake Tahoe in Stateline, NV, September 27 to 29, 2011.

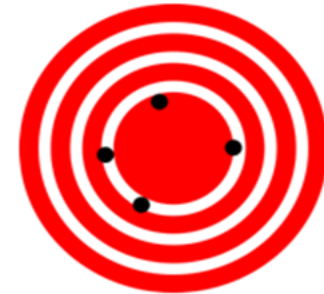
Good accuracy, Low precision

- Variability: Unevenness, Changeability
- Precision and Accuracy
- Reference Value and Probability

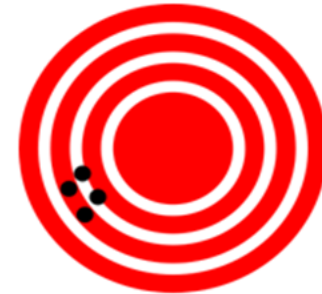
High precision, Low accuracy
