SADDLE UP!
TEXAS 2025

TEXTURE SIGNATURE PERFORMANCE INDEX: INTEGRATING THE DATA

EVERETT SCHMITZ, PATHWAY SERVICES INC.

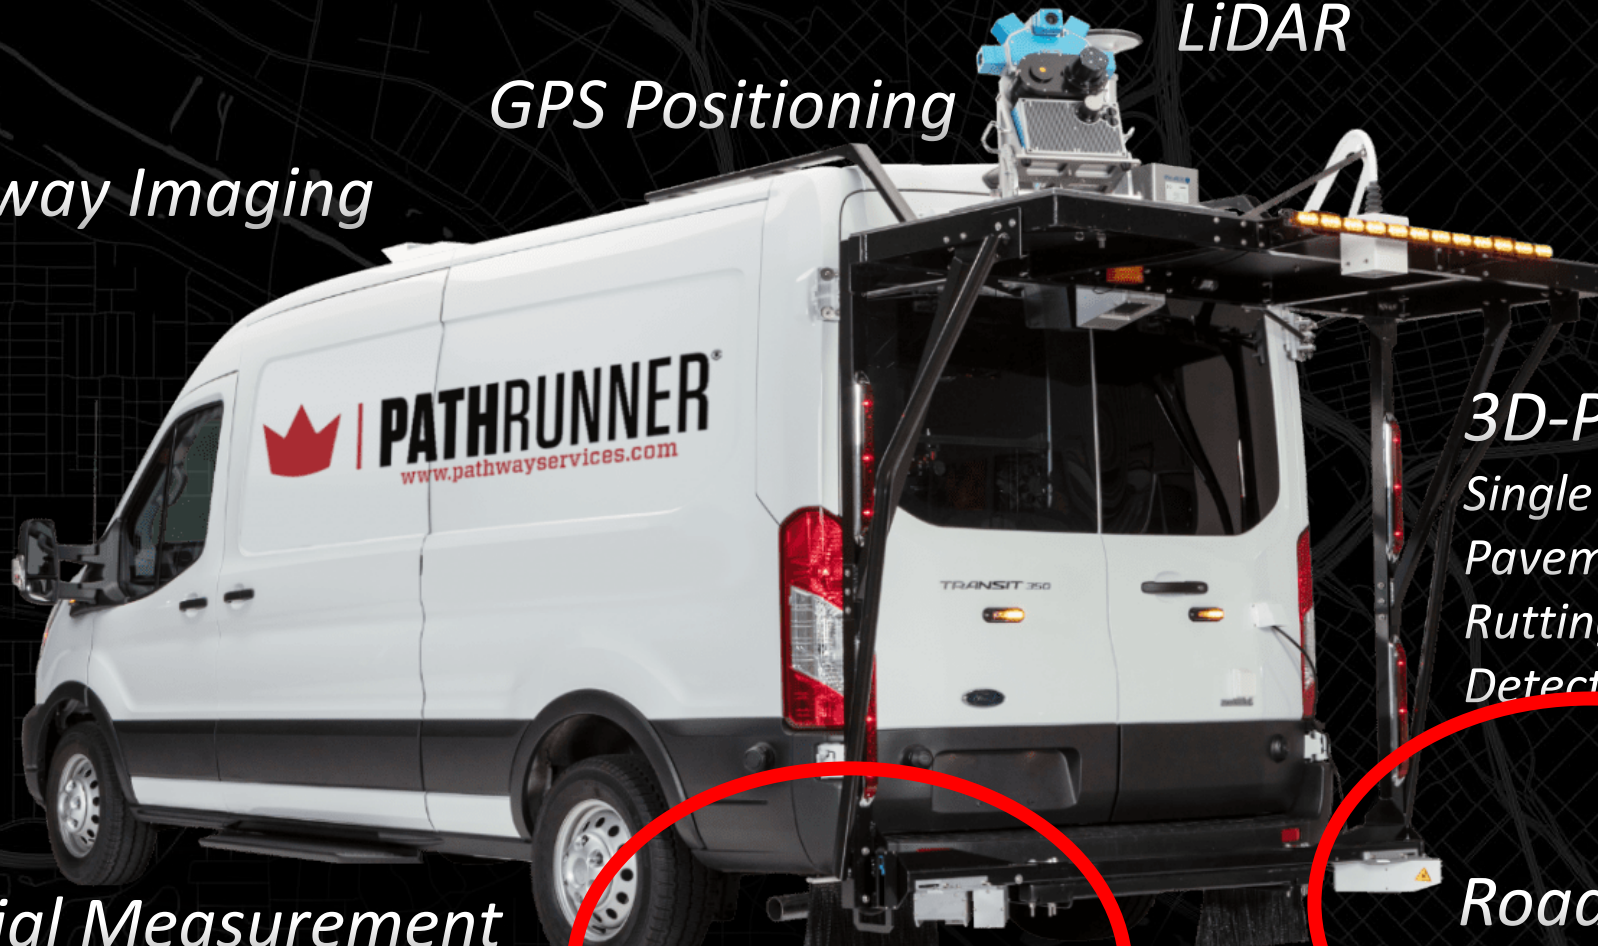
The PathRunner

Roadway Imaging

GPS Positioning

LiDAR

3D-PAS

*Single Camera/Single Laser:
Pavement Imaging,
Rutting, Faulting, Crack
Detection*

*Inertial Measurement
Pitch/Roll/RTK*

*Macrotexture
MPD/MTD/TSN/TSPI*

*Road Profiler
IRI*

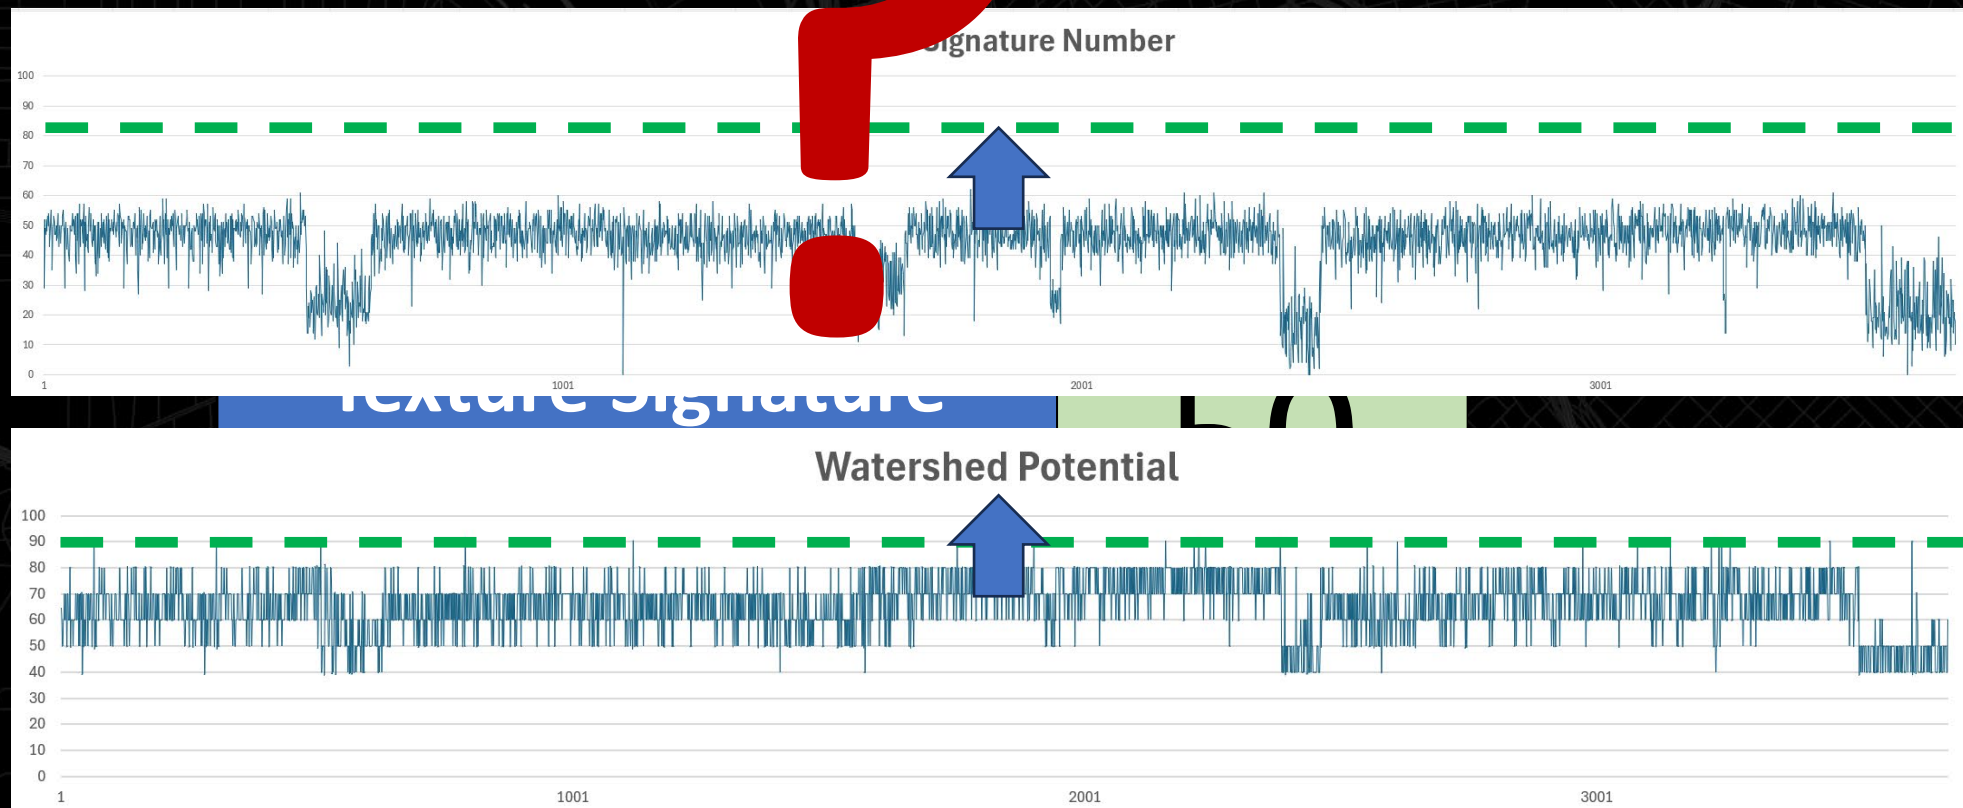
50F → 80B

- *HSFT?*
- *Rehab?*
- *Chip seal?*
- *Reduce speed?*
- *Warning signs?*
- *???*
