“Creating affordable & reliable roads”

Health issues raised by poorly maintained road networks

Task leader: Johan Granlund
Swedish Road Administration, Consulting Services

Tests at the *Beaver Road 331*

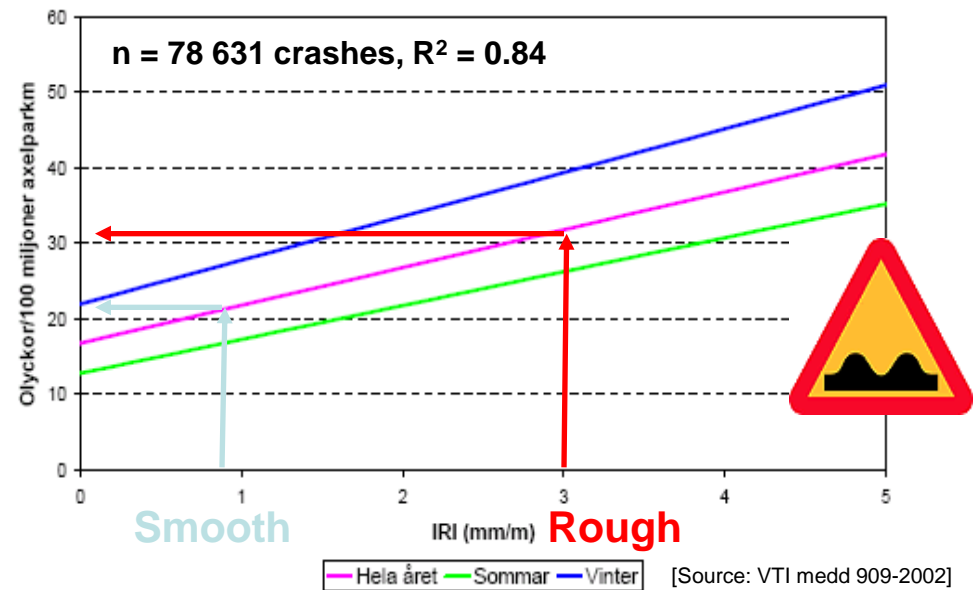
Crash rate

Bumpy roads have more than 50 % higher crash rate

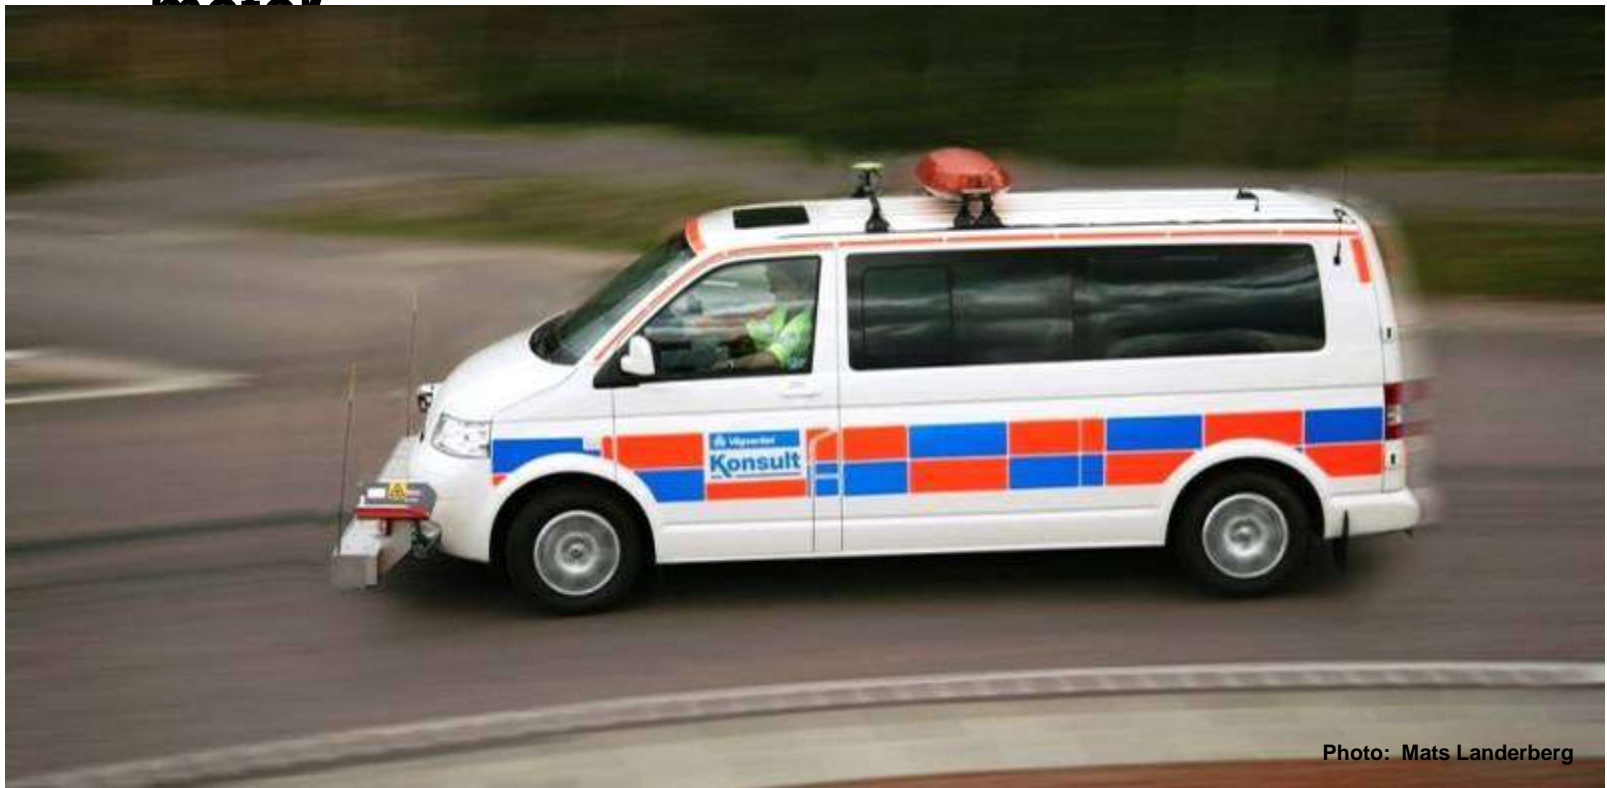
Reference Measurement

A laser/inertial Profilograph scanned the test road's surface condition 20 000 times per meter

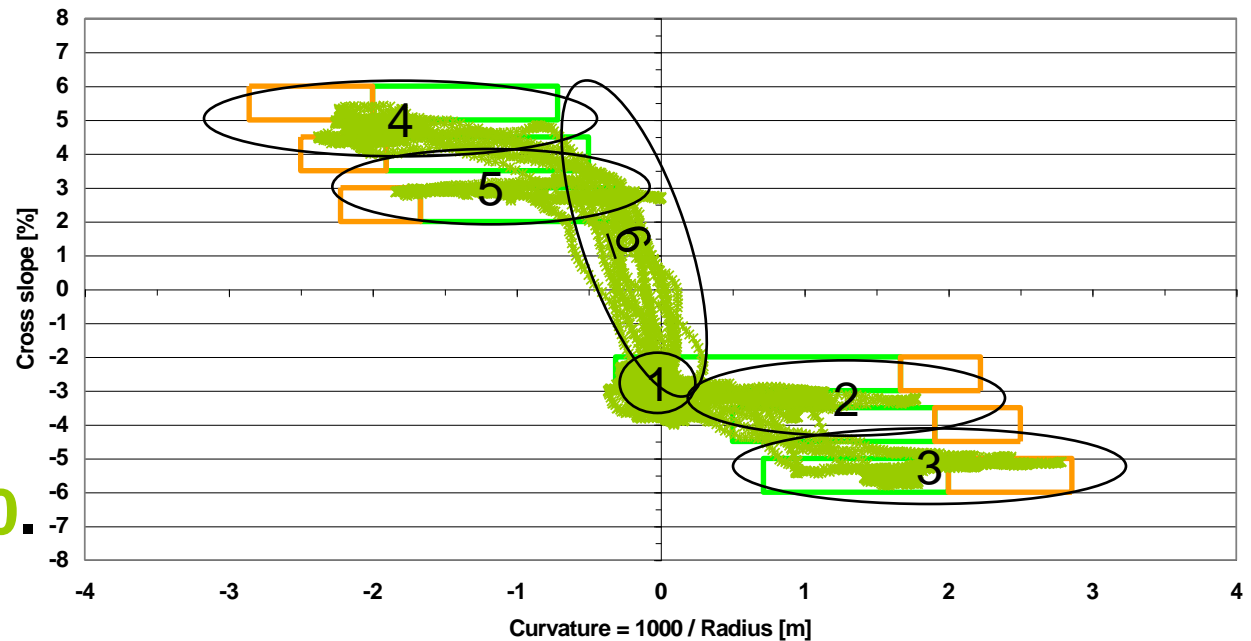
Reference Cross Slope vs Curvature

n = 12 300
reference data
(1 m per point)
from new Hw 90.

1: Straight sections

2: Wide right hand curves

3: Sharp right hand curves

4: Sharp left hand curves

5: Wide left hand curves

6: Transitions at left hand curves

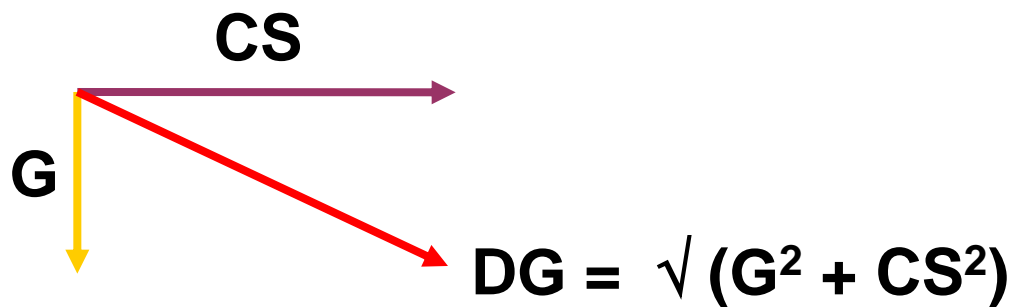
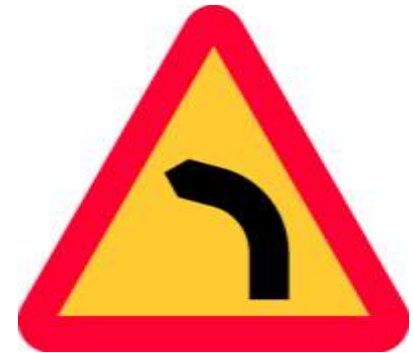
Low Drainage Gradient

Drainage Gradient (DG) is the resultant of Cross Slope (CS) and longitudinal Gradient (G).

**Risk areas are where CS pass 0 % (zero) and change sign:
This occurs at **entrances and exits of left* hand curves.****
