#### EVALUATING PAVEMENT MACROTEXTURE USING 3D LASER TECHNOLOGY AND ITS CORRELATION WITH SKID RESISTANCE

#### INTRODUCTION

- A FORENSIC INVESTIGATION RELATED TO INCREASED WET WEATHER ACCIDENTS WAS CONDUCTED.
- THE ROAD OF INTEREST INCLUDED A 7-MILE SECTION OF INTERSTATE WITH 2/3 LANES PER DIRECTION. PAVEMENT STRUCTURE COMPRISED OF COMPOSITE PAVEMENT.
- ACCIDENTS OCCURRED MORE FREQUENTLY AFTER RESURFACING THE CONCRETE PAVEMENT WITH A SPECIALIZED ASPHALT CONCRETE MIXTURE: 1 IN. HIGH-PERFORMANCE THIN OVERLAY (HPTO).
- ANOTHER AREA WITH HPTO THAT WAS PREVIOUSLY CONSTRUCTED AND WITHOUT WET WEATHER INCIDENTS WAS EVALUATED FOR COMPARISON.
- AID WAS TASKED TO INVESTIGATE THE ROOT CAUSE OF THE PROBLEM AND RECOMMEND CORRECTIVE ACTIONS.

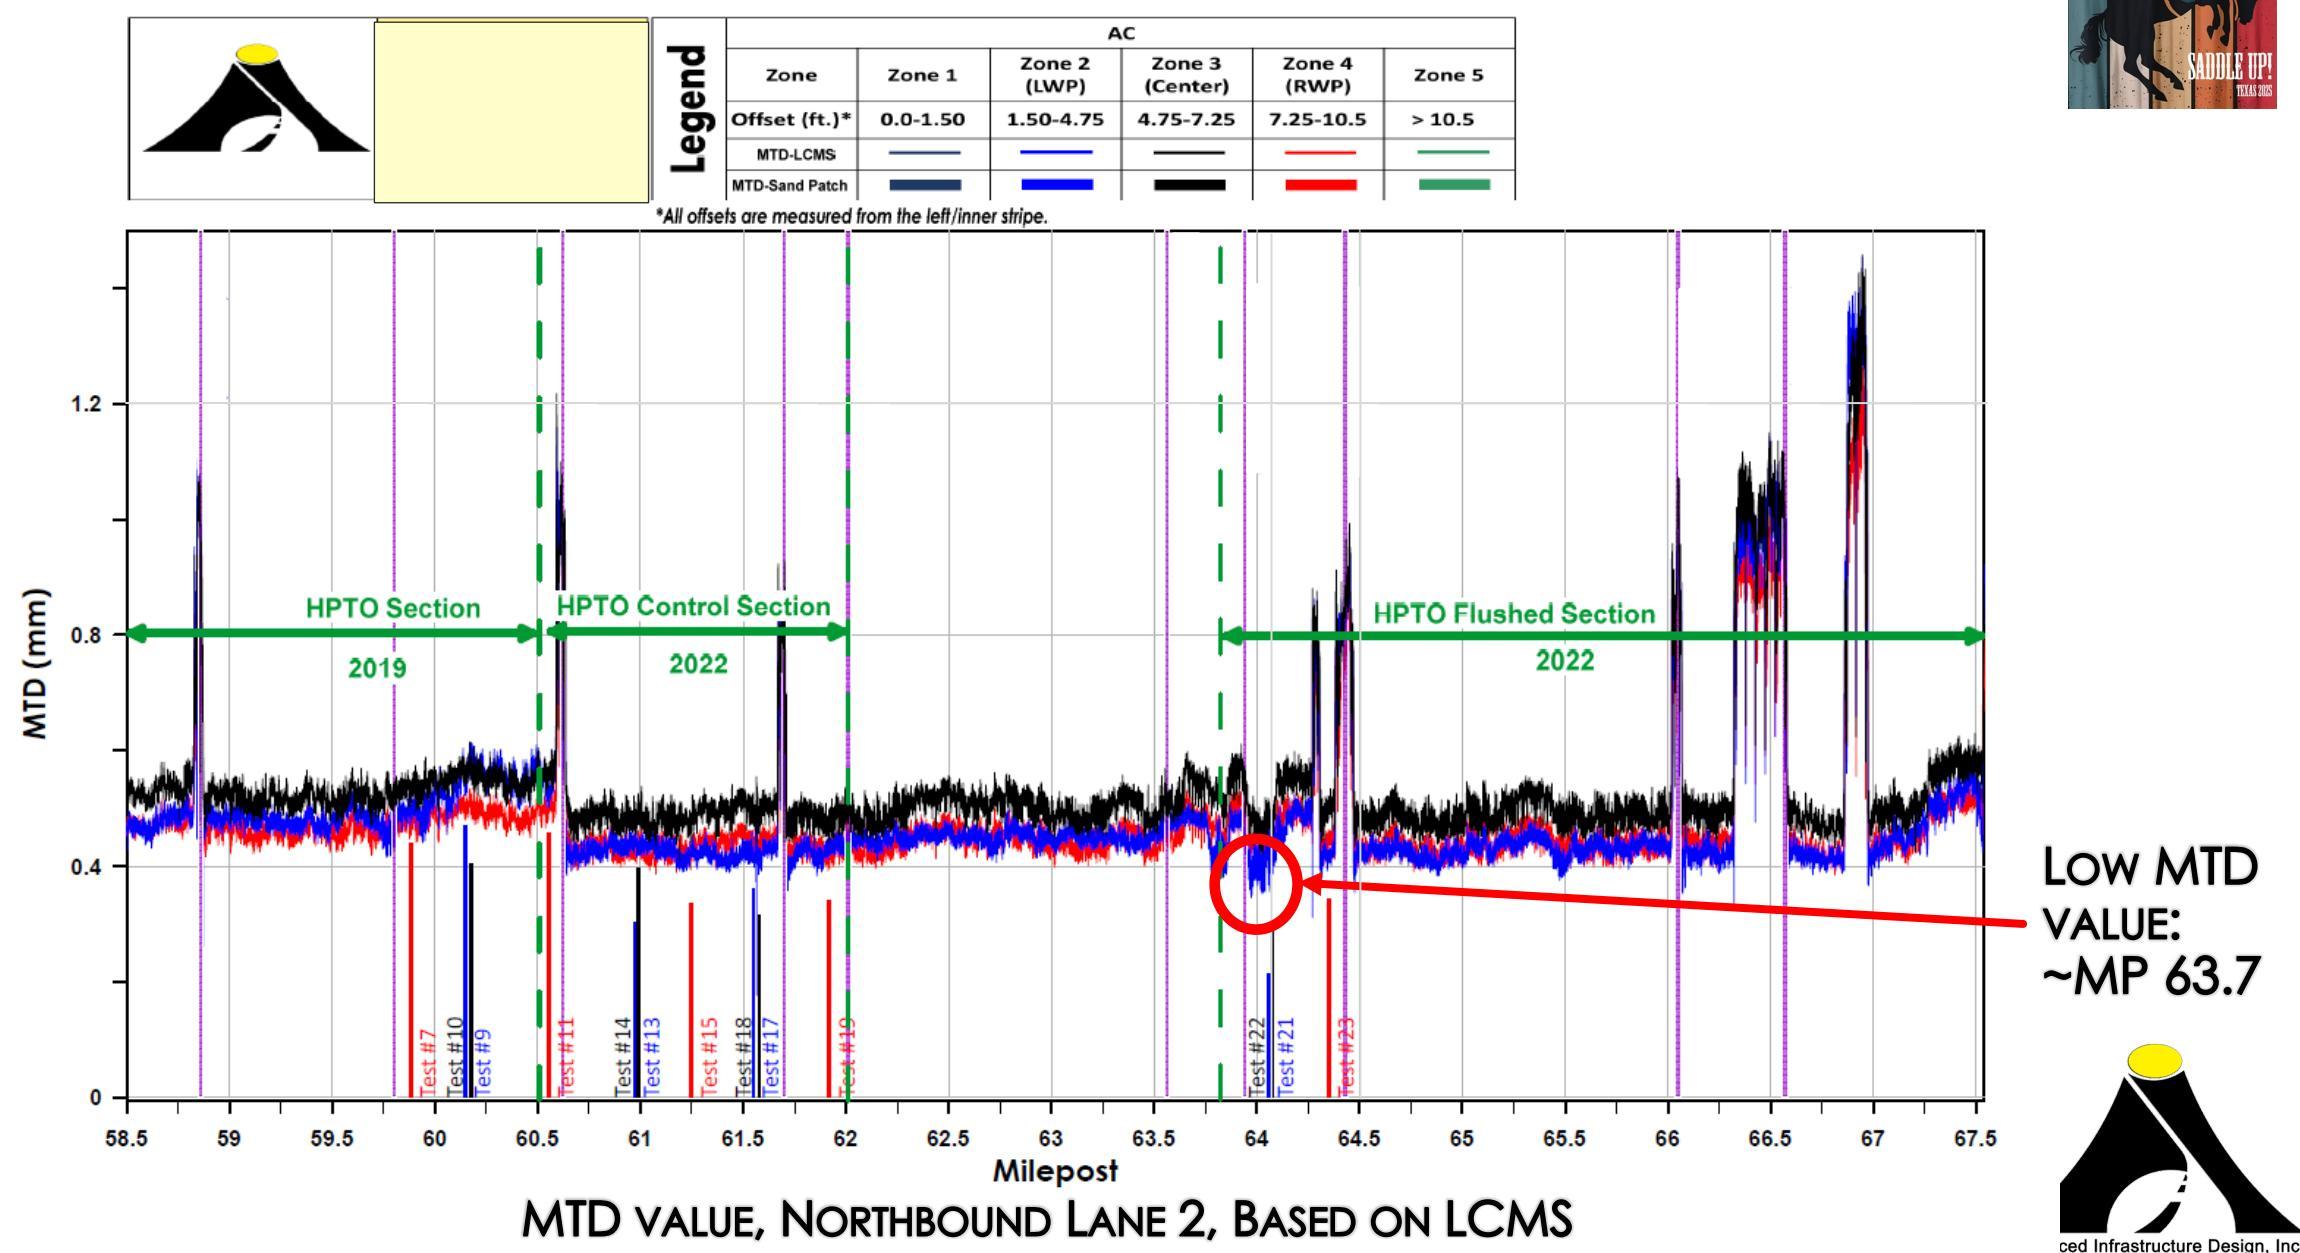
• SKID TESTING RESULTS

AREAS WITH LOW MTD VALUES SHOWED LOW SKID NUMBER AS WELL

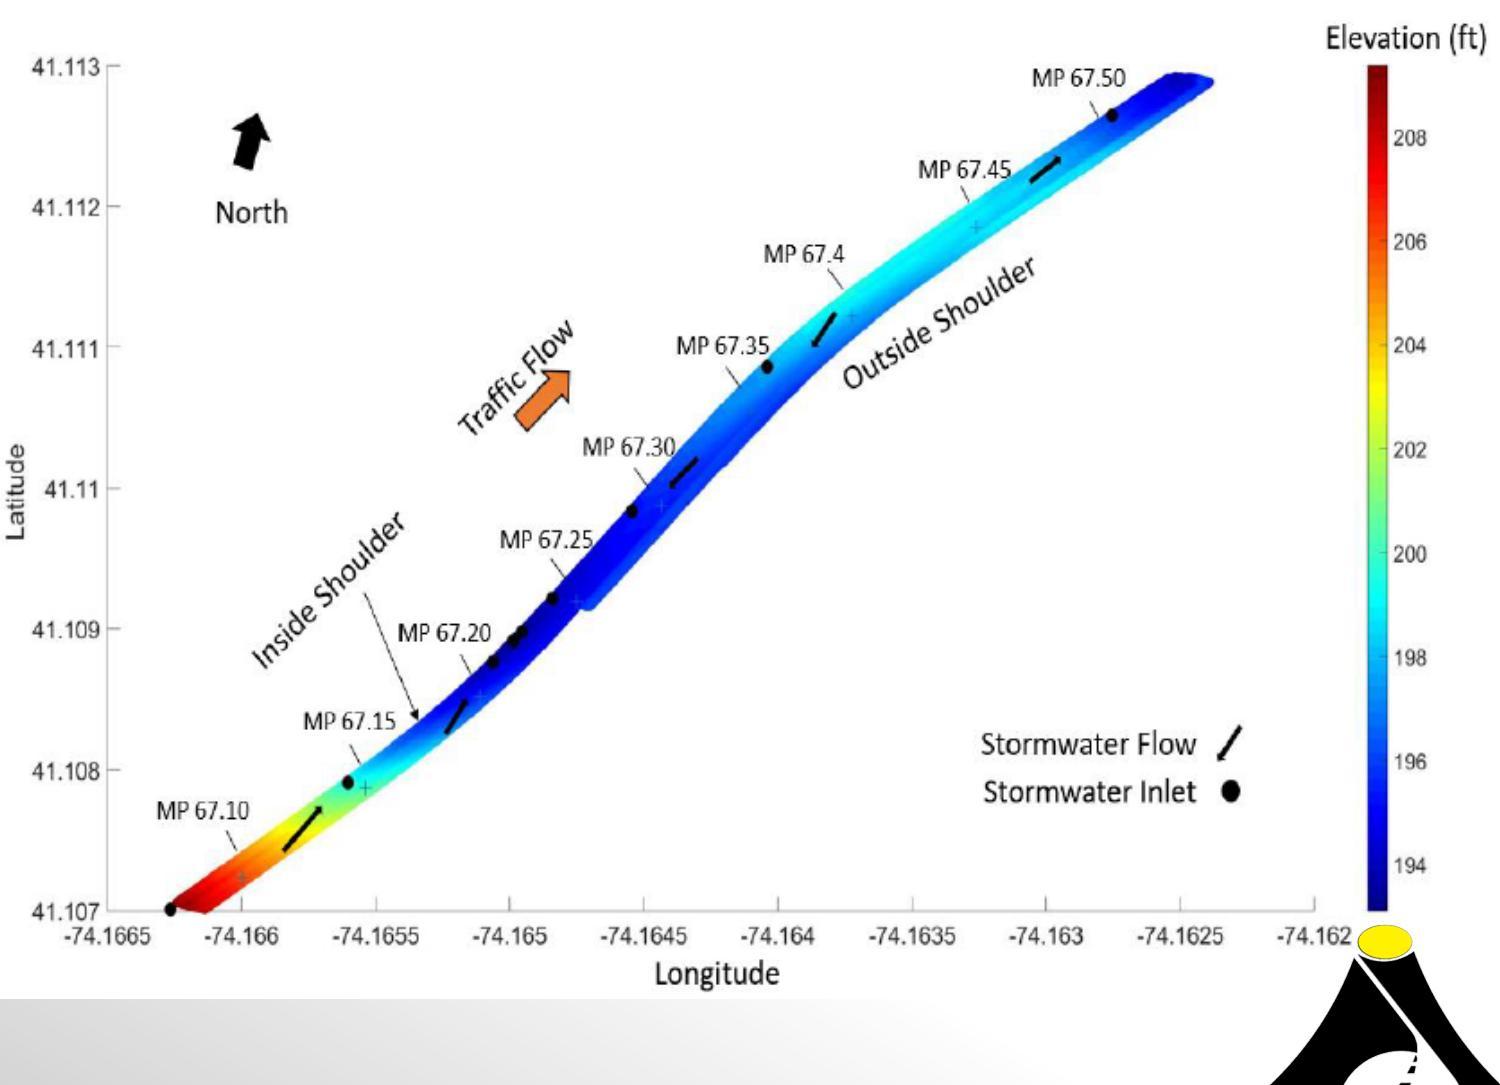
INLETS APPEAR TO BE LOCATED APPROPRIATELY,
BASED ON THE PROFILE. HOWEVER, THE NEARZERO SLOPES IN THIS SECTION MAY RESULT IN
SLOW-MOVING SURFACE RUNOFF AND CAUSE
WATER PONDING DURING HIGH-INTENSITY RAIN
EVENTS, CONTRIBUTING TO WET WEATHER
ACCIDENTS IN THIS AREA
