SADDLE UP!
TEXAS 2025

QC/QA FOR PAVEMENT CONDITION DATA EMPHASIS ON LCMS PAVEMENT DISTRESS IDENTIFICATION

JEANNINE MORIARTY, CT DOT
TRANSPORTATION ENGINEER III
PAVEMENT MANAGEMENT UNIT
BUREAU OF ENGINEERING AND CONSTRUCTION

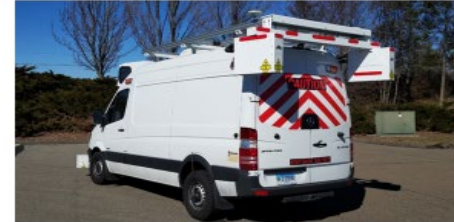
- Annual state network surveys performed with Automatic Road Analyzer (ARAN) vans
- 7,466 directional miles for the 3,733 centerline miles network
- Capable of measuring 15 different data streams at traffic speeds
- Sensors permanently installed and managed in a climate-controlled environment
- Custom built according to ConnDOT specifications

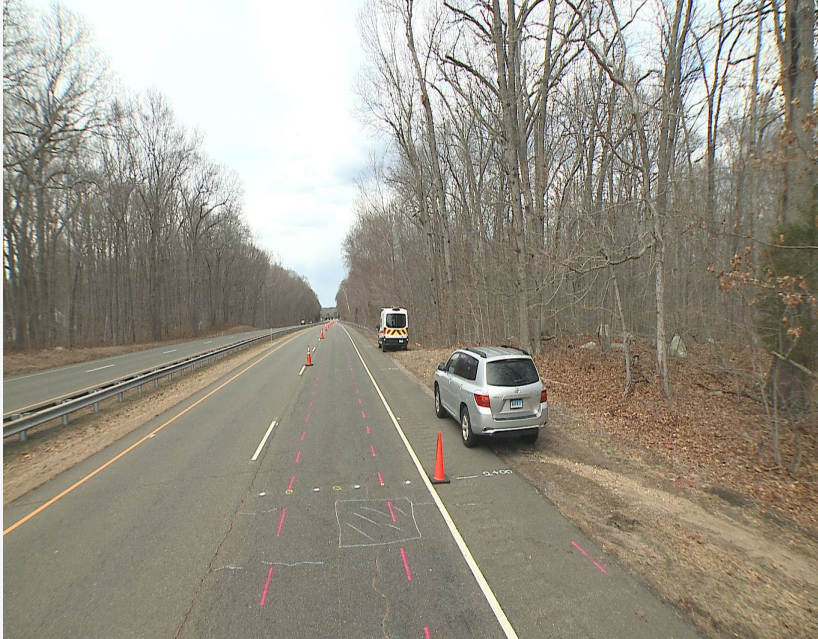
CT 450 /Validation Site 2025

same layout used for route 85 NB

Front image of manual distress (in chalk)
Section 150' to 175'

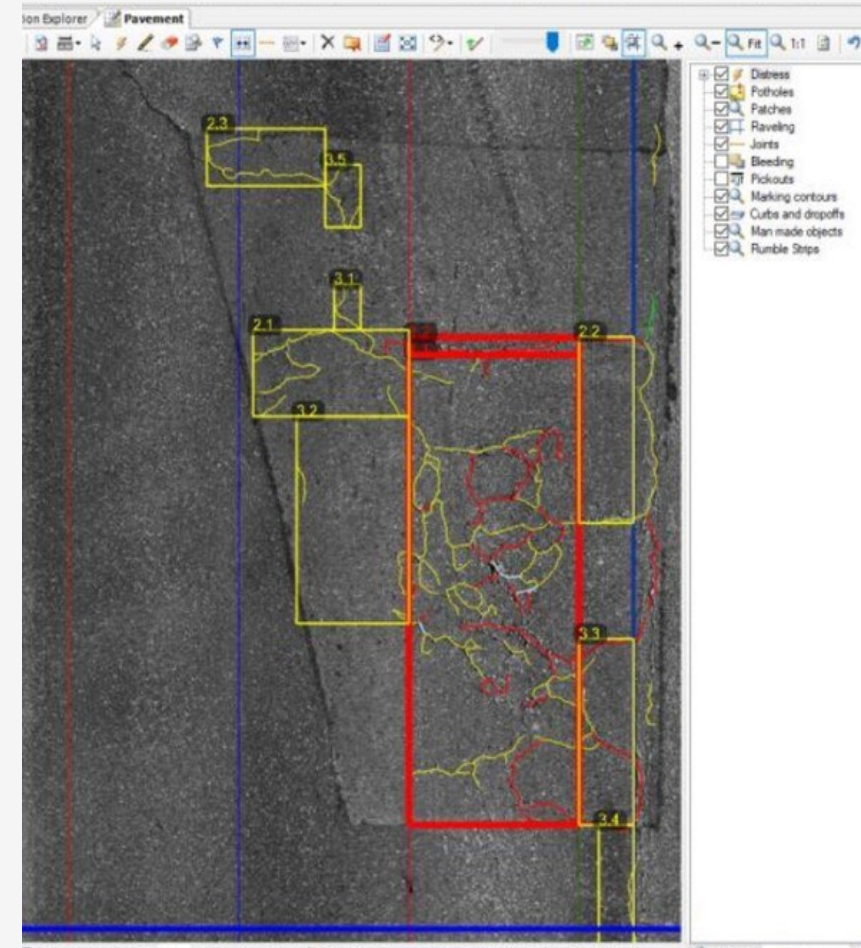
Figure 1-5 Crack map with crack number

Location of cracks are tracked in meters in pavement image. Crack number is also identified on each individual crack

1. Road zones
2. Crack ID which is crack number
3. Crack categories Longitudinal, Transverse and Alligator
4. Show crack type Long CTR and Alligator LWP etc.

(See figure 1-5 crack map with crack number and location)
