# Rutting as a Performance Indicator

Amy Simpson, Ph.D., P.E. Gonzalo Rada, Ph.D., P.E. Beth Visintine, Ph.D. Jonathan Groeger

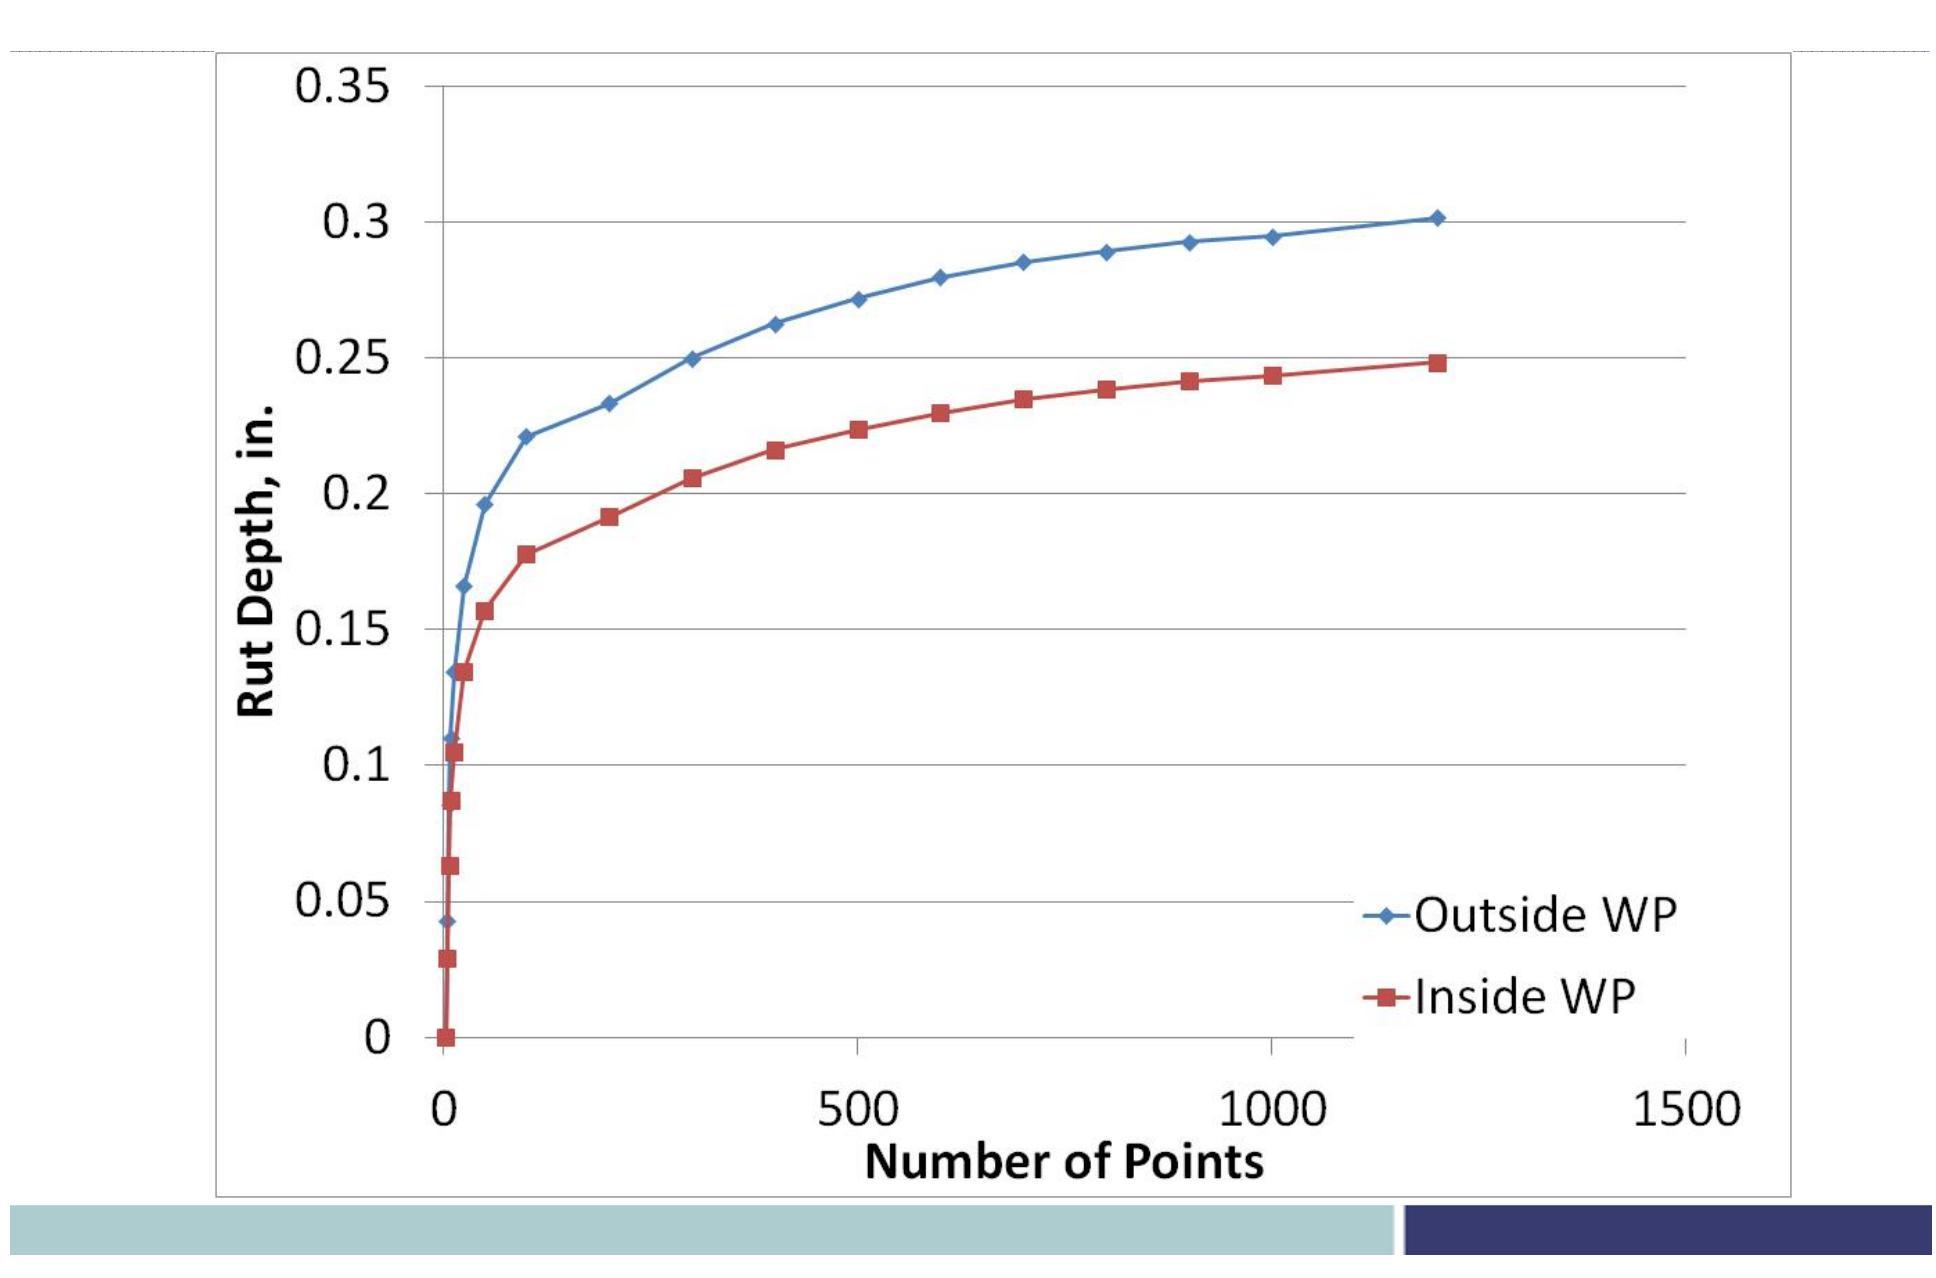
#### **Transverse Spacing**

- AASHTO PP70-10: Width should cover at least 13 ft
- Maximum spacing between data points of 0.4 inch
- Maximum spacing between profiles of 10 ft

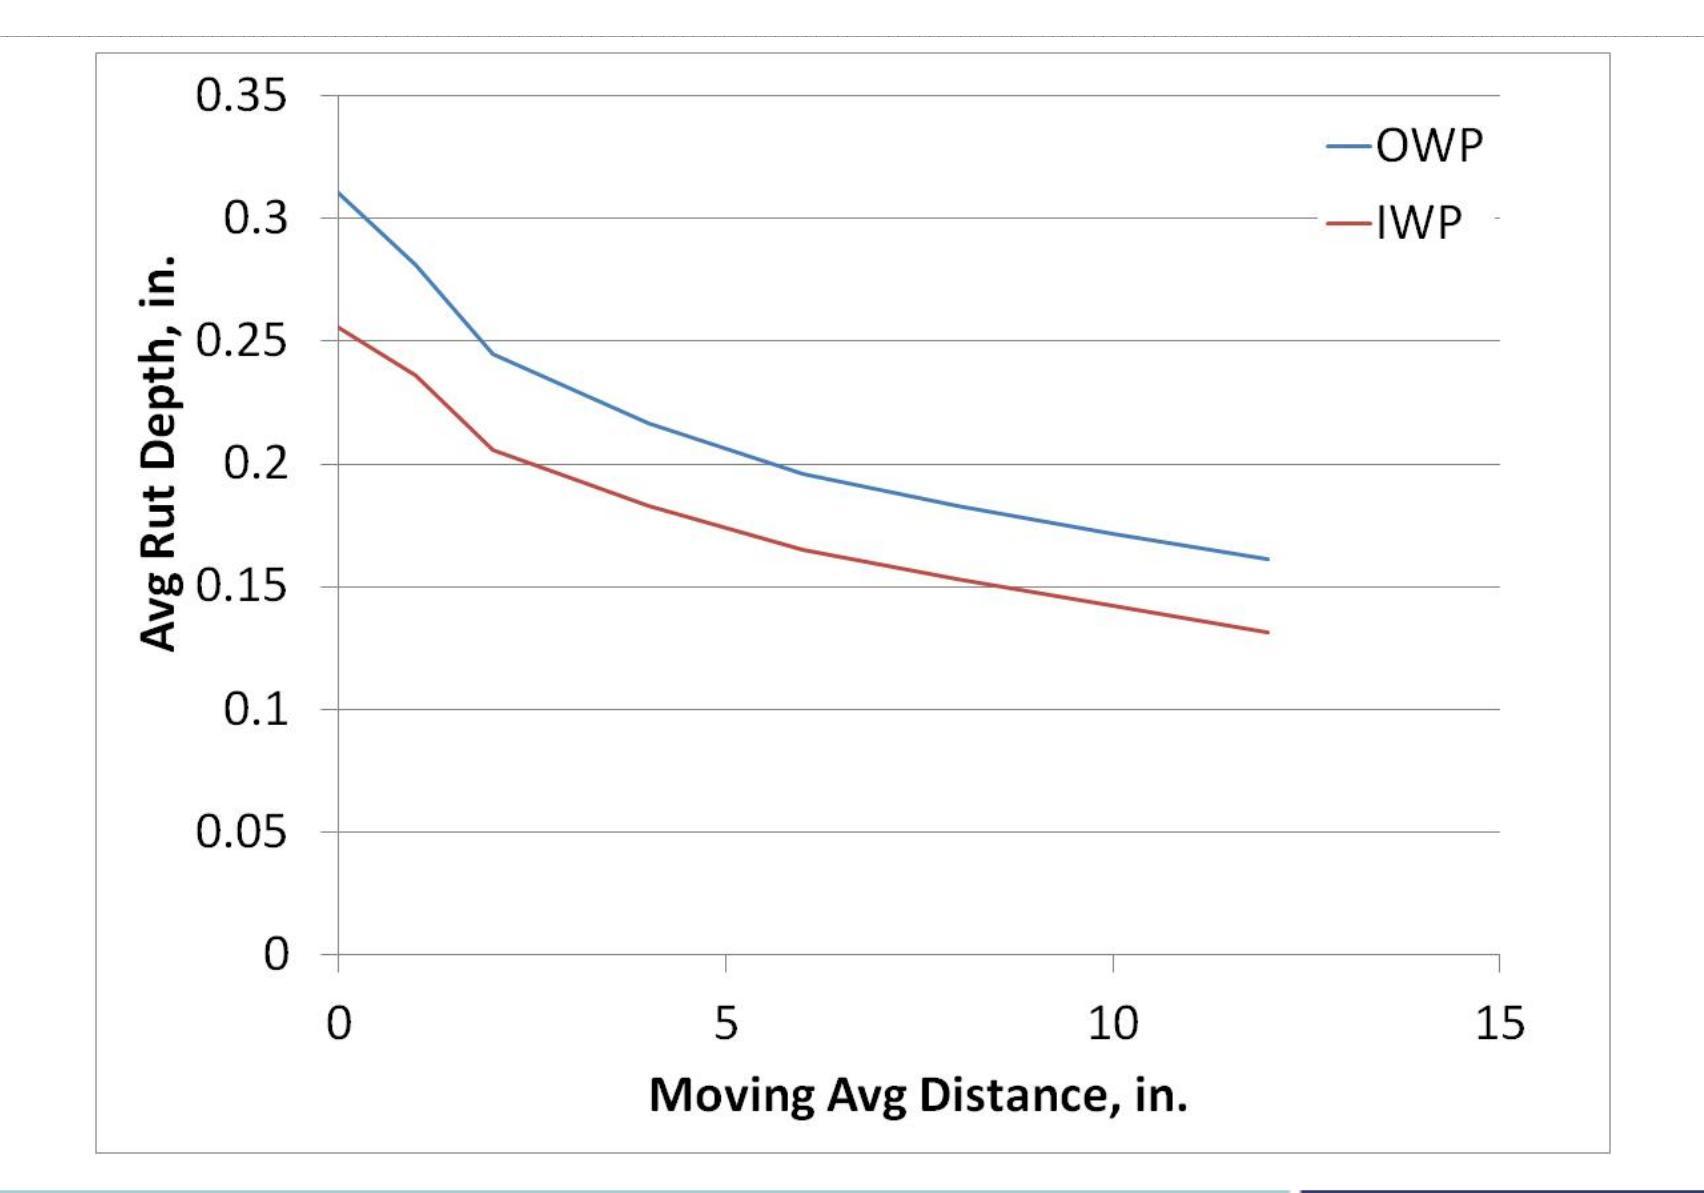
#### **Profile Filtering – Moving Average**

- 2-inch moving average filter applied to transverse profile
- Use lane width wireline reference
- Gage width from 1.2 to 1.5 inches

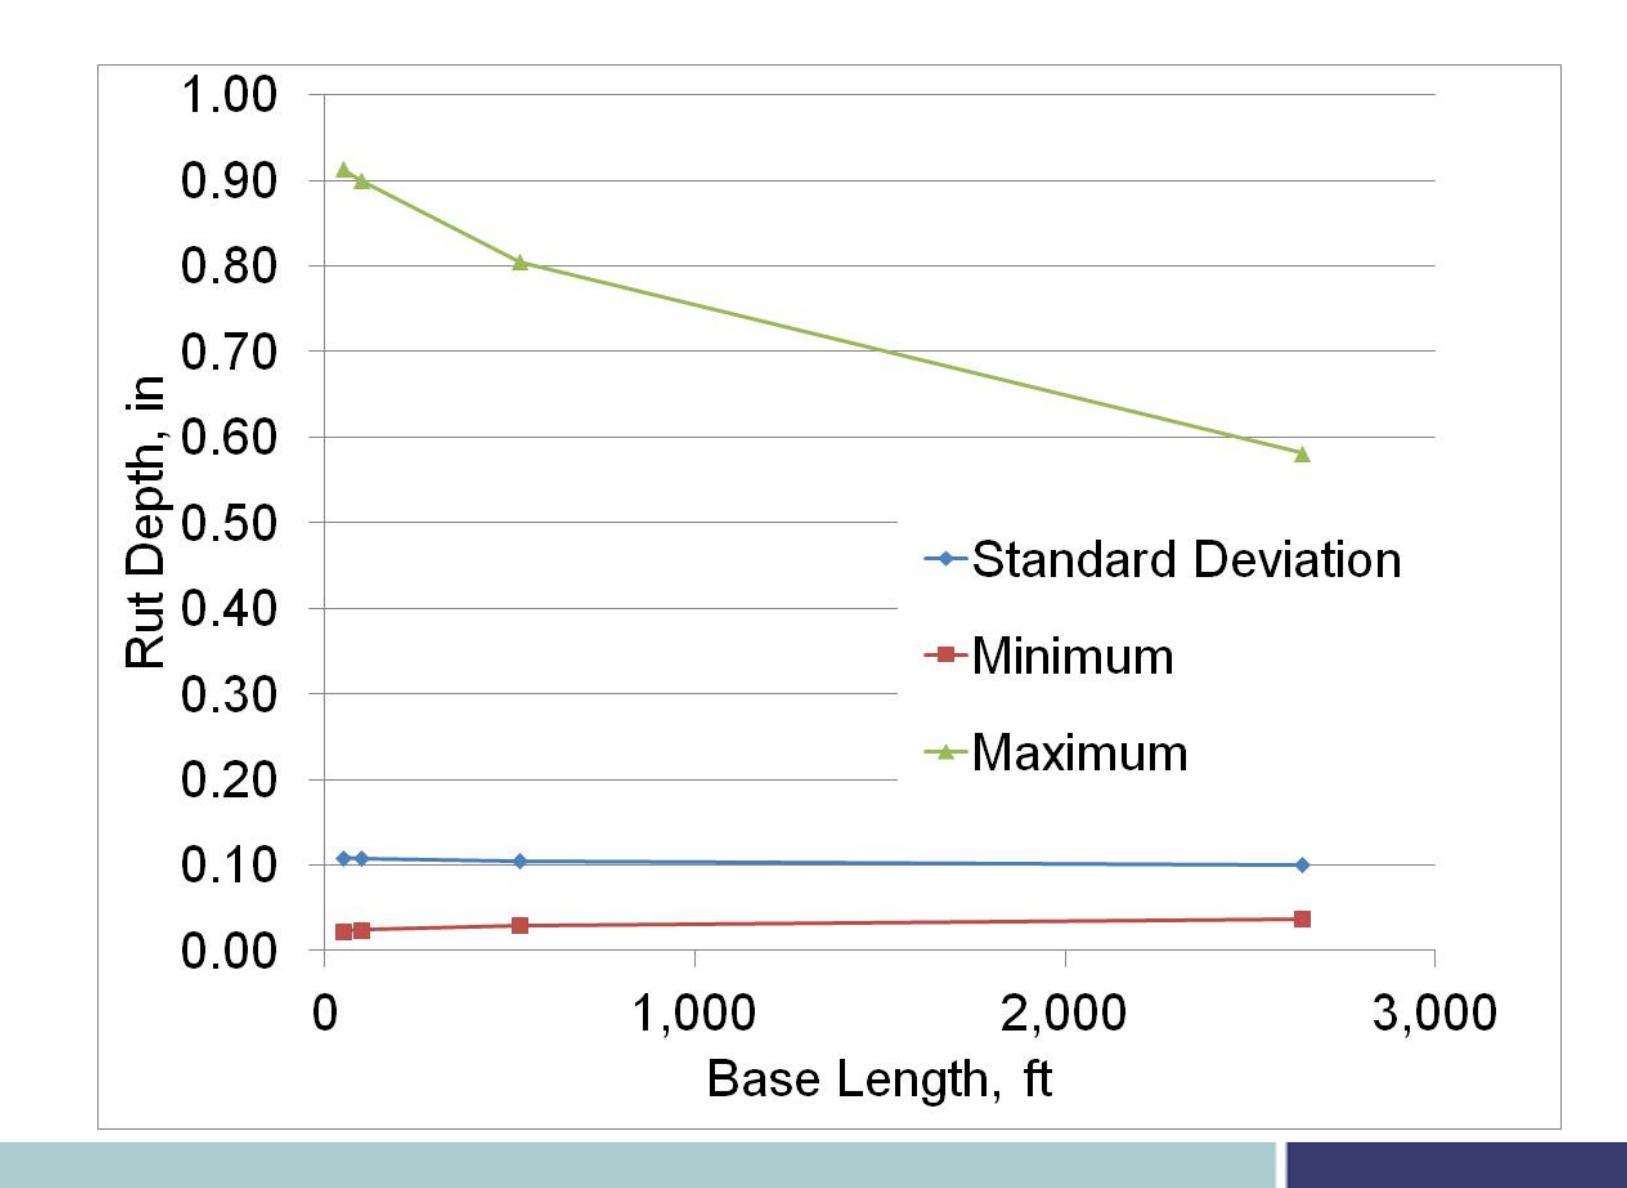
#### **Base Length**

- Data Elements
  - Average, minimum, maximum, and standard deviation of rut depth
  - Cross-slope
- Base length of 0.1-mile
- Metadata stored should include the full transverse profile
- Quality control elements identifying level of review
