Automated Replaced Slab Identification in Jointed Concrete Pavements Using Deep Learning to Improve Pavement Management

*Mahla Ardebili Pour, M.S. (Expected Graduation Date: Summer 2026)
Advisors: Somayeh Nassiri; Jeremy Lea*

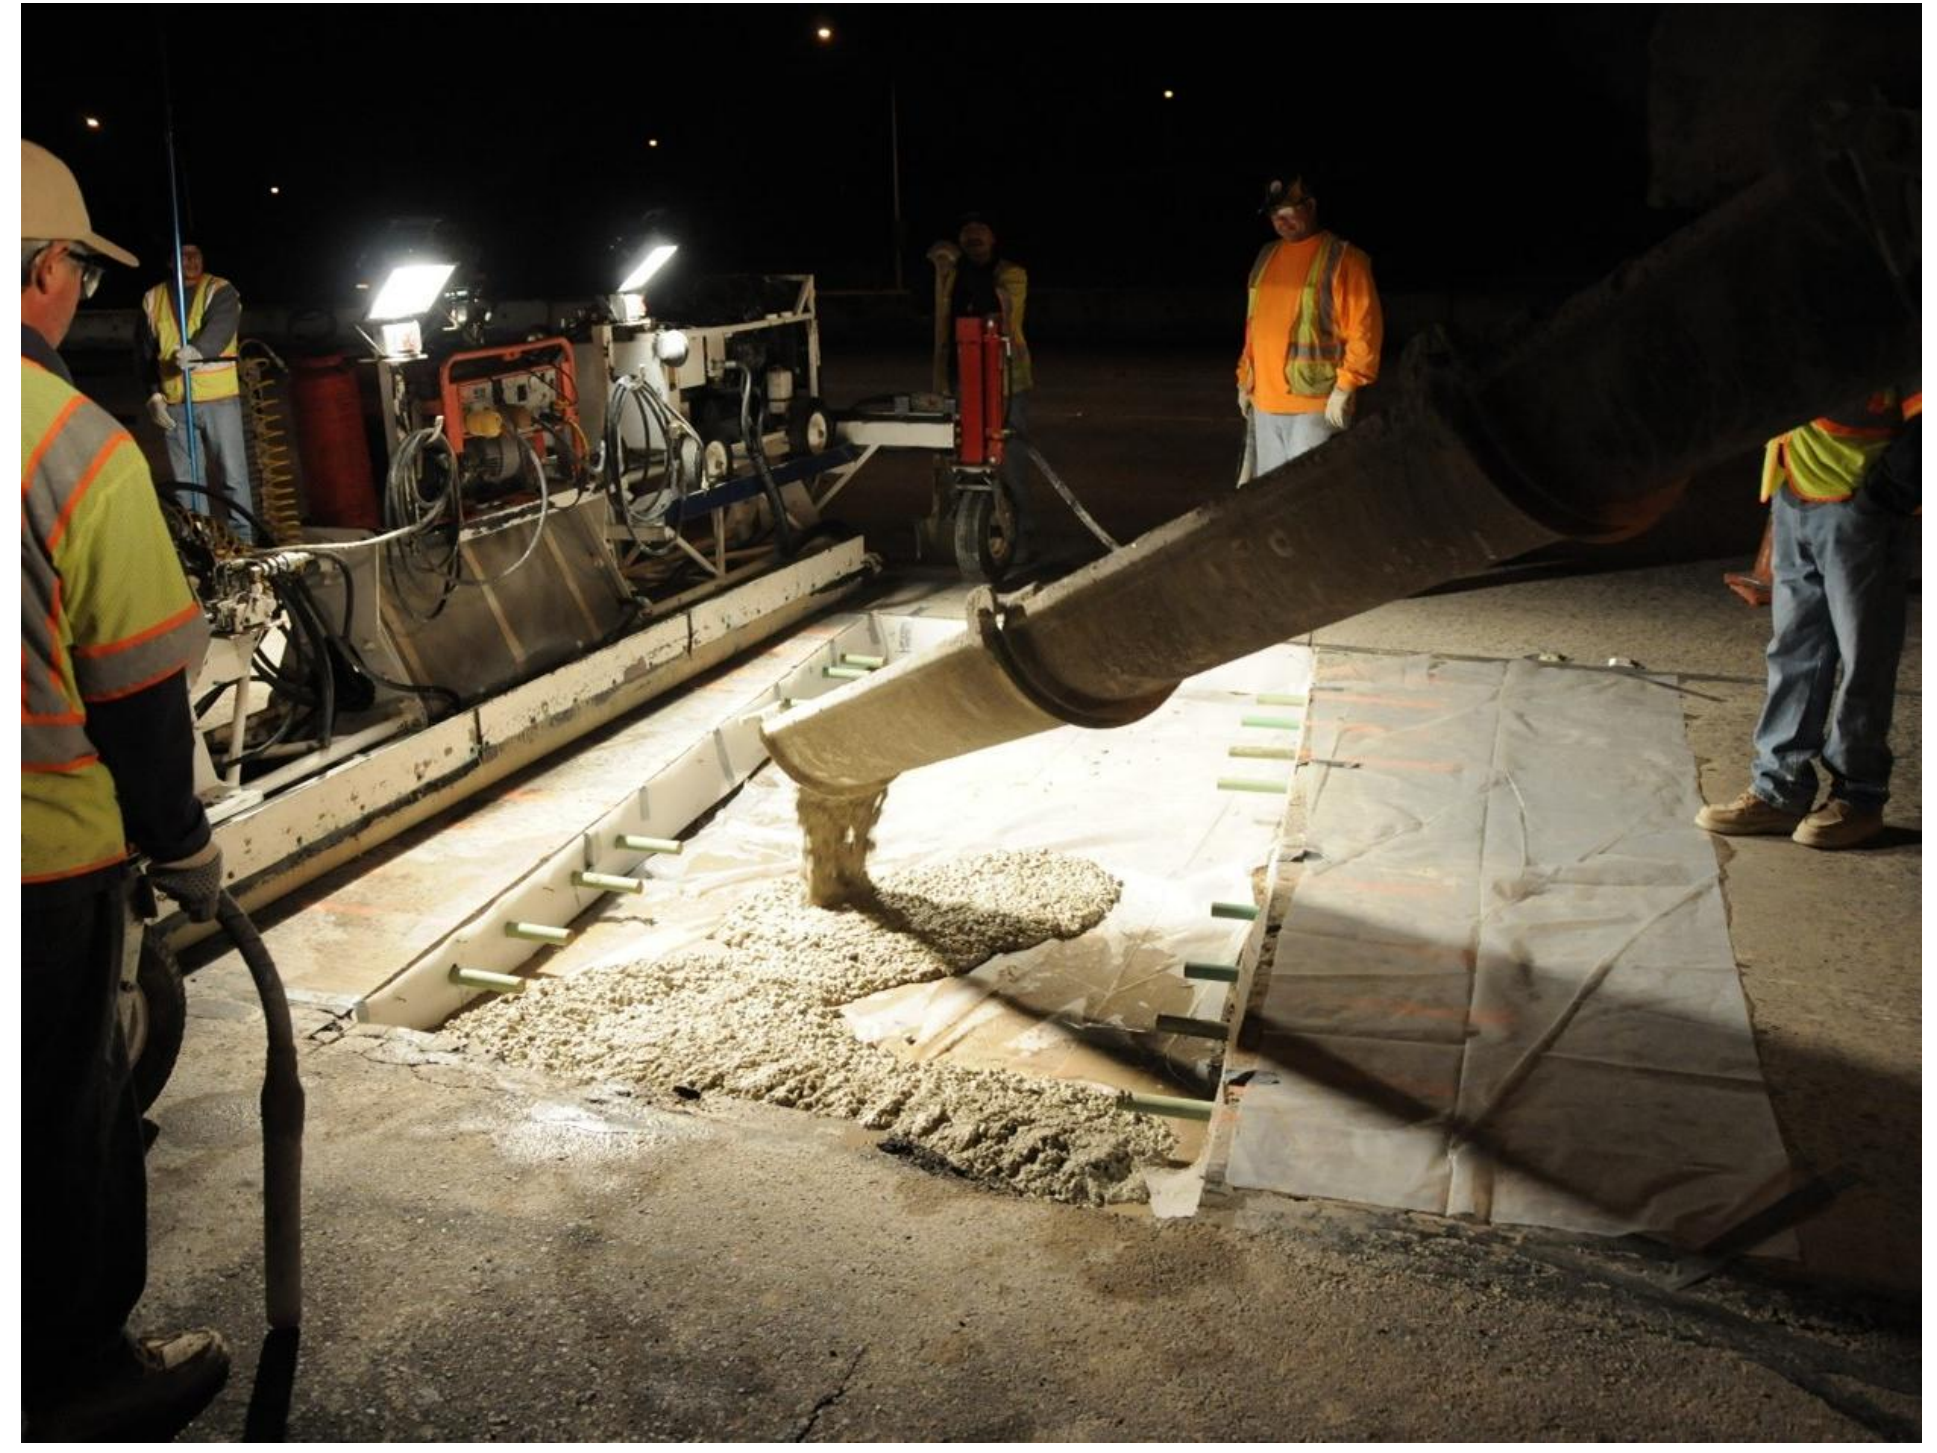
Figure 1. JPCP slabs, Caltrans [1]

Agencies need up-to-date records of pavement repairs for asset management and planning. Currently the identification of replaced Jointed Plain Concrete Pavement (JPCP) slabs (Figure 1) is manual and inconsistent. In this work we aim to automatically detect replaced slabs from high-resolution 3D surface images and deep learning. In this way we have faster and more consistent repair databases for planning and budgeting.

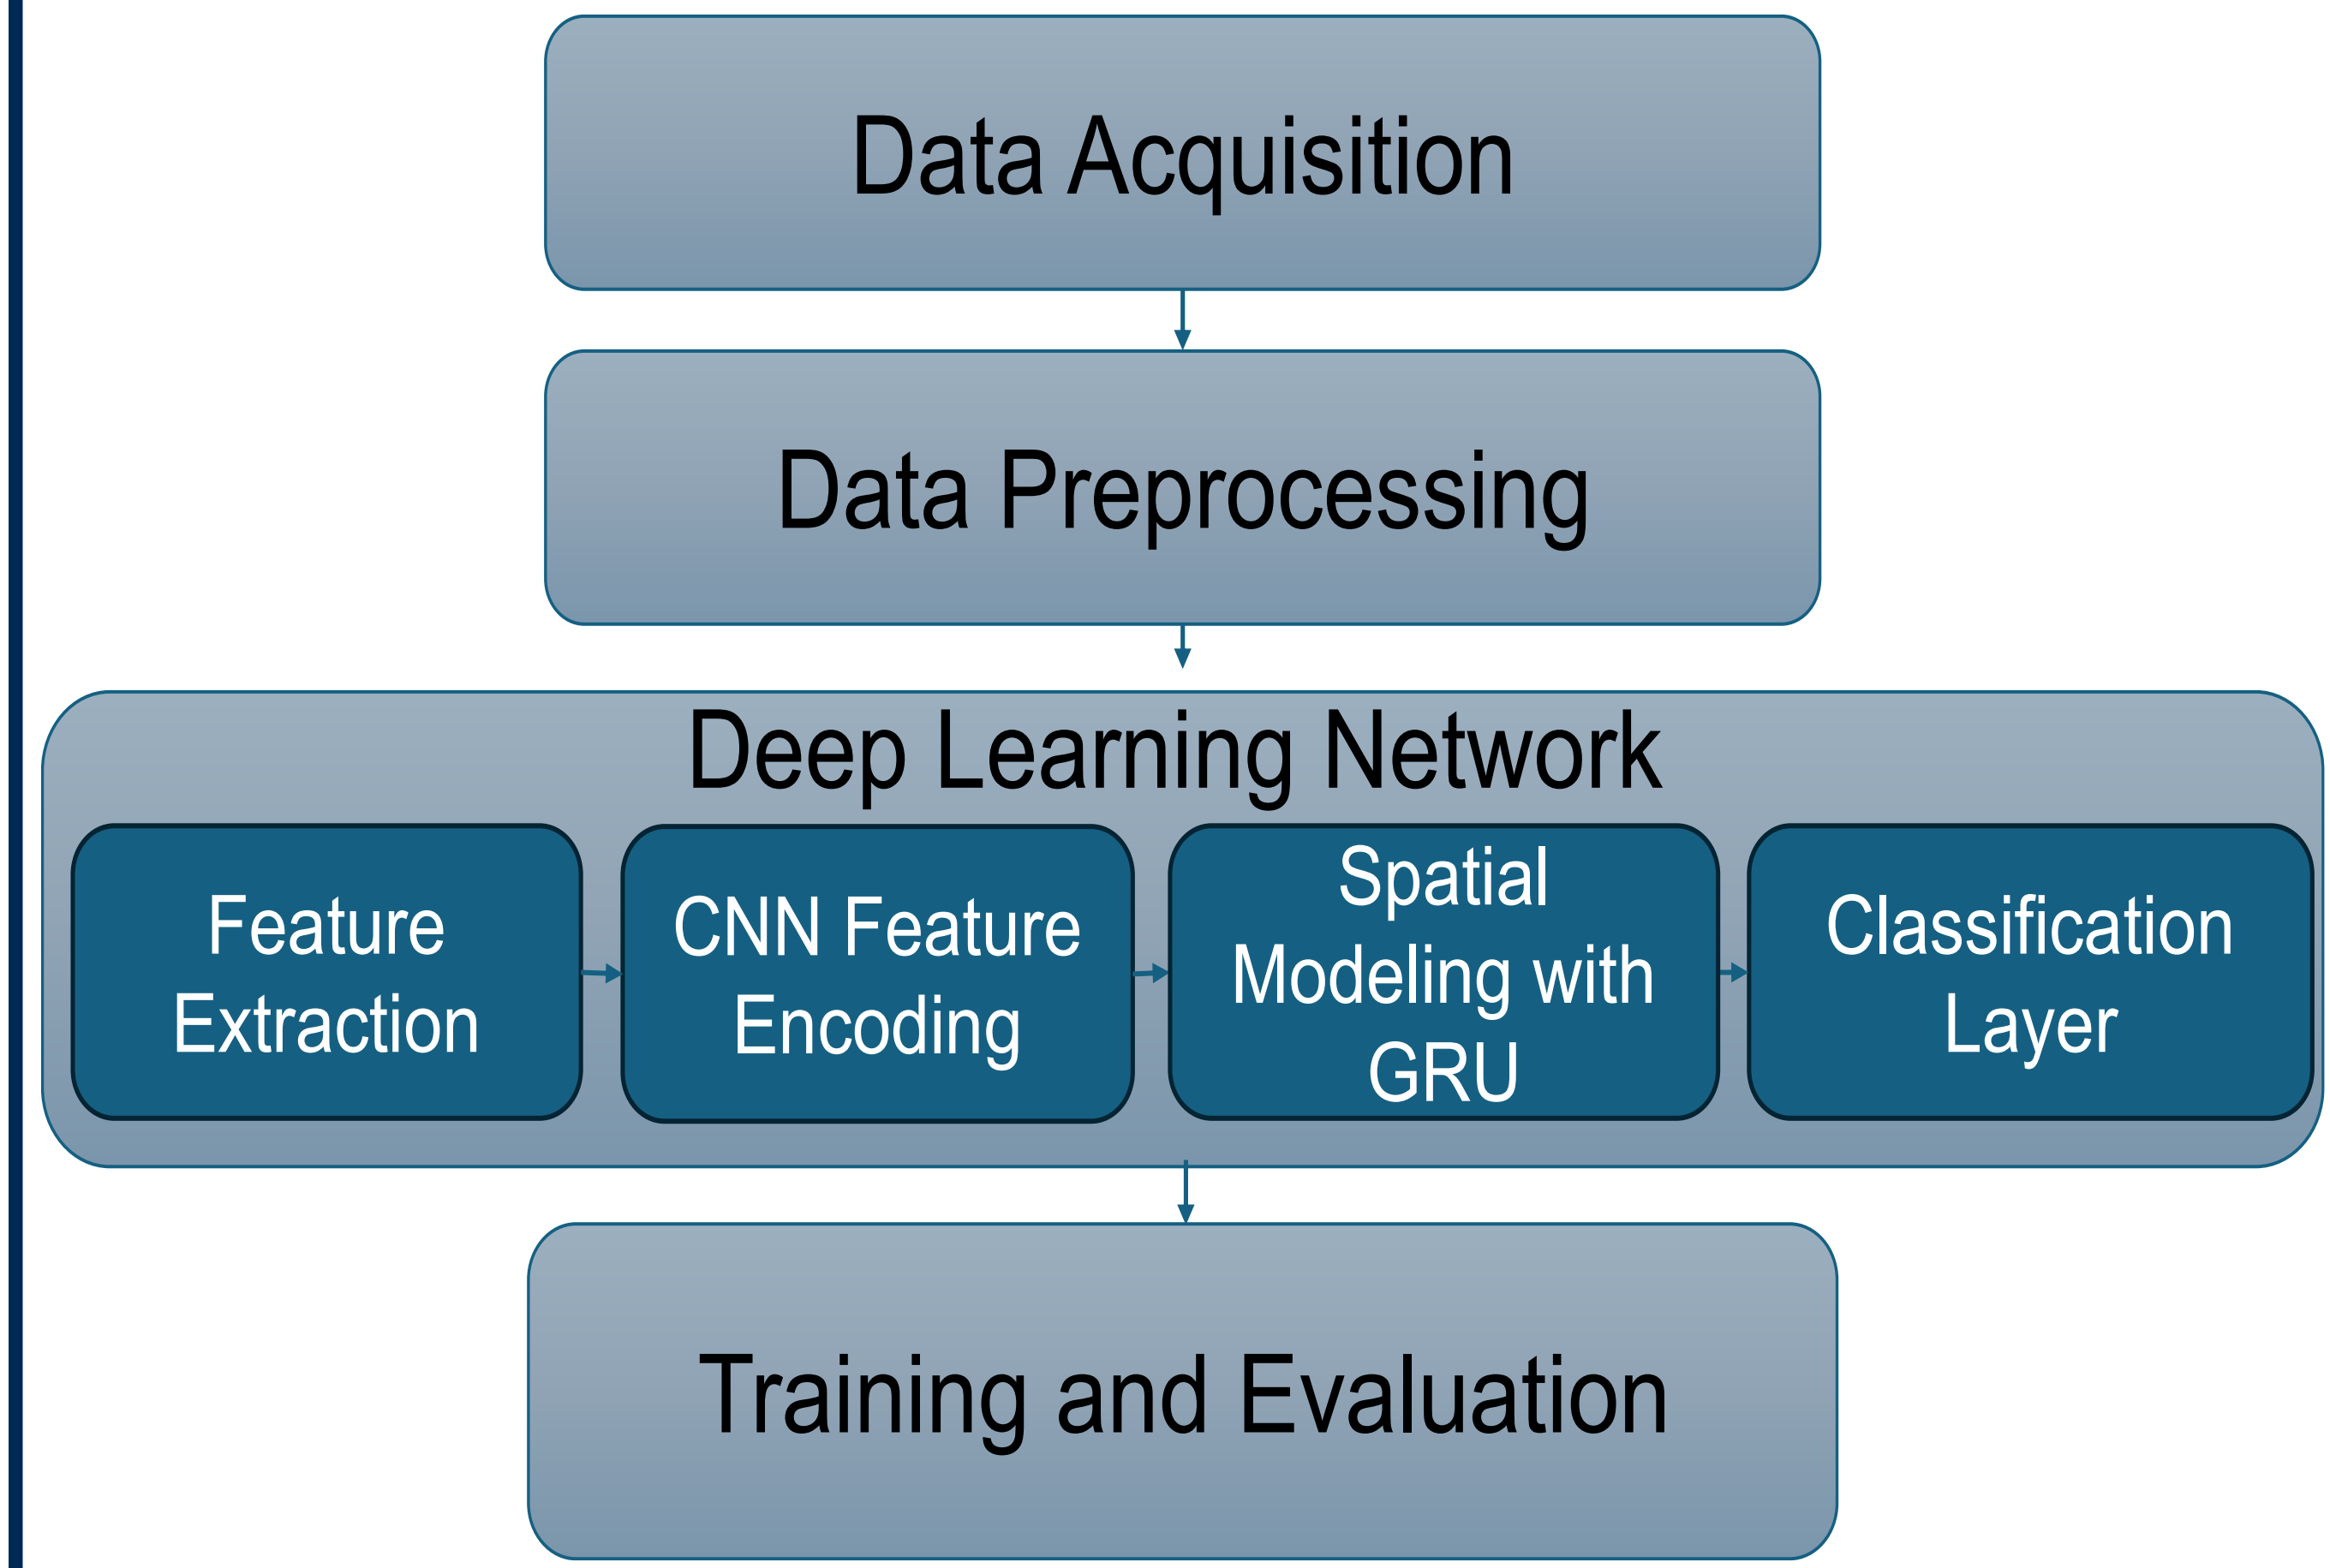
Figure 3. Workflow of this research

- Dataset: 372,805 labeled slabs from Caltrans 3D pavement imagery. Figure 2(a) shows the 3D imaging method.
- Preprocessing: full-width bottom crop to 400 × 1536 pixels (Figure 2(b)).
- Inputs: slab image + engineered green-channel features (Intensity histogram, LBP (local binary pattern) histogram)
- Model: Figure 3 summarizes the pipeline. 3D slab images are collected, cropped, and normalized. A CNN converts each slab image into a set of learned features; and a GRU uses adjacent-slab context to classify each slab as replaced or not replaced.

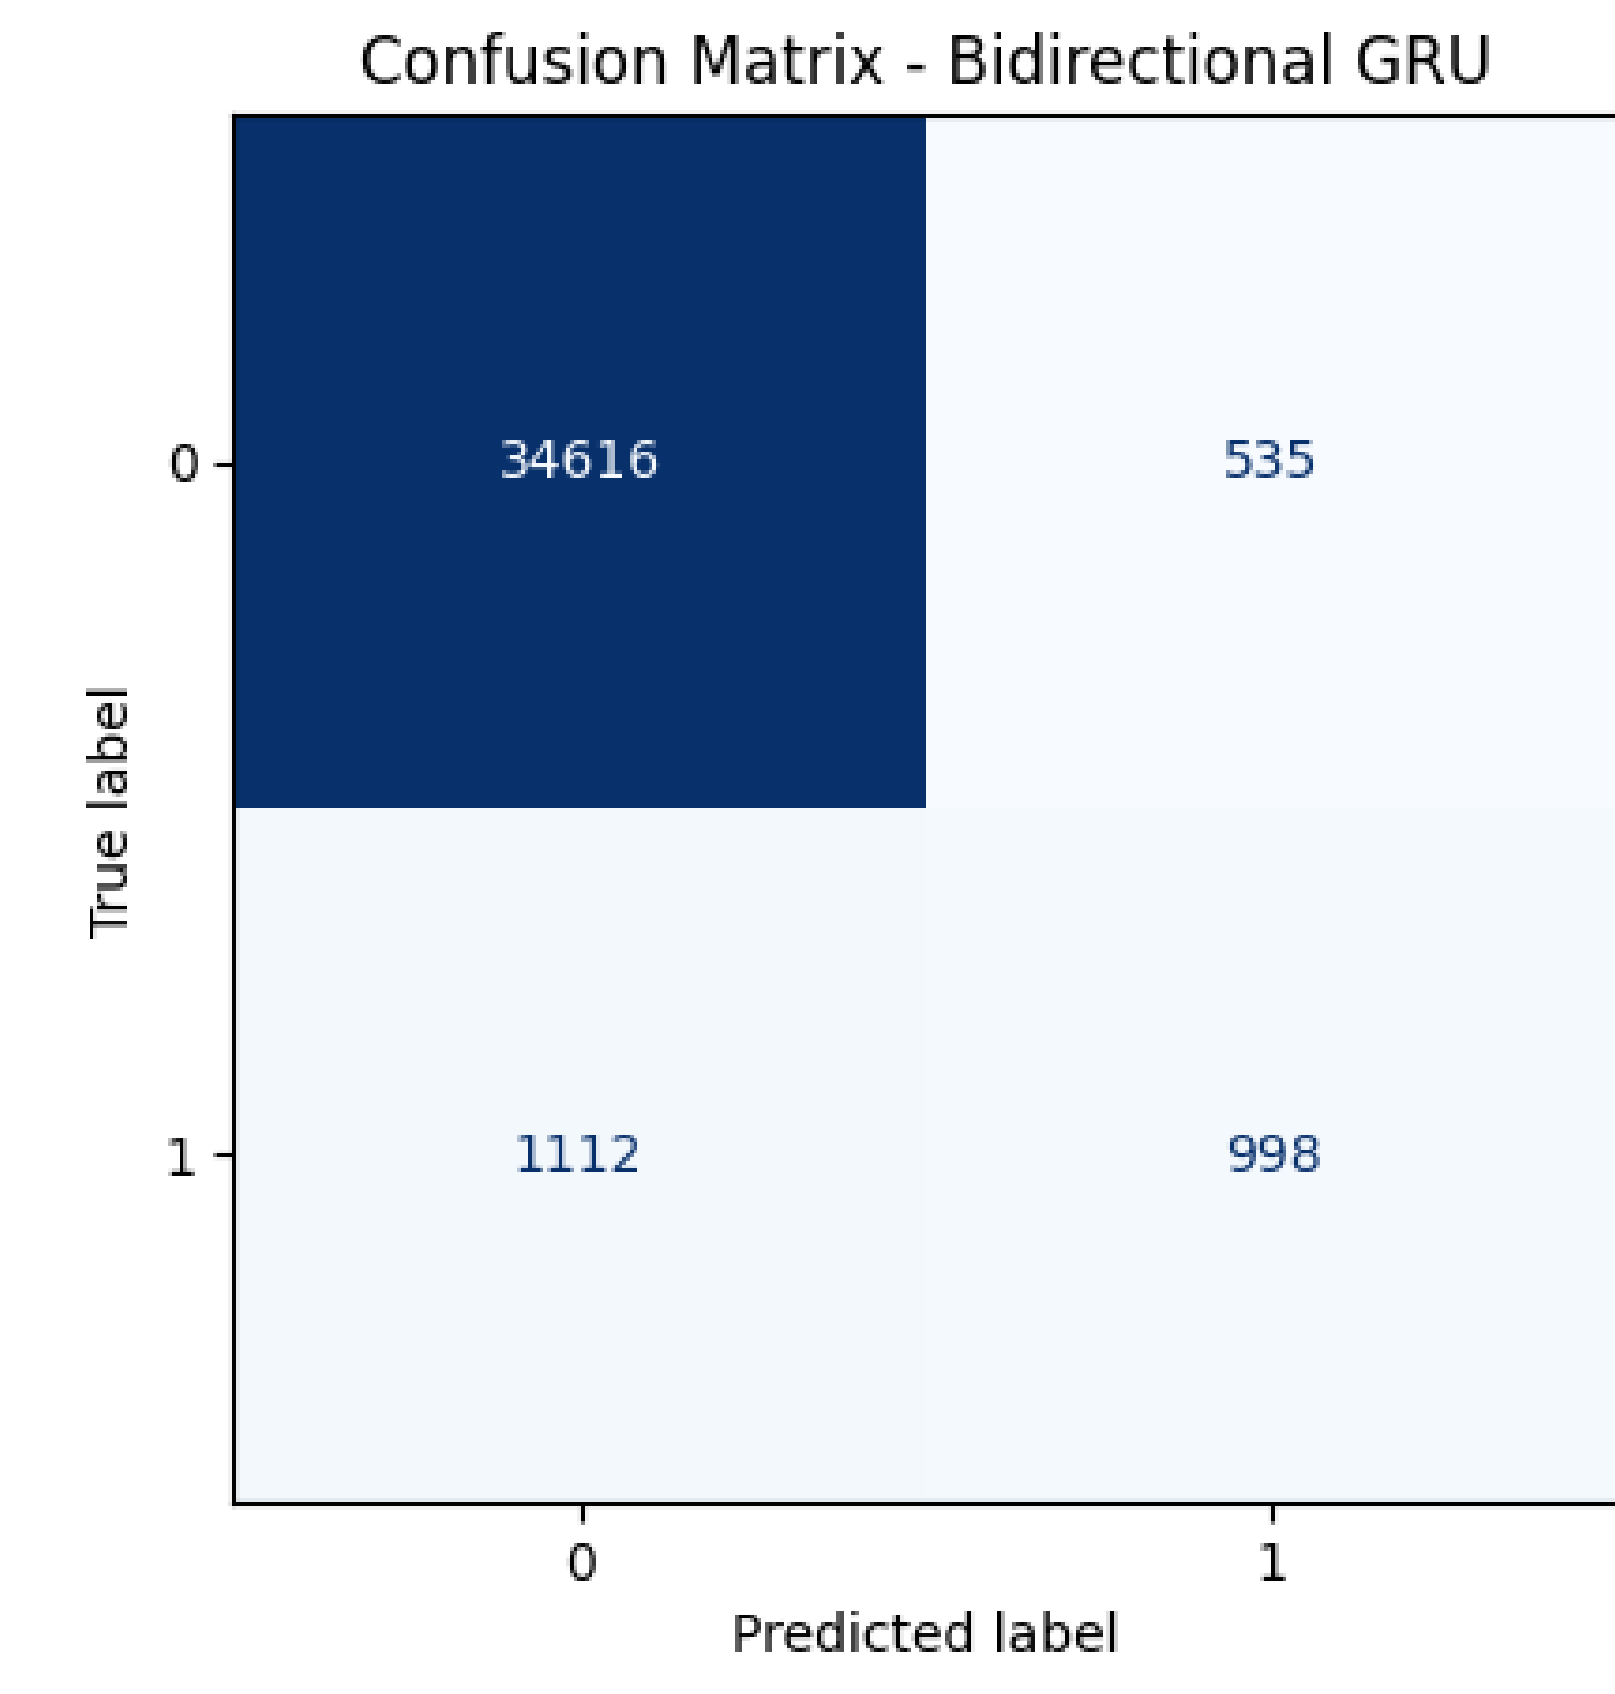
Figure 4. Confusion matrix

- On the test set the model achieved 96% accuracy.
- Figure 4 shows the test confusion matrix, which summarizes correct and incorrect predictions as true positive, true negative, false positive, and false negative (TP/TN/FP/FN). Figure 5 shows some examples from each category. Most errors occur near ambiguous boundaries.
